# Preventive maintenance IDEV

February, 10 2021, Annual visit

Equipment data		Customer Ref. :	
Equipment concerned	: IDEV	Install/Startup date	: September, 10 2020
Serial number	: SCE 153577	Capacity	: 52.5 kW
Configuration	: Group configuration		
Unit number within group system: 2 / 2

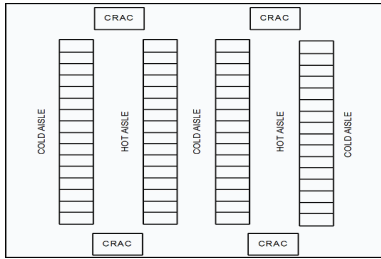
### Cooling unit alignments

To optimize a raised-floor cooling system, cooling units must be aligned with hot aisles.

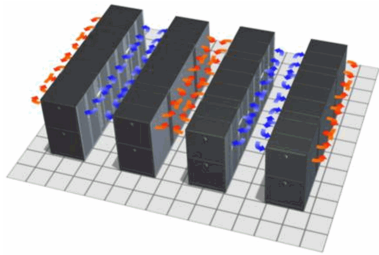
### Hot/Cold aisle configuration

Configure rows in alternating 'hot' and 'cold' aisles to avoid mixing between 'hot' and 'cold' air.

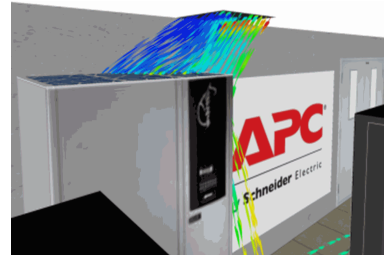
### Diffuser location

Roof or wall mounted distribution vents need to be properly positioned to better facilitate hot air removal.

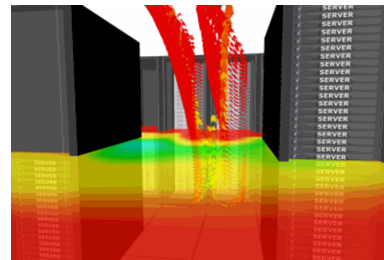
### Gaps in the rows

Prevent hot exhaust from recirculating back to the equipment's intake side by removing any openings (gaps) in the rows.
