Multi-day temp/r.h. plots, Q1 & Q2, H-123

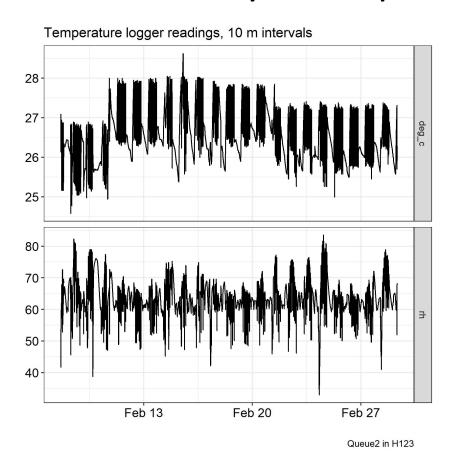
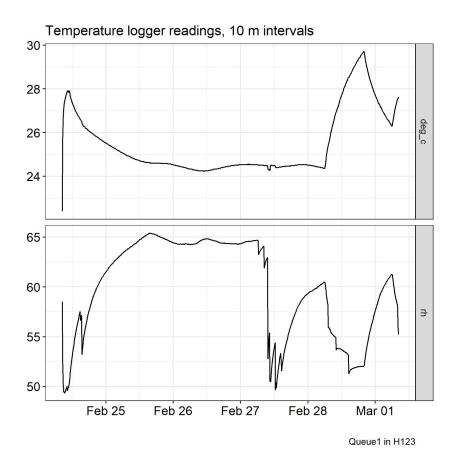
Queue 2 (south, first unit done) fluctuates within acceptable tolerance. Queue 2 has less fluctuation, but drifts and is outside acceptable tolerance with respect to the 26C target temperature.

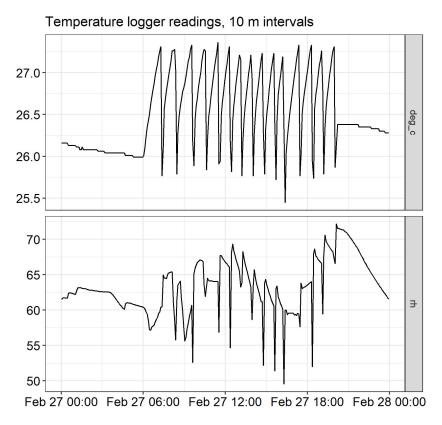
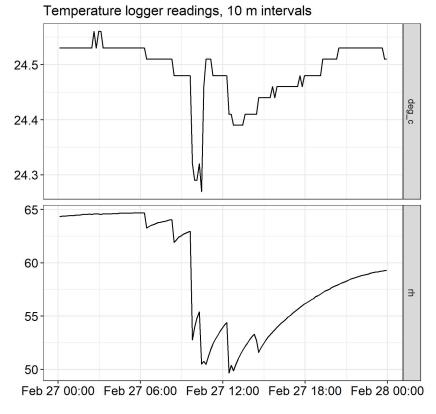
One day temp/r.h. plots, Q1 & Q2, H-123

The temperature profile for Queue 2 is consistent with the idea that heating from the lights causes some fluctuation.
There is no evidence of this for Queue 1.
