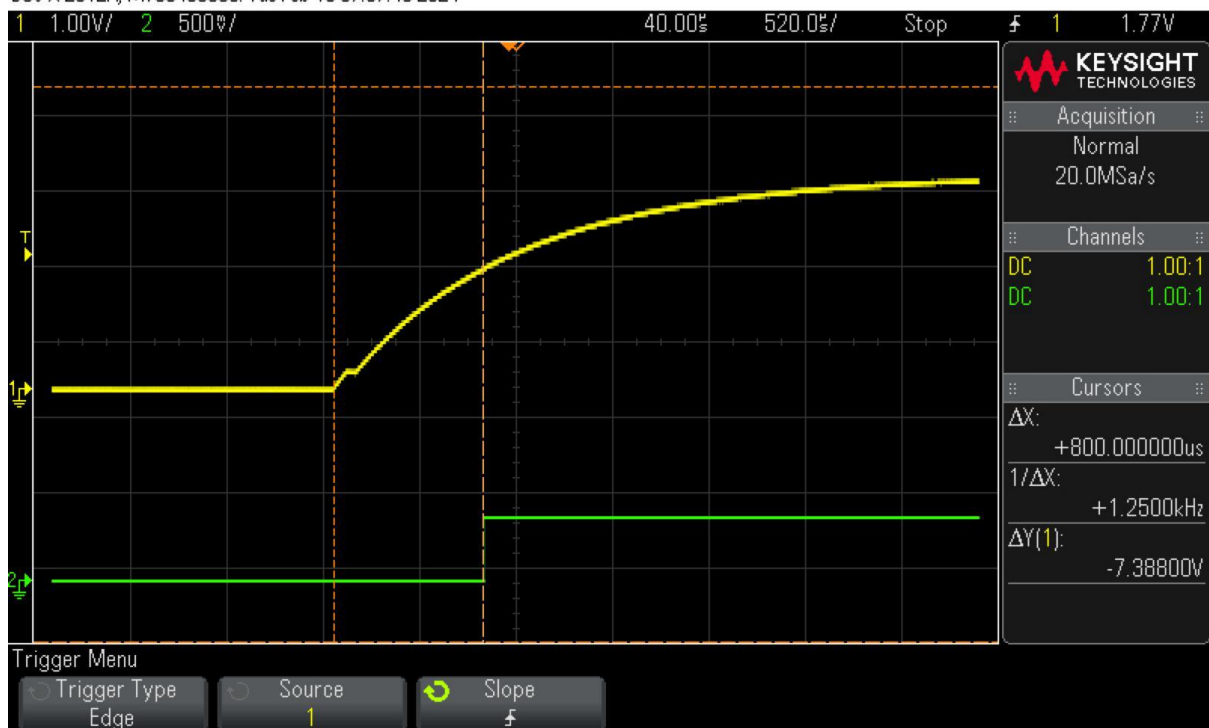
DSO-X 2012A, MY53400839: Tue Feb 13 07:57:43 2024

4. What was the latency between pushing the Discovery board button and the LED change

(interrupt handler start) that you measured with the logic analyzer? Make sure to include a screenshot in the post-lab submission.

800 microseconds was the latency
