Thermal Imaging Fault Detection for Rolling Element Bearings

Abstract—In rotating machinery, rolling element bearings are one of the most critical components and a large majority of system failures arise from faulty bearings. Hence, there is an increasing demand to find an effective and reliable condition monitoring technique. In this paper, a procedure for detecting various types of bearing faults using thermal imaging is presented and assessed. Five different fault cases are tested: no fault (NF), line fault (LF), small circle fault (SCF), double line fault (DLF), and large circle fault (LCF). Experiments were conducted on the BENTLY NEVADA RK4 Rotor Kit. The tests were performed at 1500 RPM and 2000 RPM. A video is recorded for 10 minutes using FLIR thermal imaging camera and images are extracted from the video and processed to detect the average temperature at the bearing hotspot using MATLAB. Analysis of the results show that Thermal Imaging can be used as an effective means to differentiate between different types of faults that occur in the outer race of the rolling element bearing.

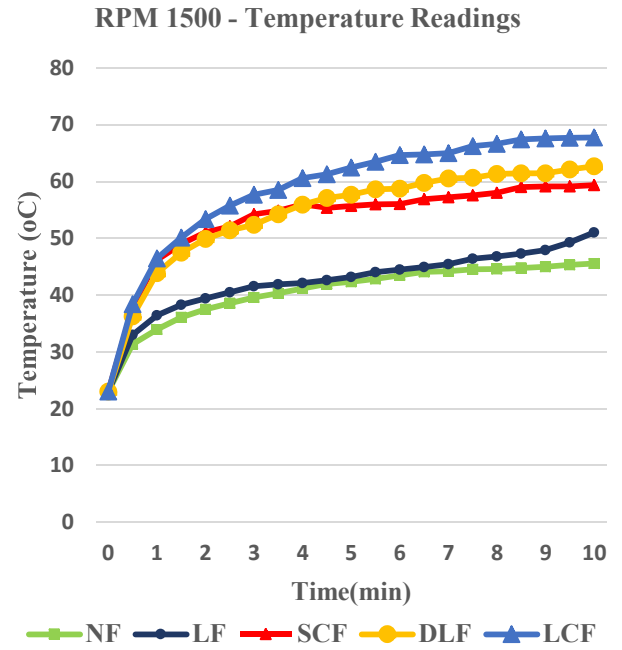
The results obtained from the thermal imaging camera are discussed in this section. The tests were conducted at 1500 RPM and at 2000 RPM. The fault cases are No Fault (NF), Line Fault (LF), Small Circle Fault (SCF), Double Line Fault (DLF), and Large Circle Fault (LCF). Fig. 6 depicts the temperature readings obtained for all the fault cases at 1500 RPM.

The temperature shown are the average temperature at the hotspot at intervals of 30 seconds from 0 – 10 minutes. It can be seen that the LCF exhibited the largest average temperature among the 5 cases. The second largest temperature was shown by the DLF. The lowest average is exhibited by NF. The temperature is higher for SCF up to 4 minutes and then the temperature is higher for DLF for the remaining 6 minutes. It can also be noticed that the temperature is quiet constant after the 7.5 minutes mark. This is because the rate of heat transfer is almost the same as the maximum heat generated beyond this time. The maximum average temperature was 68°C at 10 minutes for the LCF case followed by 64°C at 10 minutes for the DLF case. The temperature trend for all cases is such that $LCF > DLF > SCF > LF > NF$. This indicates that the fault can be identified using thermal imaging by recording samples of various faults.

Fig. 6. Temperature Readings at 1500 RPM

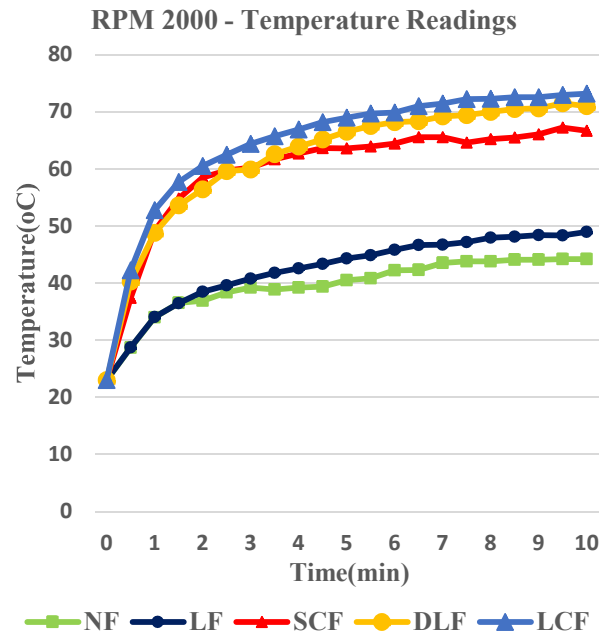
Fig. 7. Temperature Readings at 2000 RPM

Fig. 7 depicts the temperature readings obtained for all the fault cases at 2000 RPM. The temperature shown are the average temperature at the hotspot at intervals of 30 seconds from 0 – 10 minutes. It can be seen that the LCF exhibited the largest average temperature among the 5 cases. The second largest temperature was shown by the DLF. The lowest average is exhibited by NF. The temperature is higher for SCF up to 4 minutes and then the temperature is higher for DLF for the remaining 6 minutes. It can also be noticed that the temperature is quiet constant after the 7.5 minutes mark. This is because the rate of heat transfer is almost the same as the maximum heat generated beyond this time. The maximum average temperature was 74°C at 10 minutes for
