## H8 Front Panel Fixes:

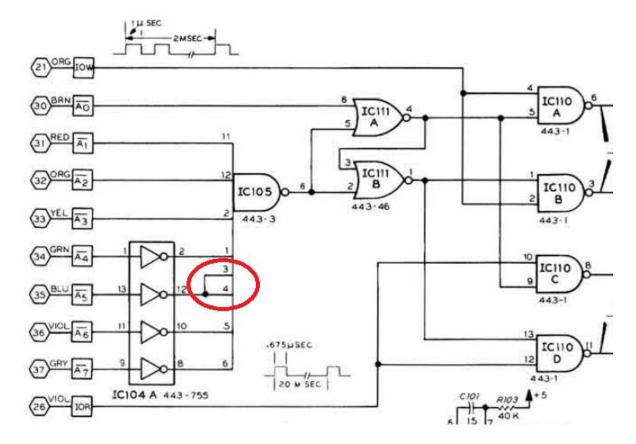
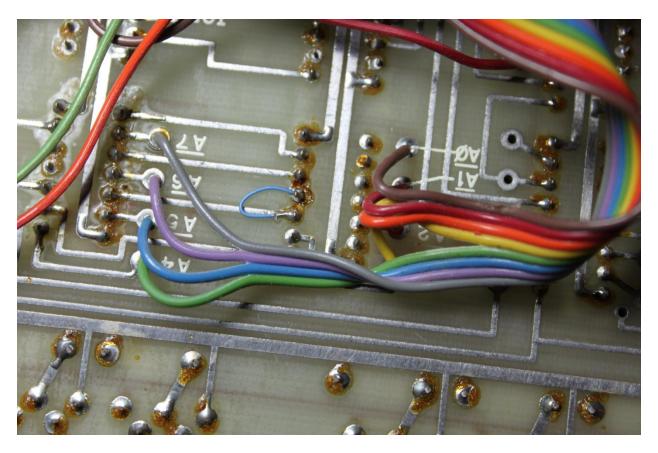
1. Pin 4 on IC105 is floating. Please connect a wire between pin 3 and pin 4 as shown in the diagram. Below is a picture showing the fix.

Please connect a wire between pin 3 and pin 4 as shown (blue wire)
