55-Story Tall Building – Before and After Earthquake Retrofit

What if the shaking from an earthquake was irrelevant because all our buildings were safe from collapse, and they could keep us safe inside them? That's one of the goals earthquake engineers are trying to accomplish. USGS earthquake engineer Mehmet Çelebi and several other colleagues in other organizations recently studied the "before" and "after" of a 55-story tall building in Osaka, Japan that was subjected to two real earthquakes, once before a seismic retrofit and again after the retrofit. This project offered a rare opportunity to study the retrofit "before" and "after" of a tall building shaken by two distant earthquakes. The scientists wanted to know how the engineering improvements had changed the response of the building to potentially-damaging shaking that is caused by large distant earthquakes.

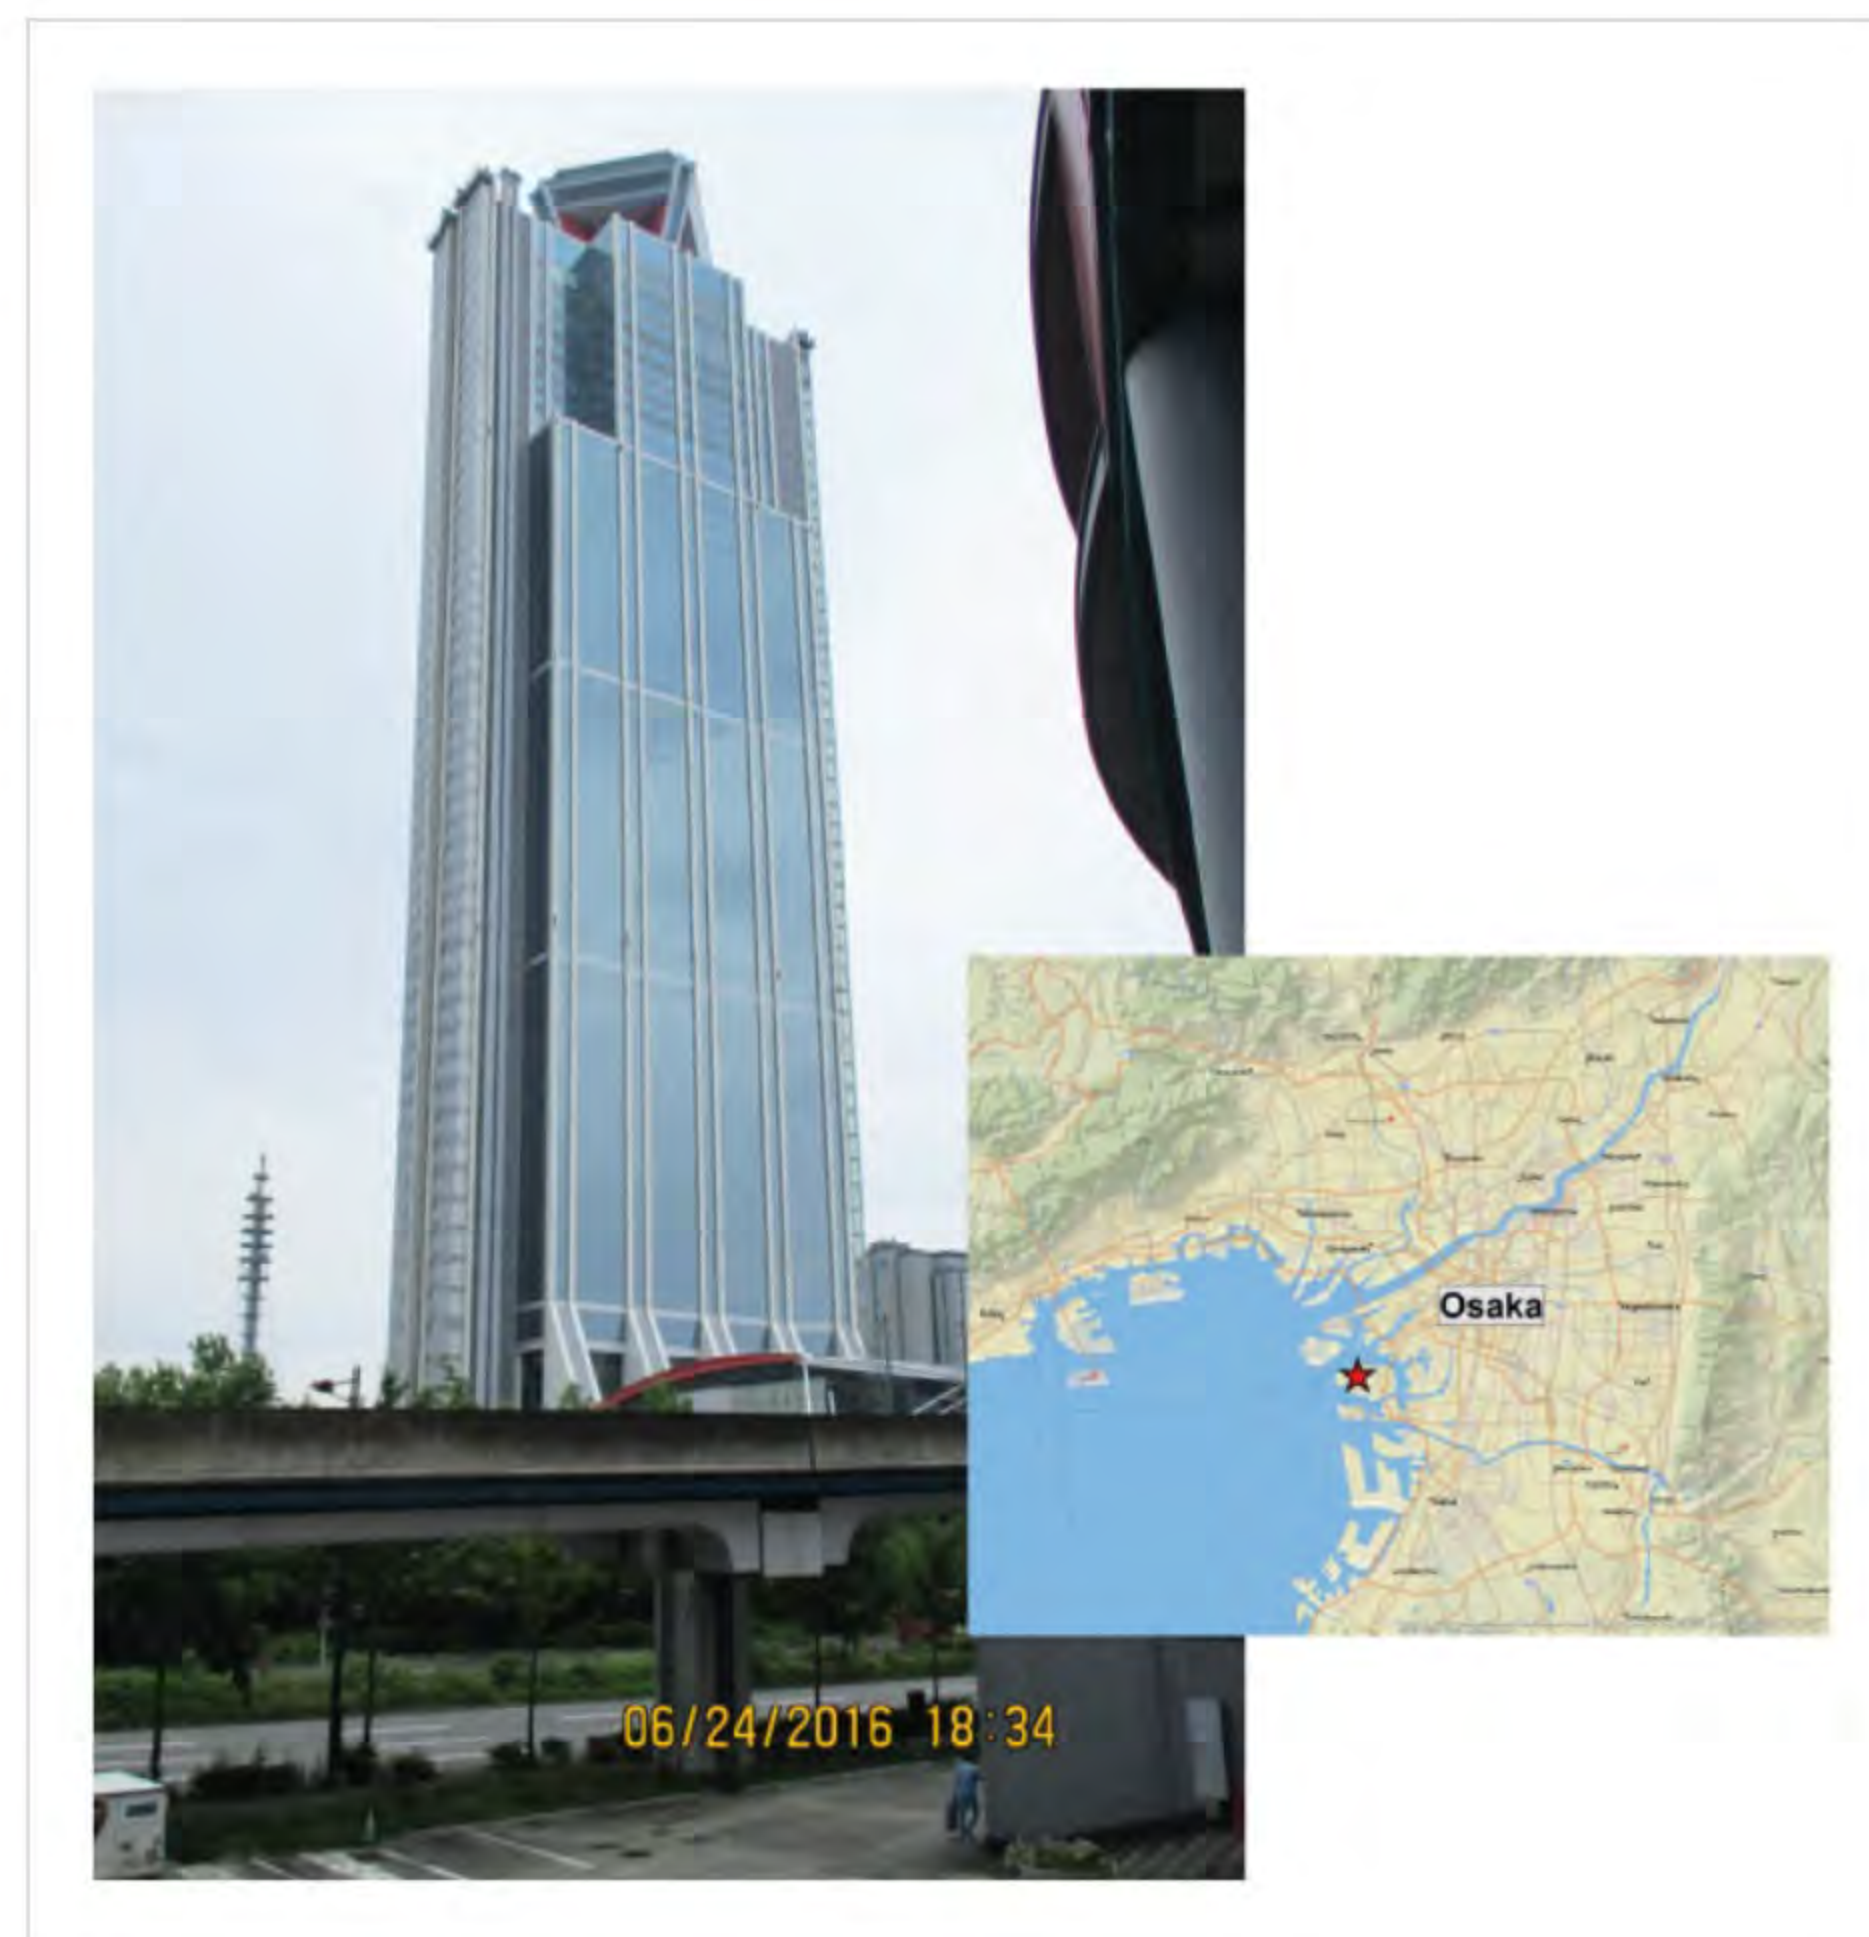
The 55-story tall building in Osaka, Japan, and a map with a red star at the location of the building. (Photo by Mehmet Çelebi, USGS)

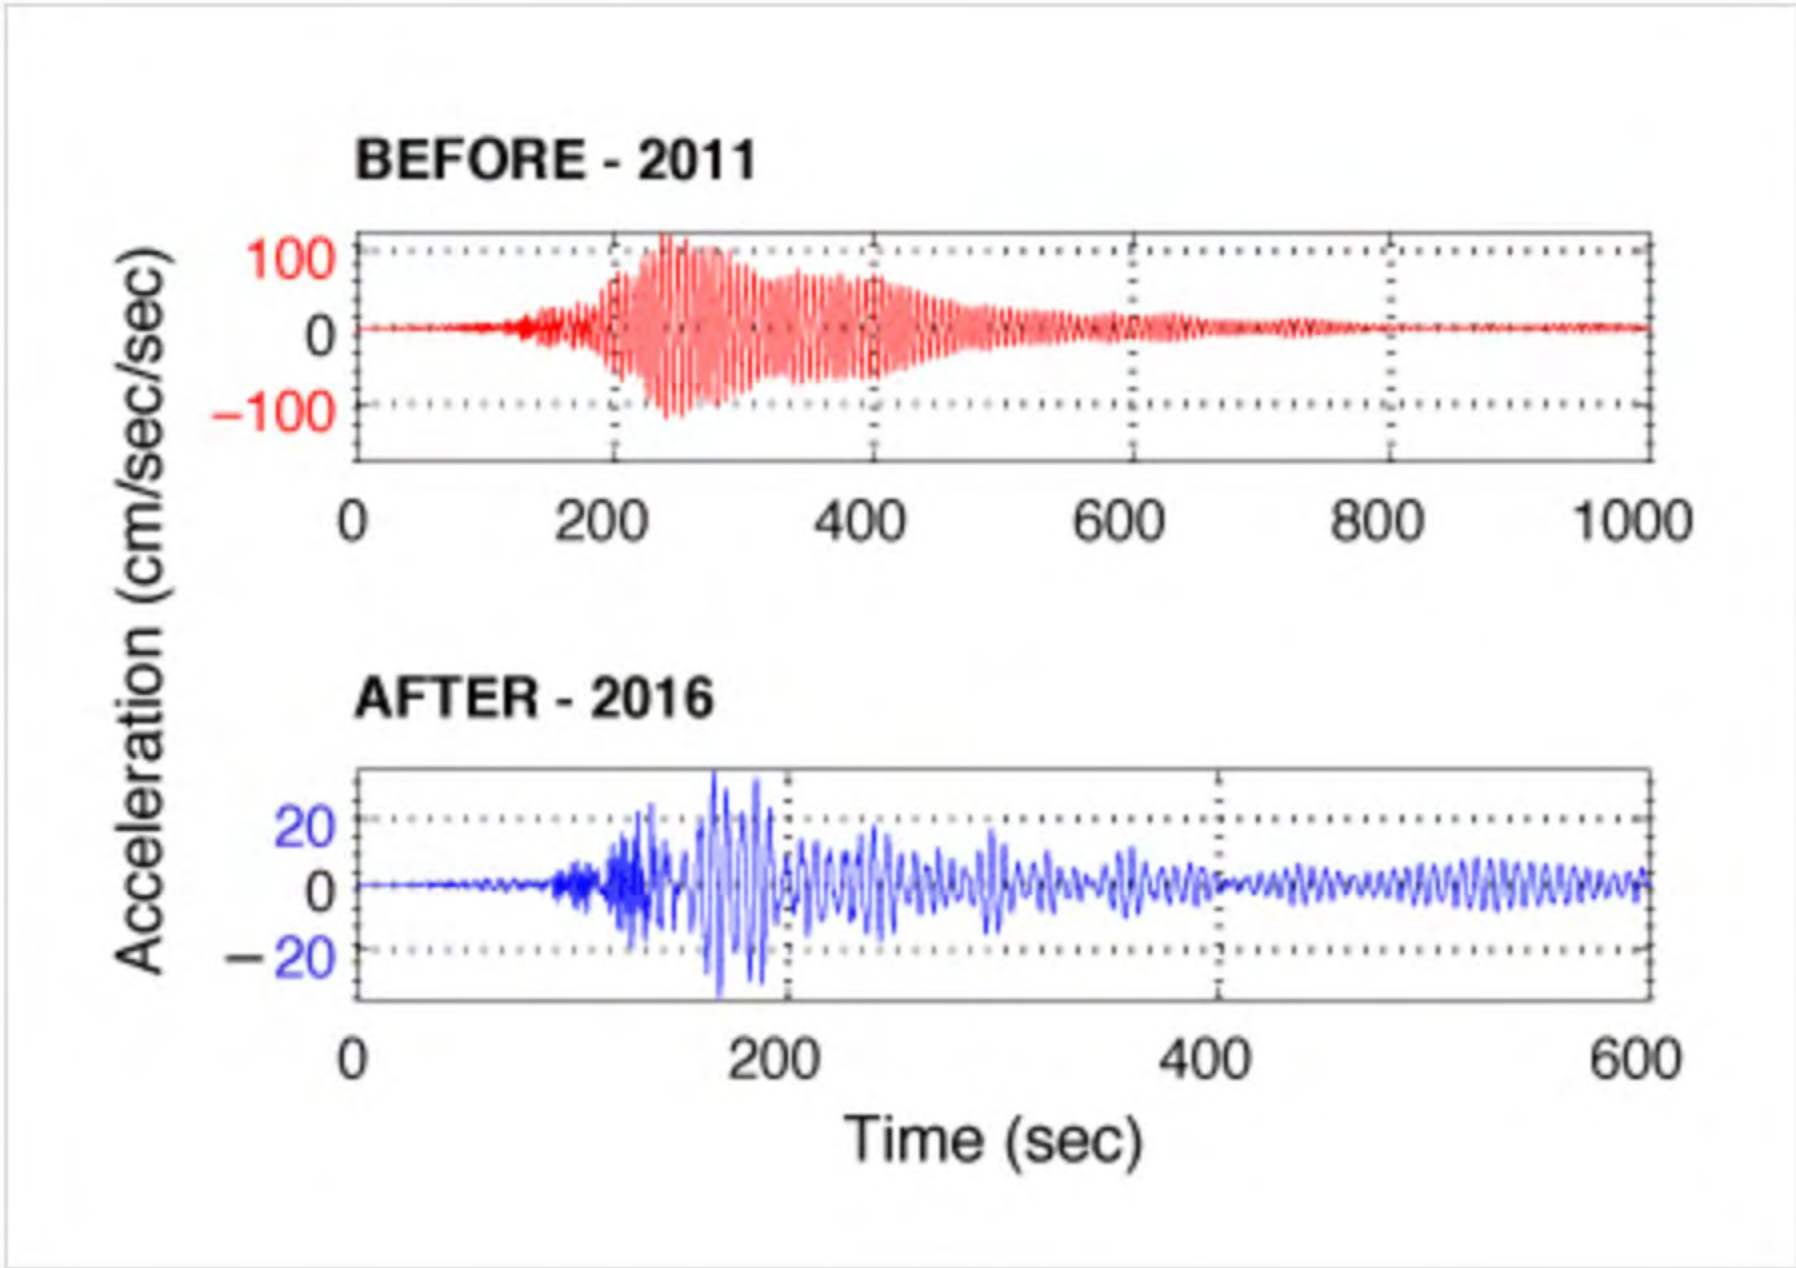
The recorded shaking of the building from two distant earthquakes before and after the retrofit. The seismic instrument that recorded these two events was on the 52nd floor oriented in the N-S direction. Note that the acceleration before was about 5 times larger than after.

Japan is in a dynamic tectonic setting, and as such, experiences frequent earthquakes. On April 24, 2016 the M7.3 Kumamoto earthquake (478 km/297 mi away) shook the building, and again the shaking was recorded on the seismic instruments inside. The good news was that indeed the severity of the shaking was lessened by the retrofit, however there are indications that the building can still experience significant shaking. This knowledge can be used for the engineering and retrofits of similar tall buildings in the future. Currently, in the United States, we are not aware of any buildings taller than 35 stories that have been retrofitted.

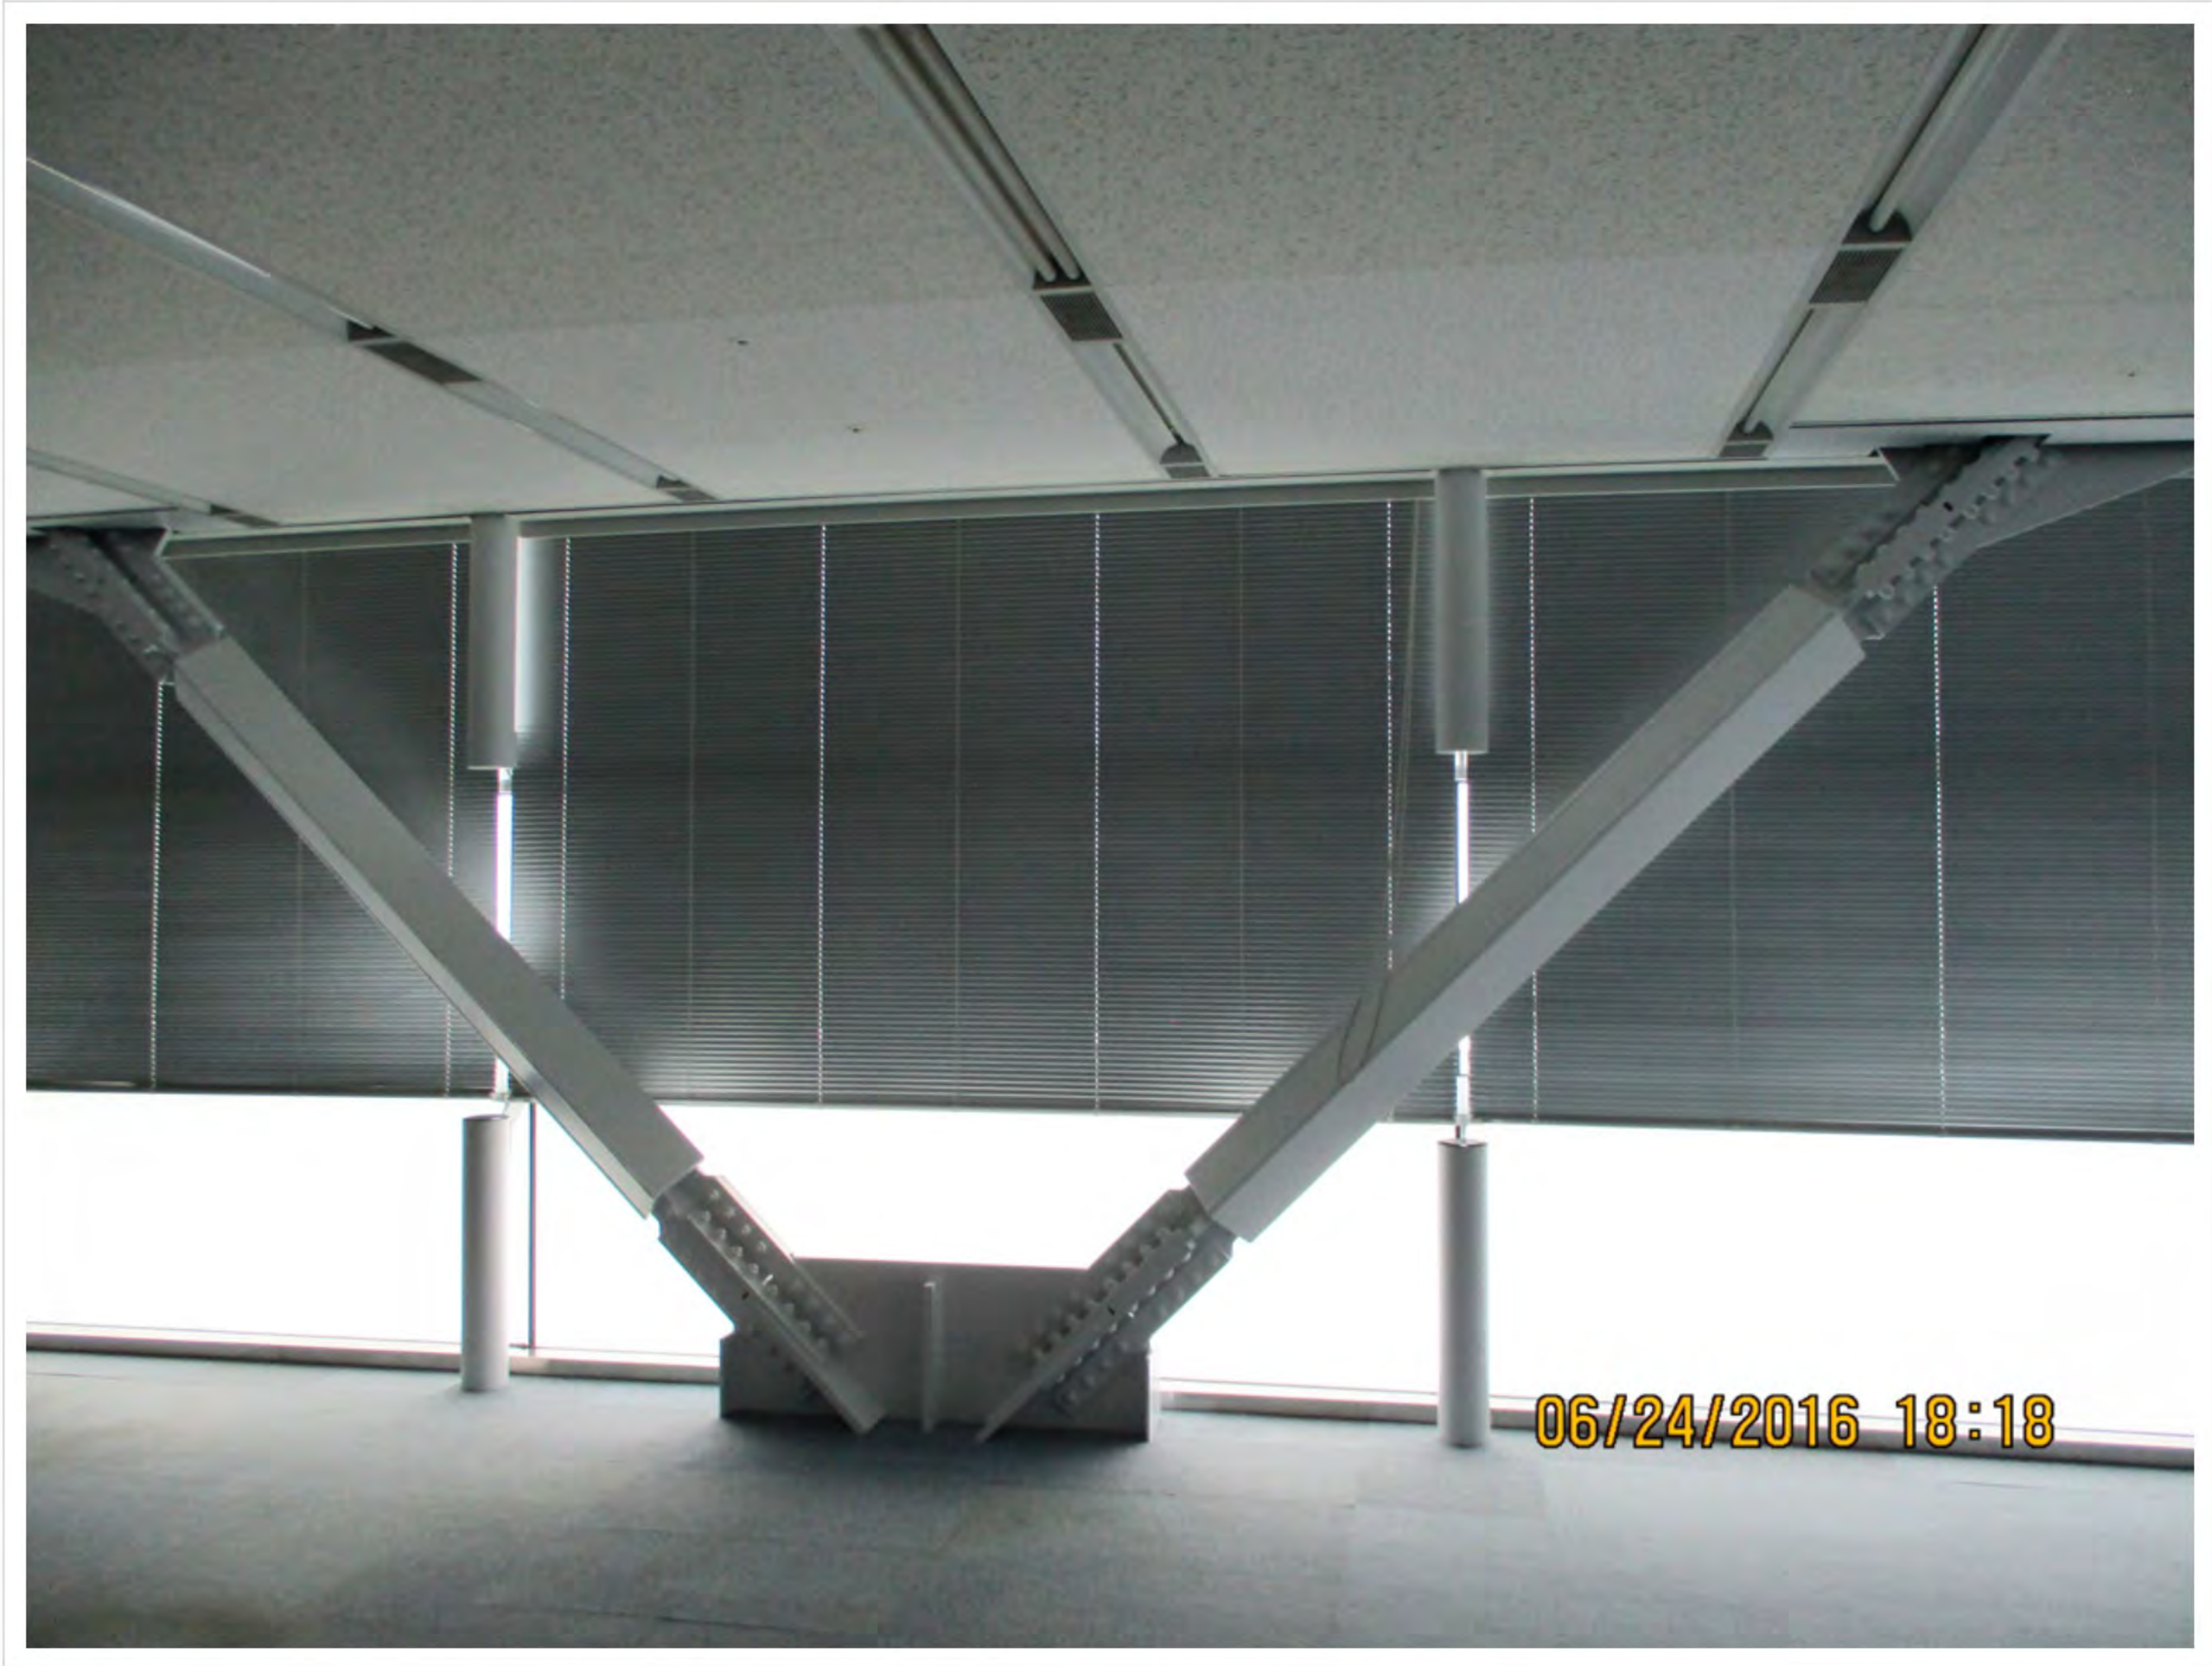
Two of the braces as seen from inside the building. (Photo by Mehmet Çelebi, USGS)

Dampers are similar to a suspension in a car that makes the ride more comfortable by decreasing the vibrations. Their function in a building is to decrease the severity of shaking in the building. When vibrations are decreased in a building, there is less chance of damage. A BRB is intended to prevent motion between the floors of the building by providing extra rigidity, and at the same time, decrease the shaking by allowing the ends to yield, or buckle, which increases the damping capability of the building. BRB's are now widely used in new and retrofitted buildings. (See the photos below.)

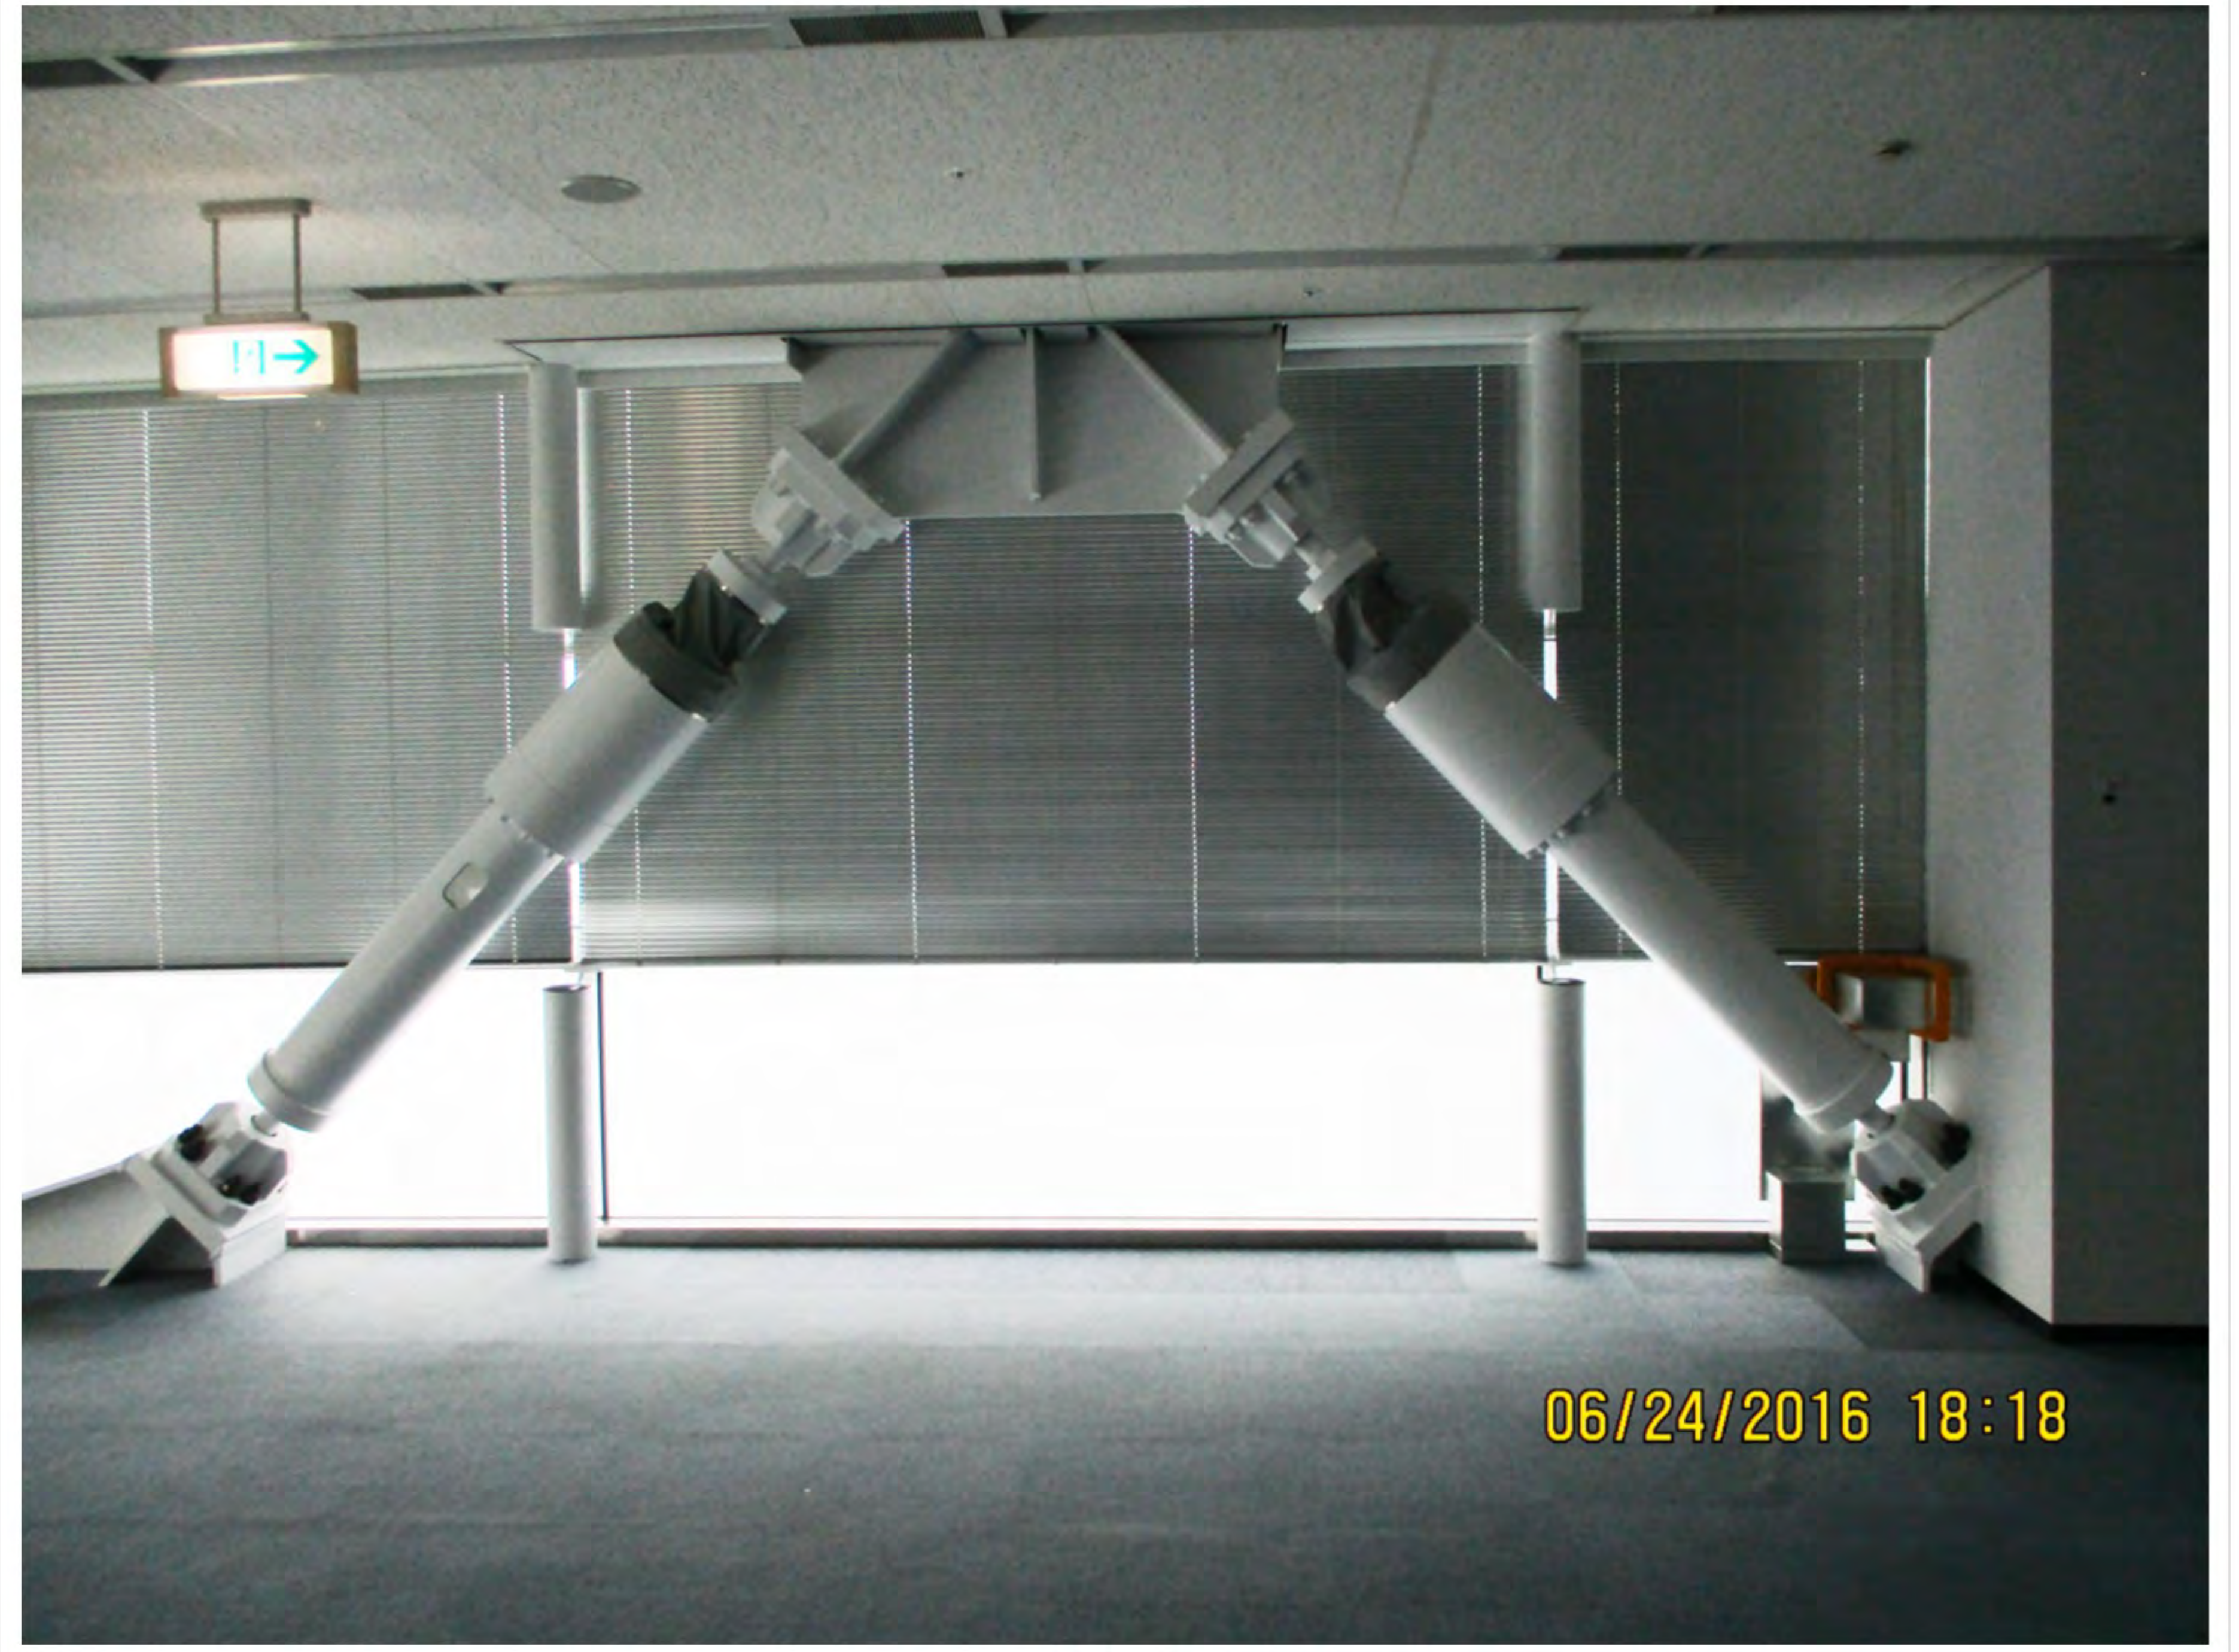
Two of the dampers as seen from inside the building. (Photo by Mehmet Çelebi, USGS)
