IC Corporation

RECALL NOTICE

IC CORPORATION RECALL # 04302 NHTSA RECALL # 04V- 251

Emergency Exit Window Instructions

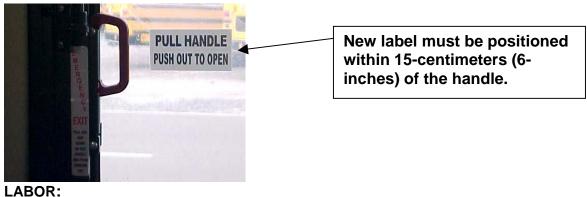
The rear emergency exit window interior opening procedure instruction label on the frame of the window located inside the bus is not 1-centimeter in height as required by FMVSS 217. In the event of an emergency, understanding the proper operation of the emergency exit window may be impaired preventing rapid egress from the bus.

IC has included with this notice a sufficient number of labels to repair the units in your inventory. The label has a peel off back that must be removed prior to placing it on the glass, as shown on the picture below. Be sure the glass is clean and dry before the application is made. To comply with federal regulations, it is important to place the label in the location shown in the picture below.
