IC Corporation

RECALL NOTICE

IC CORPORATION RECALL # 03306 NHTSA RECALL # 04V-010 February 2004

Modesty Panel at Front Barriers

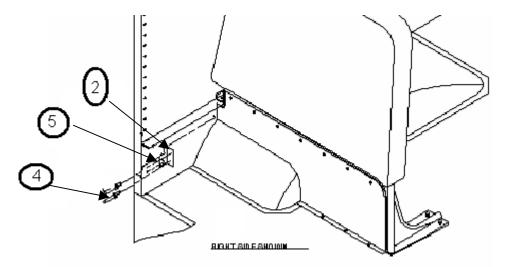
The steel modesty panel that is installed under the seat barrier behind the driver seat and behind the entrance door is cutout to clear the wheel well. This cutout allows the lower portion of the panel to be bent out of position leaving a gap between the wheel-well and the lower edge of the modesty panel at the cutout area. The edge of the cut out is protected with snake rubber (protective edging). If the snake rubber is knocked off of the edge of the panel, a raw edge is exposed facing down.

Area where panel may be bent out of position.

This repair procedure involves adding a bracket at the wall to secure the end of the modesty panel. This must be done to the panel on both sides of the bus.

- 1. Locate the angle (item #2) centered vertically with the end of the panel.
- 2. Install angle onto wall with two self-drilling screws (item #5).
- 3. Using a 1/8-inch drill bit, drill two holes through the angle and modesty panel.
- 4. Fasten angle to modesty panel with two (2) of item #4 –(rivet, pop 1/8")
