## PROBLEM STATEMENT

A wooden pedestrian bridge (see Figure) in a recreational area has been in service for **12 years**. Recently, maintenance staff observed cracks at the bottom of one of the longitudinal beams near mid-span. Because **crowd load on weekends has increased**, before weekend, right on Monday the local authority requests an engineering assessment to check whether the beam is still structurally safe under bending. The task requires evaluating the actual bending stress using the flexural formula, comparing it with the allowable stress, and redesigning the beam using any suitable structural material.

## SECTION A: EXISTING BEAM

## SECTION B: REDESIGN BEAM

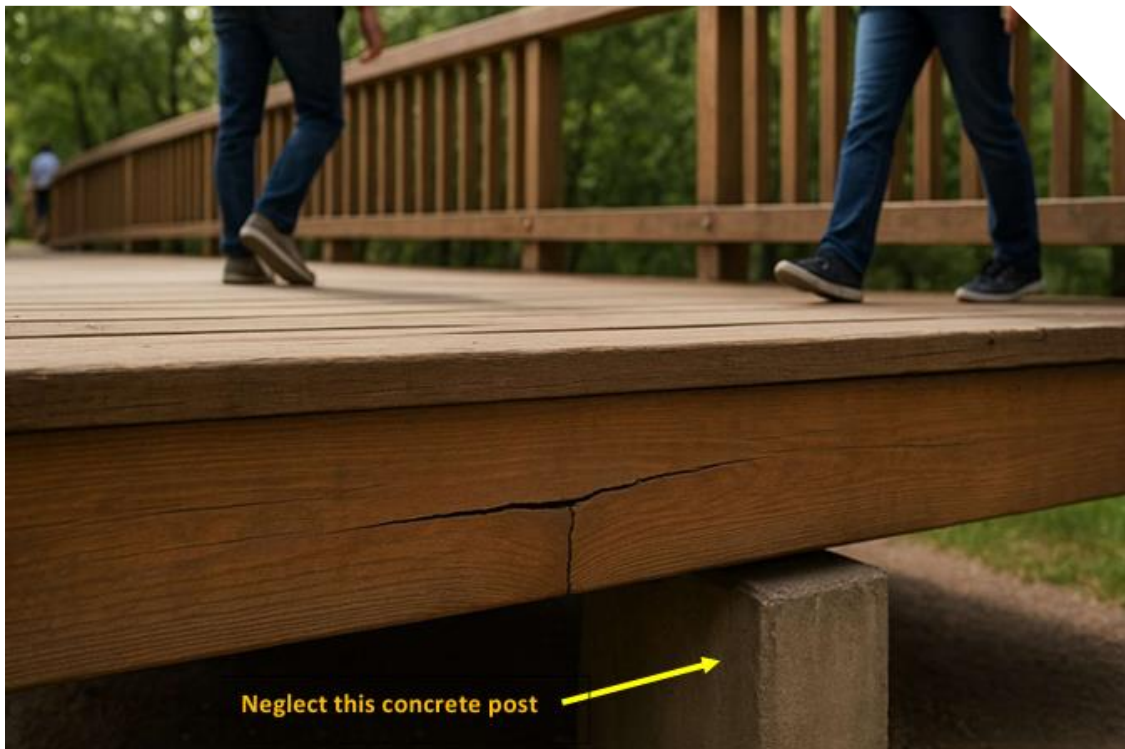
Beam Type: Simply Supported

Span Length (L): 4.2 m

Cross-Section (Timber):

Width = 150 mm × Depth = 250 mm

Loading Conditions: Self-weight of the timber beam

Pedestrian load (uniformly distributed):  $w = 3.5 \text{ kN/m}$

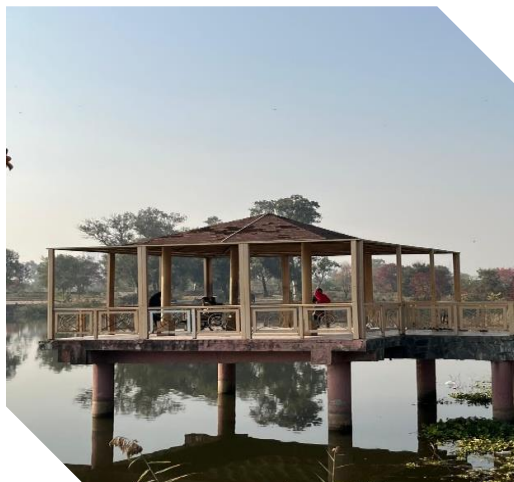
Figure 4: A lakeside wooden pavilion constructed on stilts, providing visitors with a scenic resting spot over the water at Lake View Park,

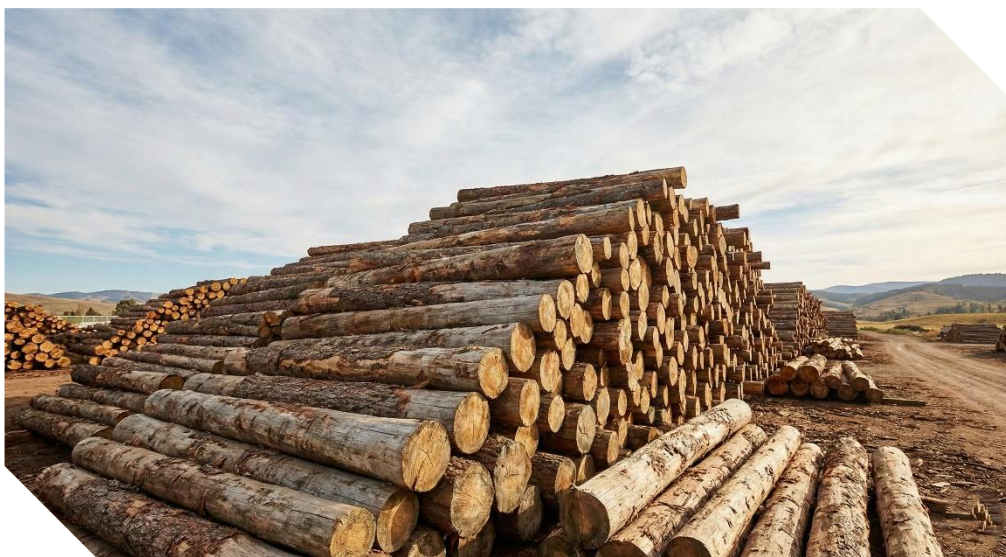
Figure 8: Picture showing Timber: Deodar or Douglas Fir with Yield Allowable bending stress of 12 MPa

- Material: Solid Sawn Timber (Douglas Fir-Larch / Deodar)
- Grade: Structural Timber (Ref: BS 5268-2 / ASTM D245)
- Specific Weight:  $5.3 \text{ kN/m}^3$
- Beam Type: Simply Supported
- Span Length (L): 4.2 m
- Rectangular Section: Width = 150 mm  $\times$  Depth = 250 mm
- Allowable bending stress = 12 MPa
- Loading Conditions: Self-weight of the timber beam + Pedestrian load (uniformly distributed):  $w = 3.5 \text{ kN/m}$

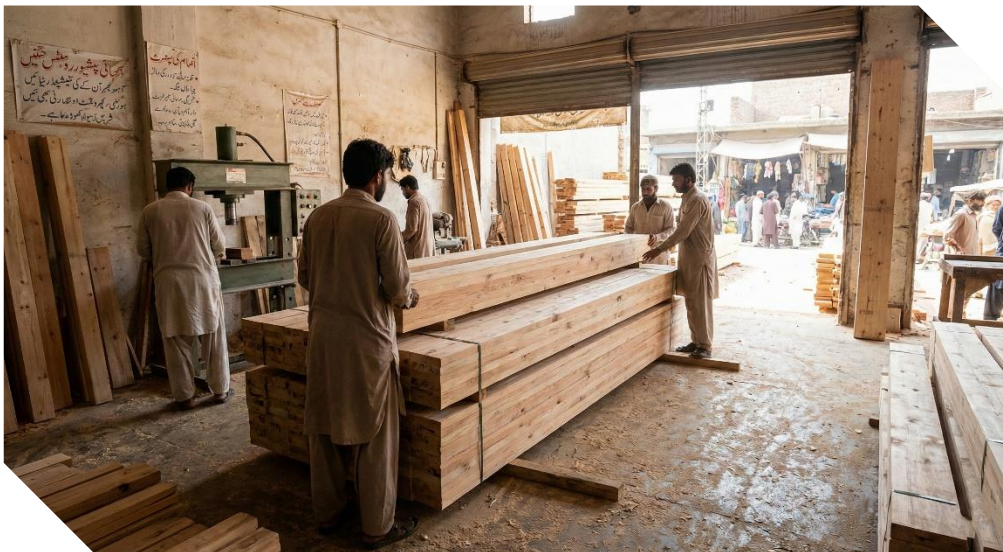
Figure 9: Picture showing Timber: Glued Laminated Timber (Glulam) with Yield Allowable bending stress of  $16.5 \times 0.60 = 9.90\text{MPa}$

- Material: Glued Laminated Timber (Glulam)
- Stress ratio exceeds 0.80 with Applied Live Load (Weekend Crowd): 7.8 kN/m (Assumption)
- Grade: 24F-V4 (Ref: ANSI A190.1 / AITC 117)
- Specific Weight:  $6\text{kN/m}^3$
- Beam Type: Simply Supported
- Span Length (L): 4.2 m
- Rectangular Section: Width = 150 mm × Depth = 400 mm
- Allowable bending stress =  $16.5 \times 0.60 = 9.90\text{MPa}$
- Loading Conditions: Self-weight of the beam + Pedestrian load (uniformly distributed):  $w = 7.8\text{ kN/m}$

MATERIAL JUSTIFICATION	
Structural Timber	Glued Laminated Wood (Glulam)
Contains natural defects (knots, splits) that create weak points.	Defects are dispersed or removed during manufacturing.
Allowable stress limited to approx. 12 MPa due to defects.	High-grade Glulam achieves 16.5+ MPa allowable stress.
Limited by the diameter of the log. Hard to find large sections (e.g., >300mm deep).	Made by stacking layers; can be manufactured to any depth (e.g., 400mm).
Custom sizes are expensive/rare.	Easy to fabricate large sections for heavy loads.
Solid logs twist and cup as they dry over time.	Kiln-dried laminations are glued with opposing grains to resist warping.
Preservatives may not penetrate deep into the heartwood.	Individual laminations can be treated before gluing for deep protection.
