SERVICE PROCEDURE

G-07506 May 2007

SUBJECT: SAFETY RECALL (U.S.)

DAVCO® FUEL PRO® 382 PRE-HEATER on certain 7000, 8000, 9000 and ProStar™ Models built

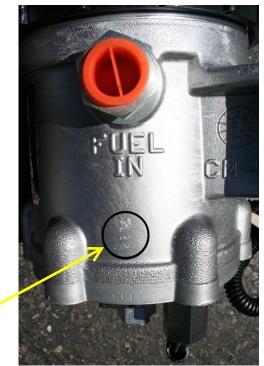
Figure 1

1. Inspect the date code stamped in to the "FUEL IN" side of the filter housing.

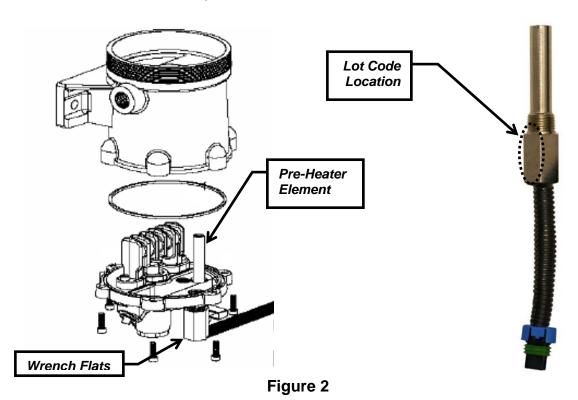
- 2. If the filter housing has a date code from **3356** thru **0507**, or is unreadable, continue on to Step 3.
 - If the filter housing date code is not in the above range, no further action is required.
- 3. Inspect the lot code of the pre-heater. The lot code is located on the wrench flats of the pre-heater.

4. If the Lot Code on the pre-heater matches any of the codes in Table 1, the pre-heater requires replacement. Skip to **PRE-HEATER REPLACEMENT**, step 5.
