## Volume 6 Paper C134

# The Visual Determination of Exfoliation Rate of Al Alloy Slices in Humidity

X. Zhao and G. S. Frankel

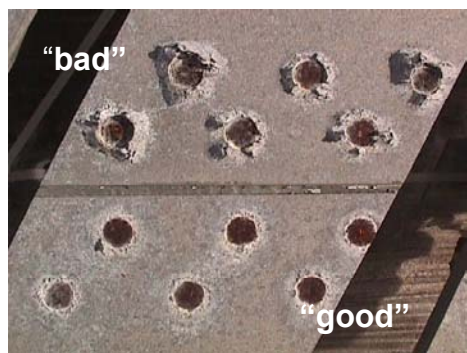
Figure1. Daytona Beach Exposure Sample. 9 Month Exposure Of Bare Material (Al and Steel Rivets).

Test samples were machined from a piece of a wingskin of a retired KC135 airplane. The wing skin section contained two plates attached to an underlying support beam by steel rivets. The piece of wing skin was exposed in the uncoated condition at an atmospheric exposure test site near Daytona Beach, FL. As shown in figure 1, the two plates in the test piece exhibited vastly different exfoliation behavior during the exposure near the seacoast: one of the plates exfoliated badly next to the steel rivets and the other plate only developed

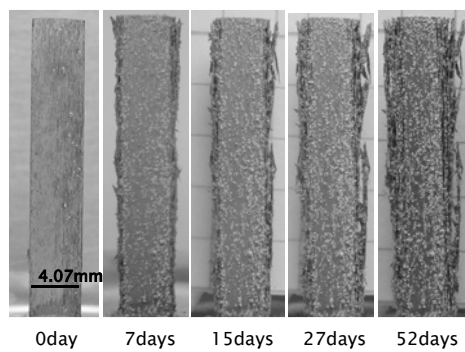
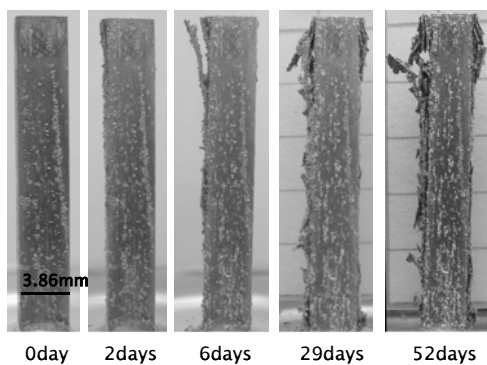
(a)

(b)

Figure 2. Image of AA7178 wingskin sample exposed to 96% humidity following electrochemical pretreatment. (a) “Bad” sample. (b) “Good” sample.

**Figure 2** shows images of the “good” and bad plates from the AA7178 wingskin

sample exposed to 96% RH for 0–52 days following electrochemical pretreatment. After several days of high humidity exposure (96% RH), EFC was evident on both edges of the slice from the “bad” plate and it continued to progress over the exposure period of almost 2 months, Figure 2a. The behavior of the slice removed from the “good” plate behaved quite differently. Severe EFC formed on one side of the sample (left side of images in Figure 2b), while the other side of the sample was practically unattacked. The side of the slice that was not attacked in the ESH test was the side of the plate that was exposed upwards to the environment at Daytona Beach. Overall, the “bad” sample was attacked much faster than the “good” sample. As seen in Figure 2, corrosion product oozed out of the sides (corresponding to

transverse face of the microstructure) of both good and bad samples upon exposure to 96% RH. This deliquescence is evidence of the chloride corrosion product deposited in the microstructure during the electrochemical pretreatment.

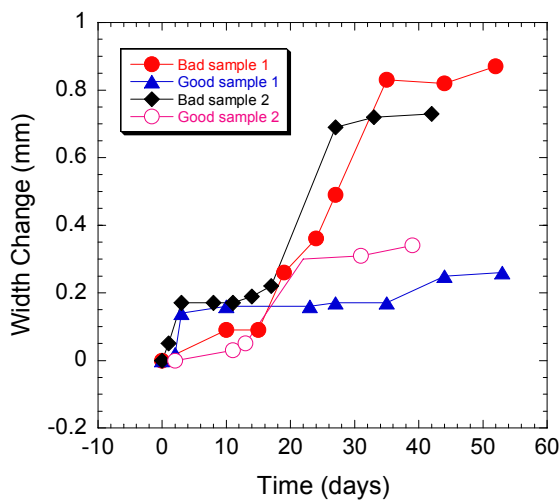
Figure 3. Exfoliation corrosion kinetics of AA7178 wingskin samples exposed to 96% RH.

The kinetics of EFC can be determined by measuring the change in width of the central unexfoliated region. Regions with different rates of attack are evident as shown in **figure 3**. The EFC started out slowly, about 0.01 mm/day. Then,

after some delay time on the order of 2 weeks, the rate increased to a higher value, about 0.03 mm/day. The rate then decreased again to a lower value of about 0.005 mm/day. This indicates that there is a susceptible layer inside the plate near the surface. The different behavior of the two plates during outdoor exposure at Daytona Beach is reflected by the ESH results.

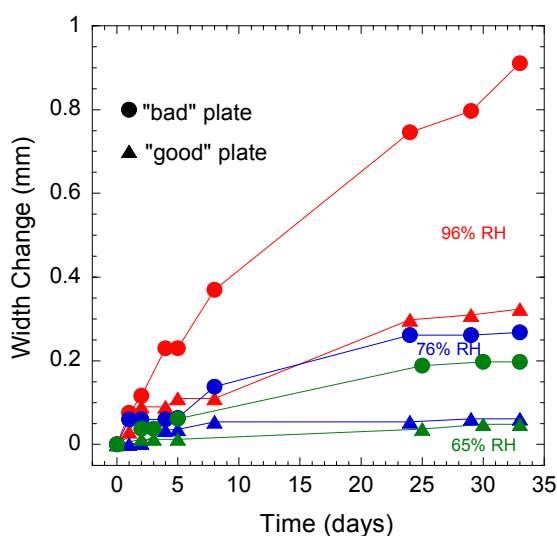
Figure 4. Exfoliation Corrosion kinetics of AA7178 wingskin sample exposed to different humidities.

ESH testing was performed on “good” and “bad” samples under a range of humidities. The two plates exhibited different exfoliation behavior in different humidities. In the lowest humidity (30%,  $\text{CaCl}_2$ ), the surfaces of both samples were still rather shiny after 60 days exposure, and no EFC was evident. Clearly this humidity is below the critical humidity of the corrosion product. In 49% RH, some product oozed out of the surface and EFC was seen on the down side of the “good” sample after 3 days. However, the EFC ceased after that time, perhaps as a result of a drying out of the corrosion

product formed during the pretreatment as a result of equilibration with the humidity in the chamber. In 65.1% RH, both sides of the “bad” sample exfoliated gradually after around 1 week exposure even though no change was observed at the beginning. Above 49% RH, samples exfoliated more severely with increasing humidity. The critical humidity for EFC propagation seems to be just above 50%. The width of the unattacked region was measured at ten different positions along the axis of each sample for RH values from 65–96%. From these measurements, the average rate of EFC was determined. The average EFC rate was 3.0, 4.2, and 14.2,  $\mu\text{m}/\text{day}$  for the “bad” samples in 66, 76, and 96% RH, respectively. For “good” samples, the values were 0.61, 0.76, and 5.0  $\mu\text{m}/\text{day}$ , respectively, for the same humidities. The EFC kinetics of wingskin samples are shown in [figure 4](#).

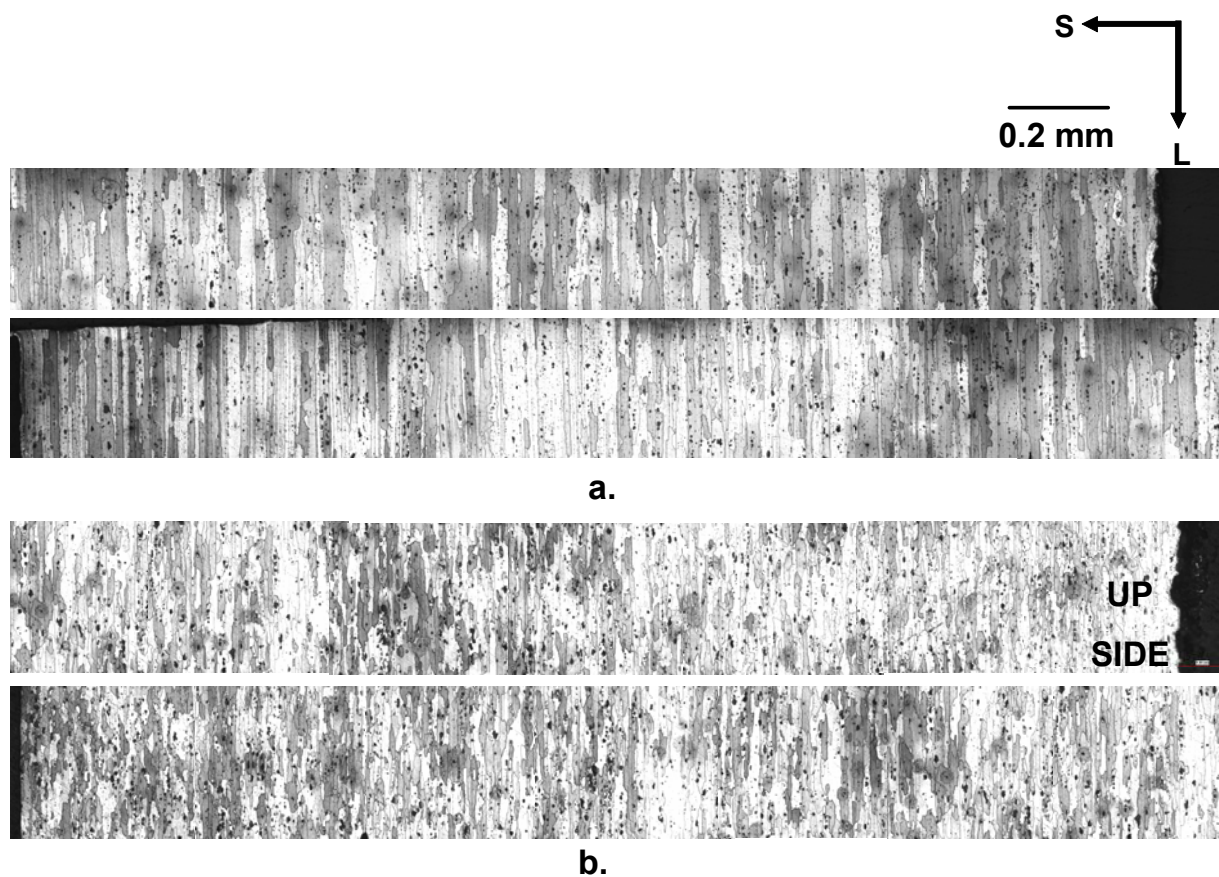
Figure 5. Metallographic sections of AA7178 wingskin plate. (a) “Bad” plate. (b) “Good” plate. The sections are through thickness montages, starting at the right of the top image in each pair and then wrapping around to end at the left side of the bottom image in each pair.

The microstructure of the two plates exhibit differences that correlate with the EFC behavior. As shown in [figure 5](#), the “bad” plate has a microstructure that has more elongated grains. In contrast, the near-surface regions of the “good” plate exhibit smaller grains with a smaller aspect ratio. A recrystallized equiaxed microstructure should be more resistant to exfoliation (but should exhibit faster IGC in the S direction). There is no clear difference in the microstructure of the near-surface up and down sides of the “good” sample to help explain the different EFC behavior.
