ADMINISTRATIVE BULLETIN

NO. AB-100

TITLE : **Post-Earthquake Repair and Retrofit Requirements for One- and Two-Family Dwellings**

PURPOSE : The purpose of this Bulletin is to establish policy for interpreting the San Francisco Building Code regarding post-earthquake damage retrofit triggers for one- and two-family dwellings of wood-frame construction and to detail the scope and criteria for such triggered retrofits. The Bulletin also provides guidance on the scope of required building repair if retrofits are not triggered.

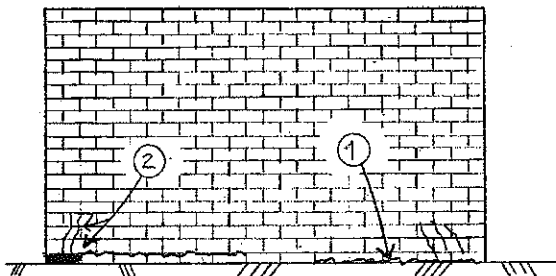
URM1F	COMPONENT DAMAGE	System: URM
	CLASSIFICATION GUIDE	Component Type: Solid Wall
		Behavior Mode: Flexural Cracking/ Toe Crushing/Bed Joint Sliding

Level	Description of Damage	Typical Performance Restoration Measures
Insignificant $\lambda_K = 1.0$ $\lambda_Q = 1.0$ $\lambda_D = 1.0$ $\mu_A \leq 1.5$	<p><i>Criteria:</i></p> <ol style="list-style-type: none"> 1. Horizontal hairline cracks in bed joints at the heel of the wall. 2. Possibly diagonally-oriented cracks and minor spalling at the toe of the wall. <p><i>Typical Appearance:</i></p>

Not necessary for restoration of structural performance. (Measures may be necessary for restoration of nonstructural characteristics.)
Slight	Not used

This type of moderately ductile behavior has been experimentally observed in walls with $L/h_{eff} \approx 1.7$ in which bed joint sliding and toe crushing strength capacities are similar. Damage occurs in the following sequence. First, flexural cracking occurs at the heel of the wall. Then diagonally-oriented cracks appear at the toe of the wall, typically accompanied by spalling and crushing of the units. In some cases, toe crushing is immediately followed by a steep inclined crack propagating upward from the toe. Next, sliding occurs along a horizontal bed joint near the base of the wall, accompanied in some cases by stair-stepped bed joint sliding at upper portions of the wall. With repeated cycles of loading, diagonal cracks increase. Eventually, crushing of the toes or excessive sliding leads to failure.

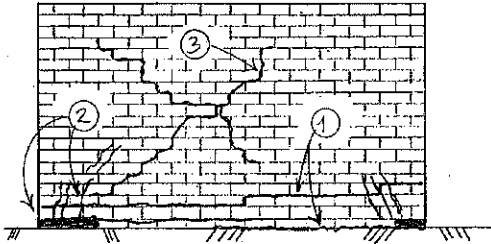
URM1F

Level	Description of Damage	Typical Performance Restoration Measures
<p>Moderate</p> <p>$\lambda_K = 0.9$ $\lambda_Q = 0.6^1$ $\lambda_D = 0.9$</p> <p>1. As an alternative, calculate as V_{bjs2}/V_{tc}</p> <p>$\Delta/h_{eff} \leq 0.8\%$</p>	<p><i>Criteria:</i></p> <ol style="list-style-type: none"> 1. Horizontal cracks/spalled mortar at bed joints at or near the base of the wall indicating that in-plane offset along the crack has occurred up to approximately 1/4". 2. Possibly diagonally-oriented cracks and spalling at the toe of the wall. Cracks extend upward several courses. 3. Possibly diagonally-oriented cracks at upper portions of the wall which may be in the units. <p><i>Typical Appearance:</i></p>

<ul style="list-style-type: none"> • Replace/drypack damaged units. • Repoint spalled mortar and open head joints. • Inject cracks and open head joints. • Install pins and drilled dowels in toe regions. <p>$\lambda_K^* = 1.0^1$ $\lambda_Q^* = 1.0^1$ $\lambda_D^* = 1.0^1$</p> <p>1. In some cases, grout injection may actually increase strength, but decrease deformation capacity, by changing behavior from bed joint sliding to a less ductile behavior mode (see FEMA 307, Section 4.1.3).</p>

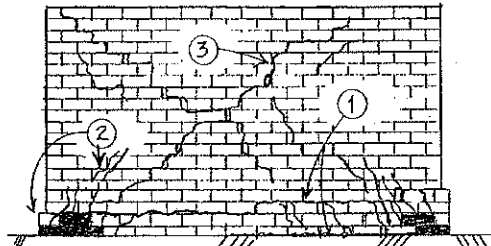
<p>Heavy</p> <p>$\lambda_K = 0.8$ $\lambda_Q = 0.6^1$ $\lambda_D = 0.9$</p> <p>1. As an alternative, calculate as V_{bjs2}/V_{tc}</p> <p>$\Delta/h_{eff} \leq 1.2\%$</p>	<p><i>Criteria:</i></p> <ol style="list-style-type: none"> 1. Horizontal bed joint cracks near the base of the wall similar to Moderate, except width is up to approximately 1/2". 2. Possibly extensive diagonally-oriented cracks and spalling at the toe of the wall. Cracks extend upward several courses. 3. Possibly diagonally-oriented cracks up to 1/2" at upper portions of the wall. <p><i>Typical Appearance:</i></p>

<ul style="list-style-type: none"> • Replace/drypack damaged units. • Repoint spalled mortar and open head joints. • Inject cracks and open head joints. • Install pins and drilled dowels in toe regions. <p>$\lambda_K^* = 1.0^1$ $\lambda_Q^* = 1.0^1$ $\lambda_D^* = 1.0^1$</p> <p>1. In some cases, grout injection may actually increase strength, but decrease deformation capacity, by changing behavior from bed joint sliding to a less ductile behavior mode (see FEMA 307, Section 4.1.3).</p>

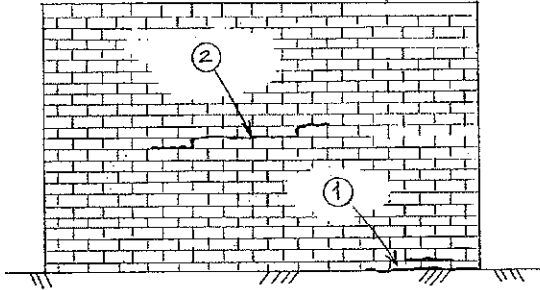
URM1H	DAMAGE CLASSIFICATION AND REPAIR GUIDE	System: URM
		Component Type: Solid Wall
		Behavior Mode: Flexural Cracking/ Toe Crushing

Level	Description of Damage	Typical Performance Restoration Measures
Insignificant $\lambda_K = 0.9$ $\lambda_Q = 1.0$ $\lambda_D = 1.0$ $\mu_A \leq 1.5$	<p><i>Criteria:</i></p> <ol style="list-style-type: none"> 1. Horizontal hairline cracks in bed joints at the heel of the wall. 2. Horizontal cracking on 1-3 cracks in the central portion of the wall. No offset along the crack has occurred and the crack plane is not continuous across the pier. 3. No cracks in masonry units. <p><i>Typical Appearance:</i></p>

Not necessary for restoration of structural performance. (Measures may be necessary for restoration of nonstructural characteristics.)
Slight	Not used	
Moderate	Not used

This type of behavior typically occurs in stockier walls with $L/h_{eff} > 1.25$. Based on laboratory testing, four steps can usually be identified. First, flexural cracking happens at the base of the wall, but it does not propagate all the way across the wall. This can also cause a series of horizontal cracks to form above the heel. Second, sliding occurs on bed joints in the central portion of the pier. Third, diagonal cracks form at the toe of the wall. Finally, large cracks form at the upper corners of the wall. Failure occurs when the triangular portion of wall above the crack rotates off the crack or the toe crushes so significantly that vertical load is compromised. Note that, for simplicity, the figures below only show a single crack, but under cyclic loading, multiple cracks stepping in each direction are possible.

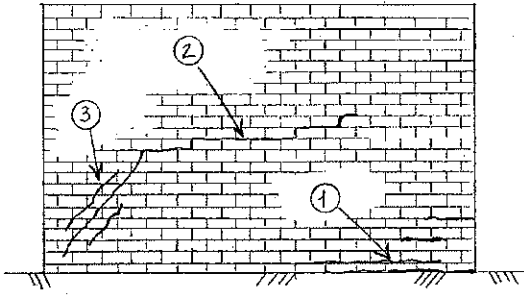
URM1H

Level	Description of Damage	Typical Performance Restoration Measures
<p>Heavy</p> <p>$\lambda_K = 0.8$ $\lambda_Q = 0.8$ $\lambda_D = 1.0$</p> <p>$\Delta/h_{eff} \leq 0.3\%$</p>	<p><i>Criteria:</i></p> <ol style="list-style-type: none"> 1. Horizontal hairline cracks in bed joints at the heel of the wall. 2. Horizontal cracking on 1-3 cracks in the central portion of the wall. Some offset along the crack may have occurred. 3. Diagonal cracking at the toe of the wall, likely to be through the units, and some of units may be spalled. <p><i>Typical Appearance:</i></p>

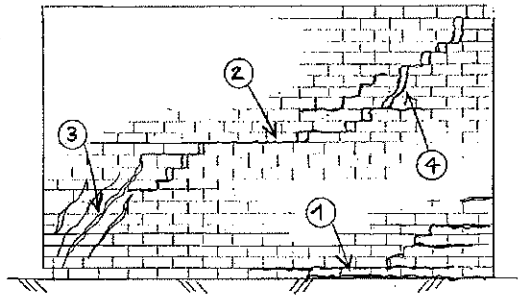
<p>Replacement or enhancement is required for full restoration of seismic performance.</p> <p>For <u>partial</u> restoration of performance:</p> <ul style="list-style-type: none"> • Repoint spalled mortar. • Inject cracks. <p>$\lambda_K^* = 0.9$ $\lambda_Q^* = 0.9$ $\lambda_D^* = 1.0$</p>
<p>Extreme</p> <p>$\lambda_K = 0.6$ $\lambda_Q = 0.6$ $\lambda_D = 0.9$</p> <p>$\Delta/h_{eff} \leq 0.9\%$</p>	<p><i>Criteria:</i></p> <ol style="list-style-type: none"> 1. Horizontal hairline cracks in bed joints at the heel of the wall. 2. Horizontal cracking on 1 or more cracks in the central portion of the wall. Offset along the crack will have occurred. 3. Diagonal cracking at the toe of the wall, likely to be through the units, and some of units may be spalled. 4. Large cracks have formed at upper portions of the wall. In walls with aspect ratios of $L/h_{eff} > 1.5$, these cracks will be diagonally oriented; for more slender piers, cracks will be more vertical and will go through units. <p><i>Typical Appearance:</i></p>

<p>Replacement or enhancement is required for full restoration of seismic performance.</p> <p>For <u>partial</u> restoration of performance:</p> <ul style="list-style-type: none"> • Replace/drypack damaged units. • Repoint spalled mortar. • Inject cracks. • Install pins and drilled dowels in toe regions. <p>$\lambda_K^* = 0.9$ $\lambda_Q^* = 0.8$ $\lambda_D^* = 1.0$</p>

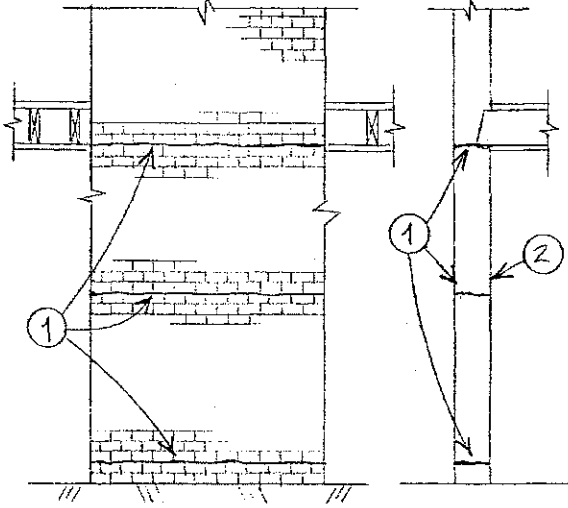
URM1M	COMPONENT DAMAGE CLASSIFICATION GUIDE	System: URM
		Component Type: Solid Wall
		Behavior Mode: Out-of-Plane Flex- ural Response

Level	Description of Damage	Typical Performance Restoration Mea- sures
Insignificant For out-of- plane loads: $\lambda_{h/t} = 1.0$ For in-plane modes given previously, assume out- of-plane damage leads to Moderate damage for URM2B and Insignificant damage for all other modes.	<p><i>Criteria:</i></p> <ol style="list-style-type: none"> 1. Hairline cracks at floor/roof lines and midheight of stories. 2. No out-of-plane offset or spalling of mortar along cracks. <p><i>Typical Appearance:</i></p>

Not necessary for restoration of structural performance. (Measures may be necessary for restora- tion of nonstructural characteristics.)

Out-of-plane failures are common in URM buildings. Usually they occur due to the lack of adequate wall ties, as discussed in Table 7-1. When ties are adequate, the wall may fail due to out-of-plane bending between floor levels. One mode of failure observed in experiments is rigid-body rocking motion occurring on three cracks: one at the top of the wall, one at the bottom, and one at midheight. As rocking increases, the mortar and masonry units at the crack locations can be degraded, and residual offsets can occur at the crack planes. The ultimate limit state is that the walls rock too far and overturn. Important variables are the vertical stress on the wall and the height-to-thickness ratio of the wall. Thus, walls at the top of buildings and slender walls are more likely to suffer damage.

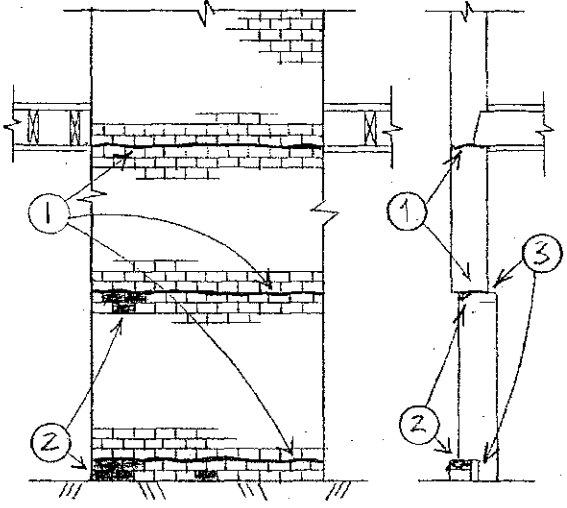
URM1M

Level	Description of Damage	Typical Performance Restoration Measures
Slight	Not used.	
Moderate For <u>out-of-plane</u> loads: $\lambda_{h/i} = 0.9$ For <u>in-plane</u> modes, see Insignificant damage	<p><i>Criteria:</i></p> <ol style="list-style-type: none"> Cracks at floor/roof lines and midheight of stories may have mortar spalls up to full depth of joint and possibly: Out-of-plane offsets along cracks of up to 1/8". <p><i>Typical Appearance:</i> See Insignificant damage above.</p>	<ul style="list-style-type: none"> Repoint spalled mortar: For <u>out-of-plane</u> loads: $\lambda_{h/i} = 1.0$ For <u>in-plane</u> loads: use Moderate for URM2B and Insignificant for all other modes.
Heavy For <u>out-of-plane</u> loads: $\lambda_{h/i} = 0.6$ For <u>in-plane</u> modes given previously, assume out-of-plane damage leads to <i>Heavy</i> for all other modes.	<p><i>Criteria:</i></p> <ol style="list-style-type: none"> Cracks at floor/roof lines and midheight of stories may have mortar spalls up to full depth of joint. Spalling and rounding at edges of units along crack plane. Out-of-plane offsets along cracks of up to 1/2". <p><i>Typical Appearance:</i></p>

<p>Replacement or enhancement is required for full restoration of seismic performance.</p> <p>For <u>partial</u> restoration of out-of-plane performance:</p> <ul style="list-style-type: none"> Replace/drypack damaged units Repoint spalled mortar $\lambda_{h/i} = 0.8$

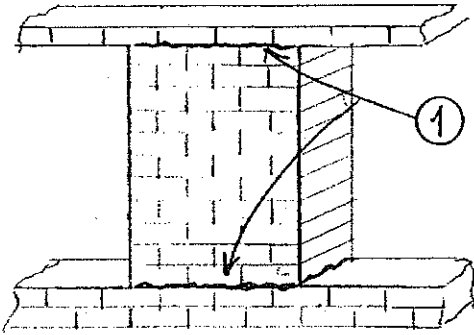
URM2A	COMPONENT DAMAGE CLASSIFICATION GUIDE	System: URM
		Component Type: Weaker Pier
		Behavior Mode: Wall-Pier Rocking

Level	Description of Damage	Typical Performance Restoration Measures
Insignificant $\lambda_K = 0.8$ $\lambda_Q = 1.0$ $\lambda_D = 1.0$ $\mu_A \leq 1.5$	<p><i>Criteria:</i></p> <ul style="list-style-type: none"> • Hairline cracks/spalled mortar in bed joints at top and bottom of pier. <p><i>Typical Appearance:</i></p>

<p>Not necessary for restoration of structural performance.</p> <p>(Measures may be necessary for restoration of nonstructural characteristics.)</p>

Rocking-critical piers form horizontal flexural cracks at the top and bottom of piers. Because the cracks typically close as the pier comes back to rest at the end of ground shaking, these cracks can be quite subtle when only a few cycles of rocking have occurred and when pier drift ratios during shaking were small. As damage increases, softening of the pier can occur due to cracking, and the pier may begin to “walk” out-of-plane at the top and bottom. At the highest damage levels, crushing of units at the corners can occur.

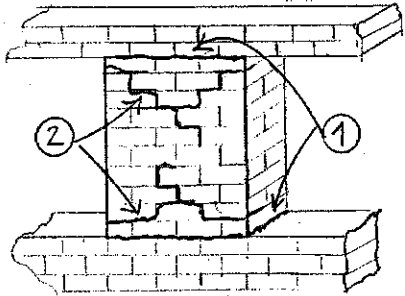
URM2A

Level	Description of Damage	Typical Performance Restoration Measures
Slight	Not used.	
Moderate $\lambda_K = 0.6$ $\lambda_Q = 0.9$ $\lambda_D = 1.0$ $\Delta/h_{eff} \leq$ $h_{eff}/L_{eff}^* \leq$ 0.4%	<p><i>Criteria:</i></p> <ol style="list-style-type: none"> 1. Hairline cracks/spalled mortar in bed joints at top and bottom of pier. 2. Possible hairline cracking/spalled mortar in bed joints within piers. <p><i>Typical Appearance:</i></p>

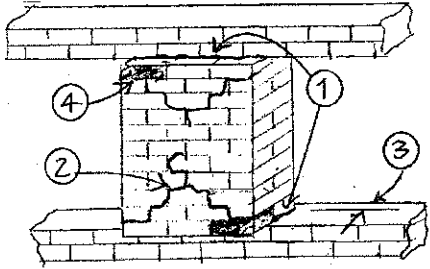
<p>Replacement or enhancement is required for full restoration of seismic performance.</p> <p>For partial restoration of performance:</p> <ul style="list-style-type: none"> • Repoint spalled mortar. $\lambda_K^* = 0.8$ $\lambda_Q^* = 0.9$ $\lambda_D^* = 1.0$
Heavy $\lambda_K = 0.4$ $\lambda_Q = 0.8$ $\lambda_D = 0.7$ $\Delta/h_{eff} \leq$ $h_{eff}/L_{eff}^* \leq$ 0.8%	<p><i>Criteria:</i></p> <ol style="list-style-type: none"> 1. Hairline cracks/spalled mortar in bed joints at top and bottom of pier, plus one or more of: 2. Hairline cracking/spalled mortar in bed joints within piers, but bed joints typically do not open. 3. Possible out-of-plane or in-plane movement at top and bottom of piers ("walking"). 4. Crushed/spalled bricks at corners of piers. <p><i>Typical Appearance:</i></p>

<p>Replacement or enhancement is required for full restoration of seismic performance.</p> <p>For partial restoration of performance:</p> <ul style="list-style-type: none"> • Replace/drypack damaged units • Repoint spalled mortar • Inject cracks $\lambda_K^* = 0.8$ $\lambda_Q^* = 0.9$ $\lambda_D^* = 1.0$

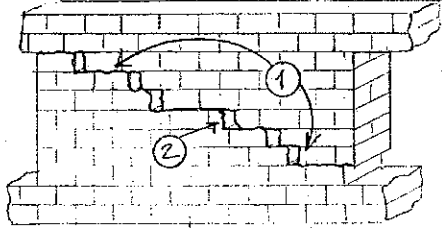
URM2B

Level	Description of Damage	Typical Performance Restoration Measures
Slight	Not used.	
Moderate $\lambda_K = 0.8$ $\lambda_Q = 0.6^*$ $\lambda_D = 1.0$ *As an alternative, calculate as V_{bjs2}/V_{bjs1} $\Delta/h_{eff} \leq 0.4\%$	<p><i>Criteria:</i></p> <ol style="list-style-type: none"> Horizontal cracks/spalled mortar at bed joints indicating that in-plane offset along the crack has occurred and/or opening of the head joints up to approximately 1/4", creating a stair-stepped crack pattern. 5% of courses or fewer have cracks in masonry units. <p><i>Typical Appearance:</i></p>

<p>Replacement or enhancement is required for full restoration of seismic performance.</p> <p>For partial restoration of performance:</p> <ul style="list-style-type: none"> Repoint spalled mortar and open head joints. Inject cracks and open head joints <p> $\lambda_K^* = 0.8$ $\lambda_Q^* = 0.8^*$ $\lambda_D^* = 1.0^*$ </p> <p>*In some cases, grout injection may actually increase strength, but decrease deformation capacity, by changing behavior from bed joint sliding to a less ductile behavior mode (see FEMA 307, Section 4.1.3).</p>

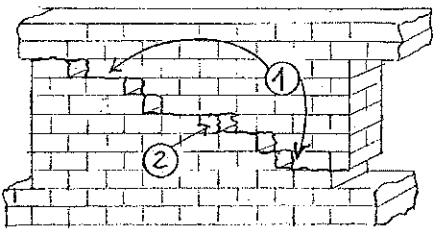
Heavy $\lambda_K = 0.6$ $\lambda_Q = 0.6^*$ $\lambda_D = 0.9$ *As an alternative, calculate as V_{bjs2}/V_{bjs1} $\Delta/h_{eff} \leq 0.8\%$	<p><i>Criteria:</i></p> <ol style="list-style-type: none"> Horizontal cracks/spalled mortar on bed joints indicating that in-plane offset along the crack has occurred and/or opening of the head joints up to approximately 1/2", creating a stair-stepped crack pattern. 5% of courses or fewer have cracks in masonry units. <p><i>Typical Appearance:</i></p>

<p>Replacement or enhancement is required for full restoration of seismic performance.</p> <p>For partial restoration of performance:</p> <ul style="list-style-type: none"> Repoint spalled mortar and open head joints. Inject cracks and open head joints. <p> $\lambda_K^* = 0.8$ $\lambda_Q^* = 0.8^*$ $\lambda_D^* = 1.0^*$ </p> <p>*In some cases, grout injection may actually increase strength, but decrease deformation capacity, by changing behavior from bed joint sliding to a less ductile behavior mode (see FEMA 307, Section 4.1.3).</p>

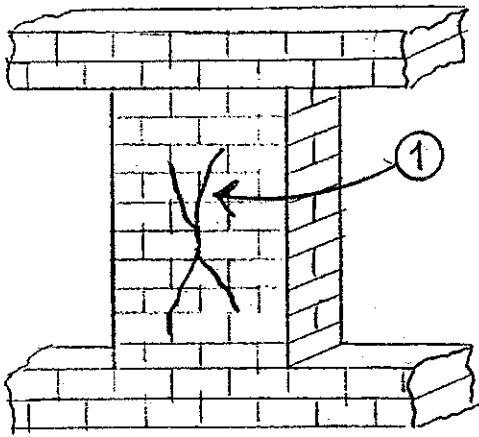
COMPONENT DAMAGE CLASSIFICATION GUIDE

Level	Description of Damage	Typical Performance Restoration Measures
Insignificant $\lambda_K = 1.0$ $\lambda_Q = 1.0$ $\lambda_D = 1.0$ $\mu_A \leq 1$	<p><i>Criteria:</i> 1. Hairline diagonal cracks in masonry units in fewer than 5% of courses.</p> <p><i>Typical Appearance:</i></p>

<p>Not necessary for restoration of structural performance.</p> <p>(Measures may be necessary for restoration of nonstructural characteristics.)</p>

Typical diagonal tension cracking—resulting from strong mortar, weak units, and high compressive stress—can be identified by diagonal cracks (“X” cracks) that propagate through the units. In many cases, the cracking is sudden, brittle, and vertical load capacity drops quickly. The cracks may then extend to the toe and the triangles above and below the crack separate. In a few cases, the load drop may be more gradual with cracks increasing in size and extent with each cycle. A second form of diagonal tension cracking also has been experimentally observed with weak mortar, strong units and low compressive stress where the cracks propagate in a stair-stepped manner in head and bed joints. The first (typical) case is shown below.

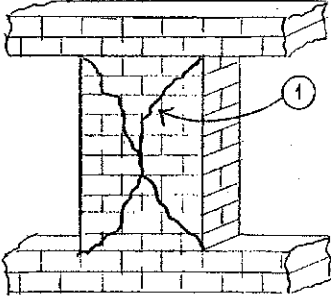
URM2K

Level	Description of Damage	Typical Performance Restoration Measures
Slight	Not used.	
Moderate $\lambda_K = 0.8$ $\lambda_Q = 0.9$ $\lambda_D = 1.0$ $\mu_A \approx 1-1.5$	<p><i>Criteria:</i></p> <ol style="list-style-type: none"> 1. Diagonal cracks in pier, many of which go through masonry units, with crack widths below 1/4". 2. Diagonal cracks reach or nearly reach corners. 3. No crushing/spalling of pier corners. <p><i>Typical Appearance:</i></p>

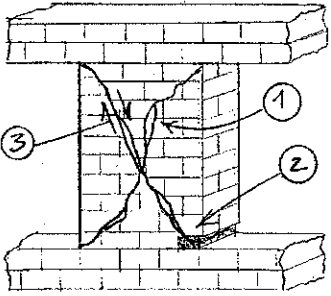
<ul style="list-style-type: none"> • Repoint spalled mortar. • Inject cracks. $\lambda_K^* = 0.8$ $\lambda_Q^* = 1.0$ $\lambda_D^* = 1.0$
Heavy $\lambda_K = 0.4$ $\lambda_Q = 0.8$ $\lambda_D = 0.7$ $\mu_A > 1.5$	<p><i>Criteria:</i></p> <ol style="list-style-type: none"> 1. Diagonal cracks in pier, many of which go through masonry units, with crack widths over 1/4". Damage may also include: 2. Some minor crushing/spalling of pier corners and/or 3. Minor movement along or across crack plane. <p><i>Typical Appearance:</i></p>

<p>Replacement or enhancement is required for full restoration of seismic performance.</p> <p>For <u>partial</u> restoration of performance:</p> <ul style="list-style-type: none"> • Replace/drypack damaged units. • Repoint spalled mortar. • Inject cracks. $\lambda_K^* = 0.8$ $\lambda_Q^* = 0.8$ $\lambda_D^* = 1.0$
