# VEHICLE RECALL

**G-05515** July 2005

**SUBJECT: SAFETY RECALL (U.S., EXPORT)**

Front Brake Hoses on certain 4200 and 4300 Models

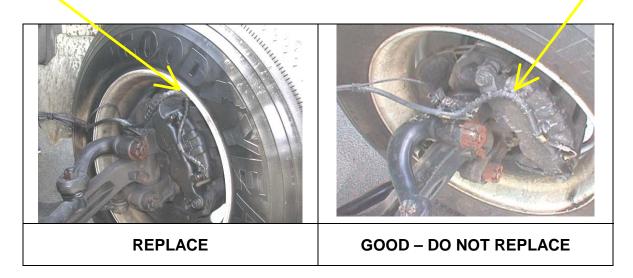
A longer front hydraulic brake hose, for a large (73mm) hydraulic caliper, may have been substituted for the shorter, correct length hose used on the small (66mm) caliper. This extra length may cause the wheel to rub through the brake hose. A hole in a brake hose can cause a partial loss of braking ability that could result in a vehicle crash without warning possibly resulting in property damage, personal injury or death.

**Table 1-** Any Brake hose that has an excess amount between the caliper P-clip and the king-pin P-clip must be replaced.

- 2. Replace Long brake hose
- 3. Bleed brake system.
- Check brake fluid level and refill as necessary.
