VEHICLE RECALL

IC CORPORATION RECALL # 04302 NHTSA RECALL # 04V- 251 June 2004

SUBJECT: VEHICLE RECALL

Emergency Exit Window Instructions

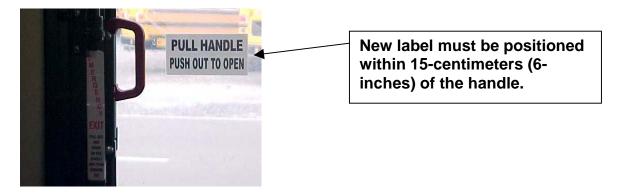
The rear emergency exit window interior opening procedure instruction label on the frame of the window located inside the bus is not 1-centimeter in height as required by FMVSS 217. In the event of an emergency, understanding the proper operation of the emergency exit window may be impaired preventing rapid egress from the bus.

IC requested the owner to place the label enclosed with the notice on the units identified to them as displayed on the green cards.

IC requests the dealer to add the new label to any of these windows in the dealer inventory. The part numbers of the windows are 448288001 through 448288020.

The customer was told that IC had included with the notice a sufficient number of labels to repair the units in their inventory. The label has a peel off back that must be removed prior to placing it on the glass, as shown on the picture below. The customer was asked to make sure the glass is clean and dry before the application is made. To comply with federal regulations, it is important to place the label in the location shown in the picture below.
