DTC U201F:11 [START STOP UNIT]

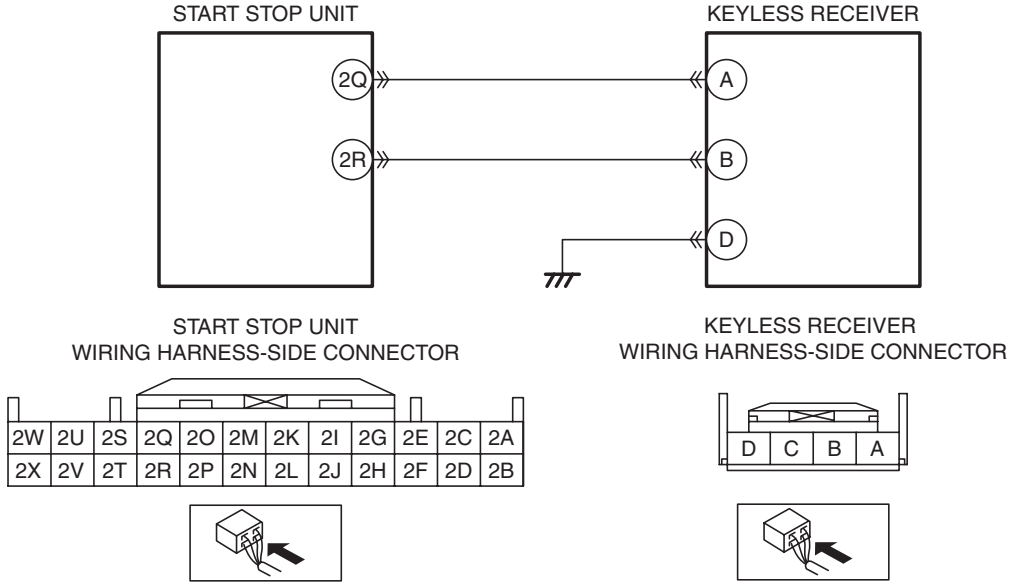
System malfunction location	**Keyless receiver circuit malfunction**
Detection condition	• Start stop unit detects keyless receiver circuit voltage of **less than 3.4 V** for **0.5 s or more**.
Fail-safe	—
Possible cause	• Keyless receiver connector or terminal malfunction • Start stop unit connector or terminal malfunction • Short to ground in wiring harness between start stop unit terminal 2Q and keyless receiver terminal A • Keyless receiver malfunction • Start stop unit malfunction
