Exercise 1

N76101012 謝慈芯

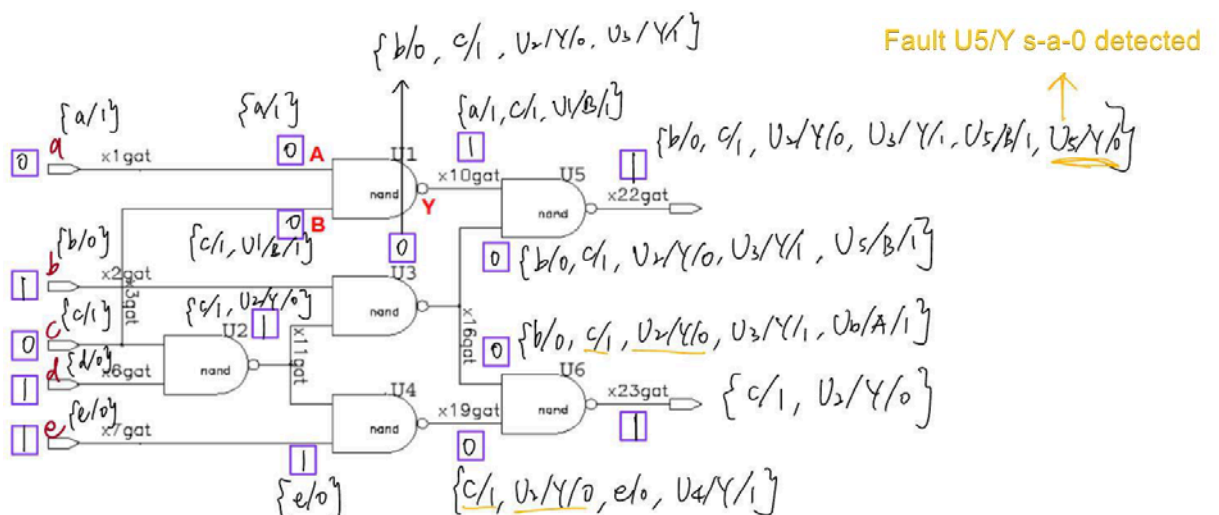
Deductive fault Simulation

(Deductive fault Simulation 分析結果為 Detected : Fault U5/Y s-a-0)
