Mercedes Benz C 250 Sedán 2013 (204.047) L4-1.8L Turbo (271.860)

AR46.40-P-0201CW Extracción/Instalación de la rótula de dirección interior con junta axial

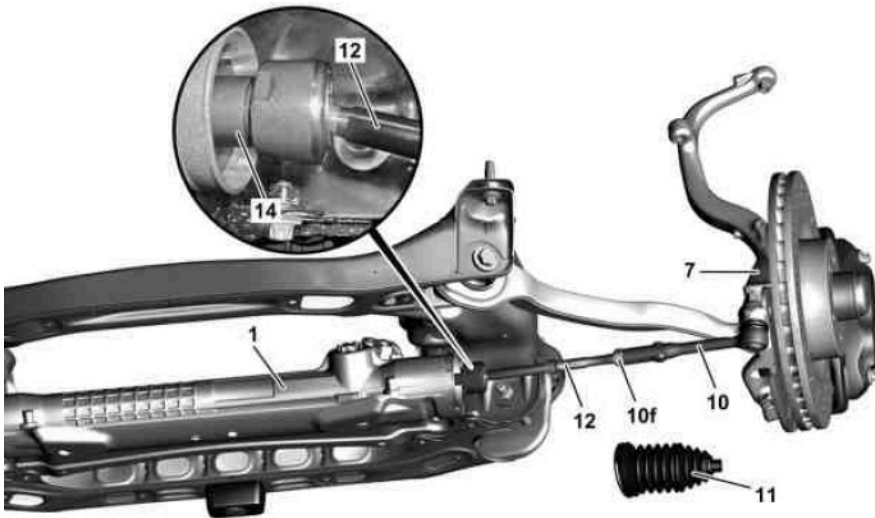
MODELO 172, 204, 207 1 Dirección de cremallera y piñón 7 Mangueta de dirección 10
Rótula de dirección 10 Tuerca de seguridad 11 Fuelle 12 Barra de acoplamiento interior 14
Cremallera dentada

Remove/install		
1	Detach boot (11)	except CODE 211 (Direct-Steer system) With CODE 211 (Direct steering)	AR46.40-P-0400CW AR46.40-P-0400EW
2	Release and unscrew tie rod (12) from rack-and-pinion steering (1)

For vehicles with hydraulic power steering, the toothed rack (14) must be counterheld when releasing and tightening the inside tie rod (12).
