PGM-FI Control System

Troubleshooting Flow Chart — TA Sensor

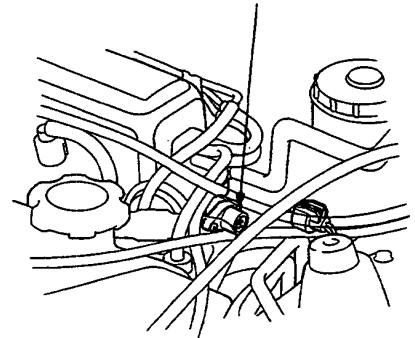
TA SENSOR

Disconnect the 2P connector from the TA sensor.

Measure resistance between the 2 terminals on the TA sensor.

Is there 1-4 k Ω ?

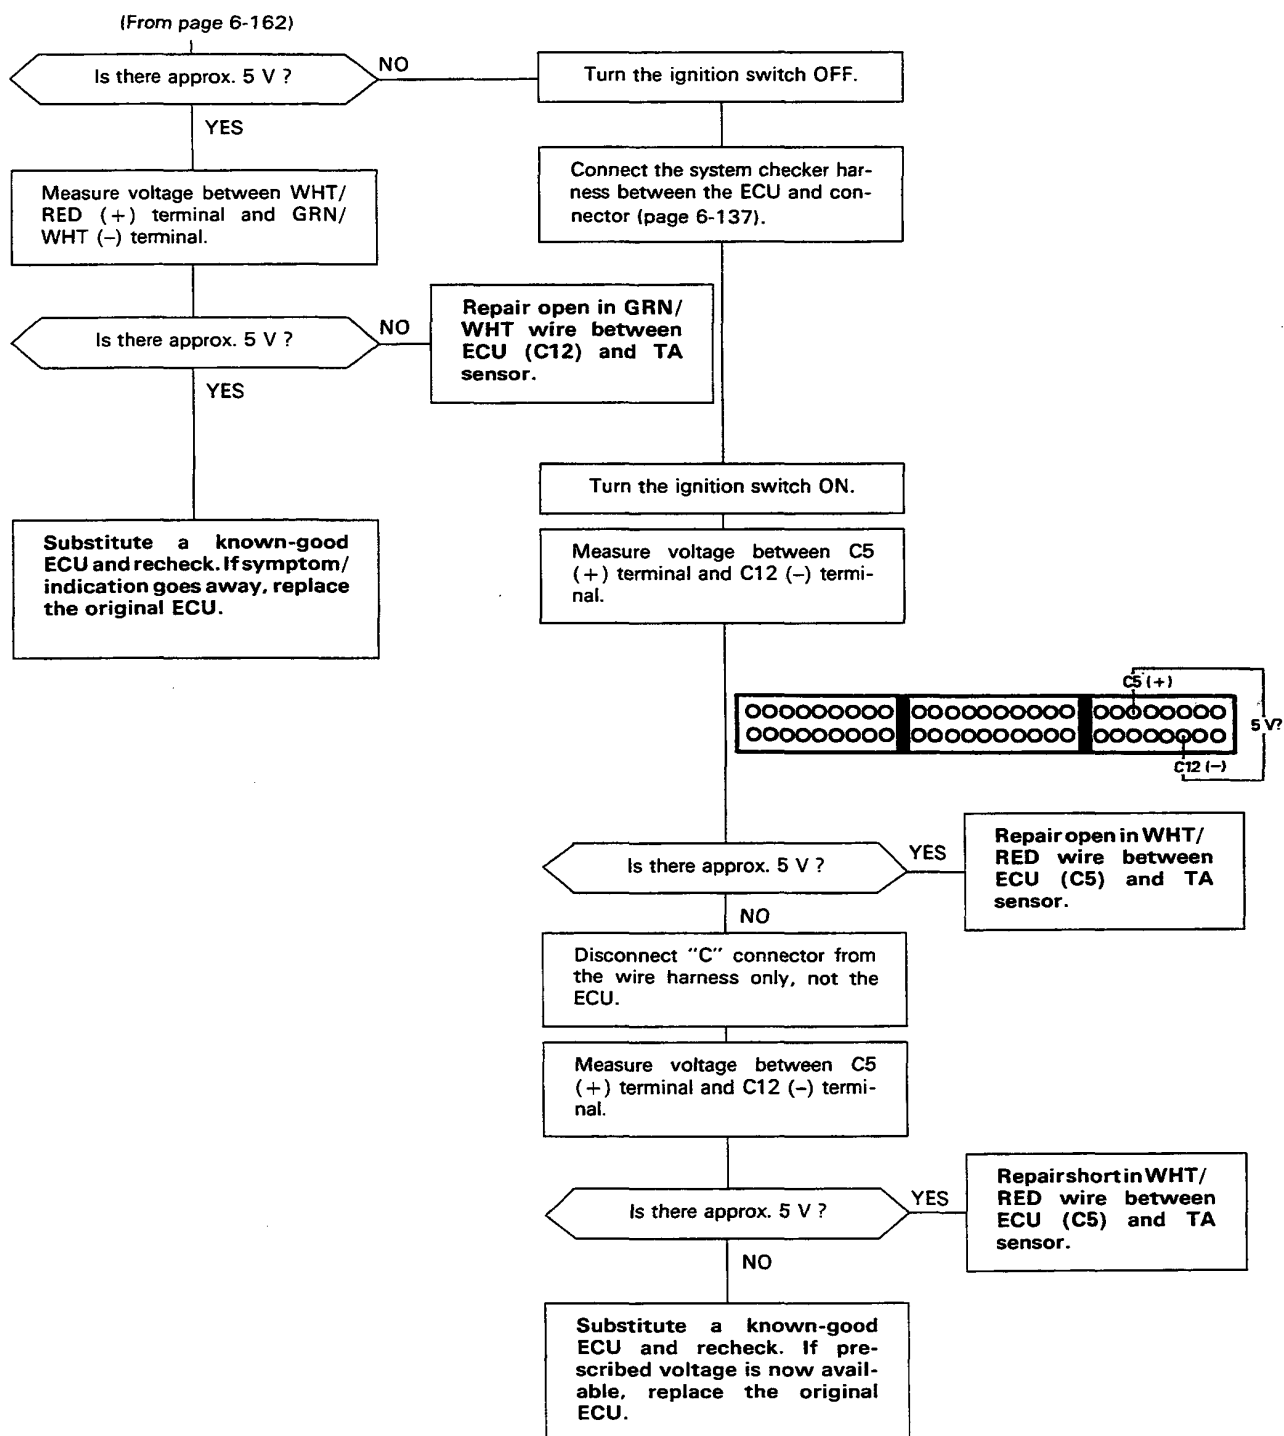
Self-diagnosis LED indicator blinks ten times: Most likely a problem in the Intake Air Temperature (TA) Sensor circuit.

Turn the ignition switch OFF.

Remove CLOCK fuse in the under-hood relay box for 10 seconds to reset ECU.

Turn the ignition switch ON.

Is PGM-FI warning light on ?
Does LED indicate CODE 10 ?

Measure voltage between WHT/
RED (+) terminal and body ground.
