JOURNEY RISK MANAGEMENT (JRM) STUDY

Gorakhpur LPG BP TO MAA VAISHNAVI INDANE

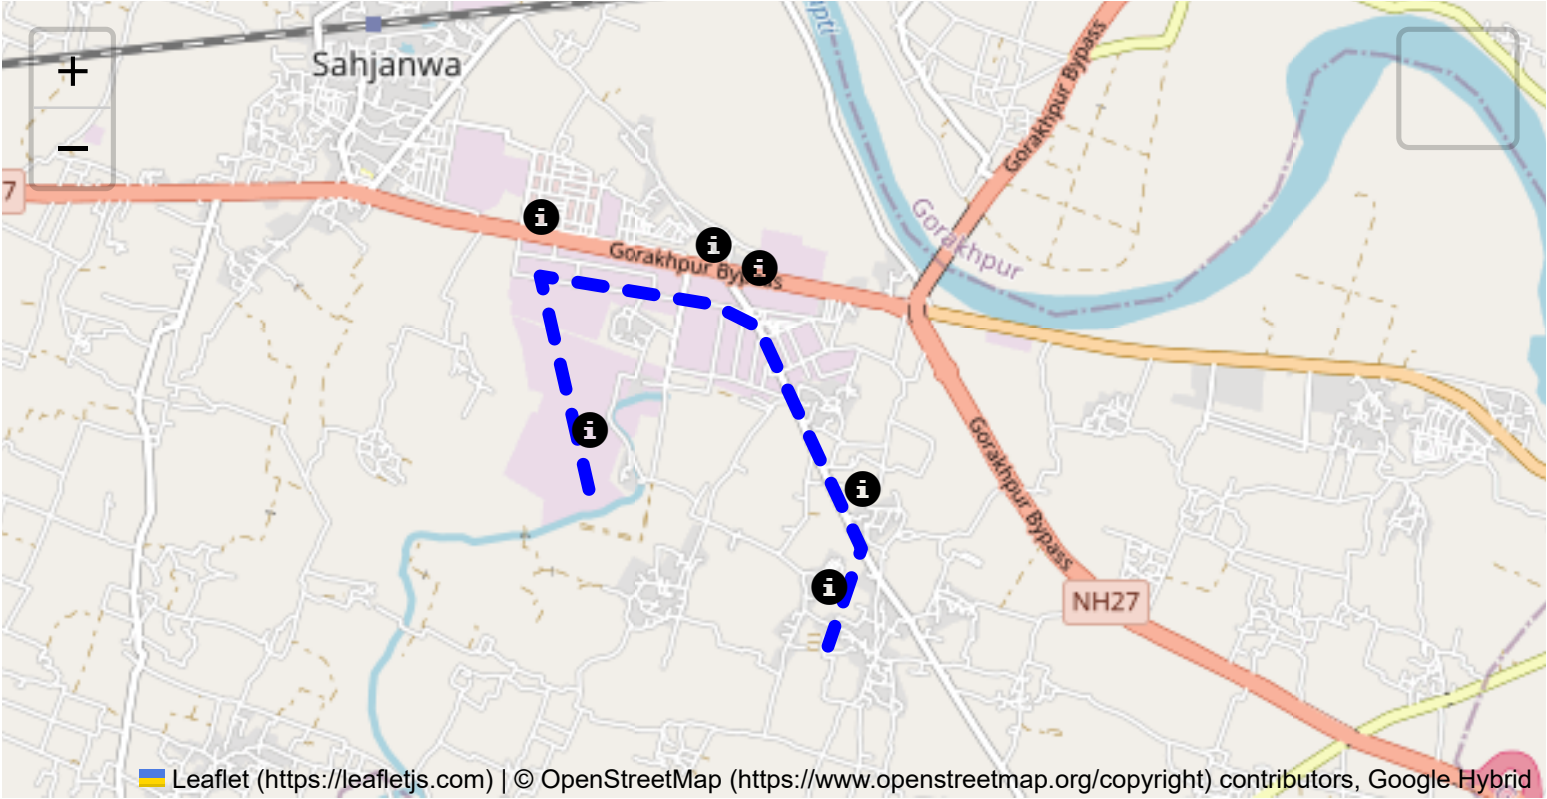
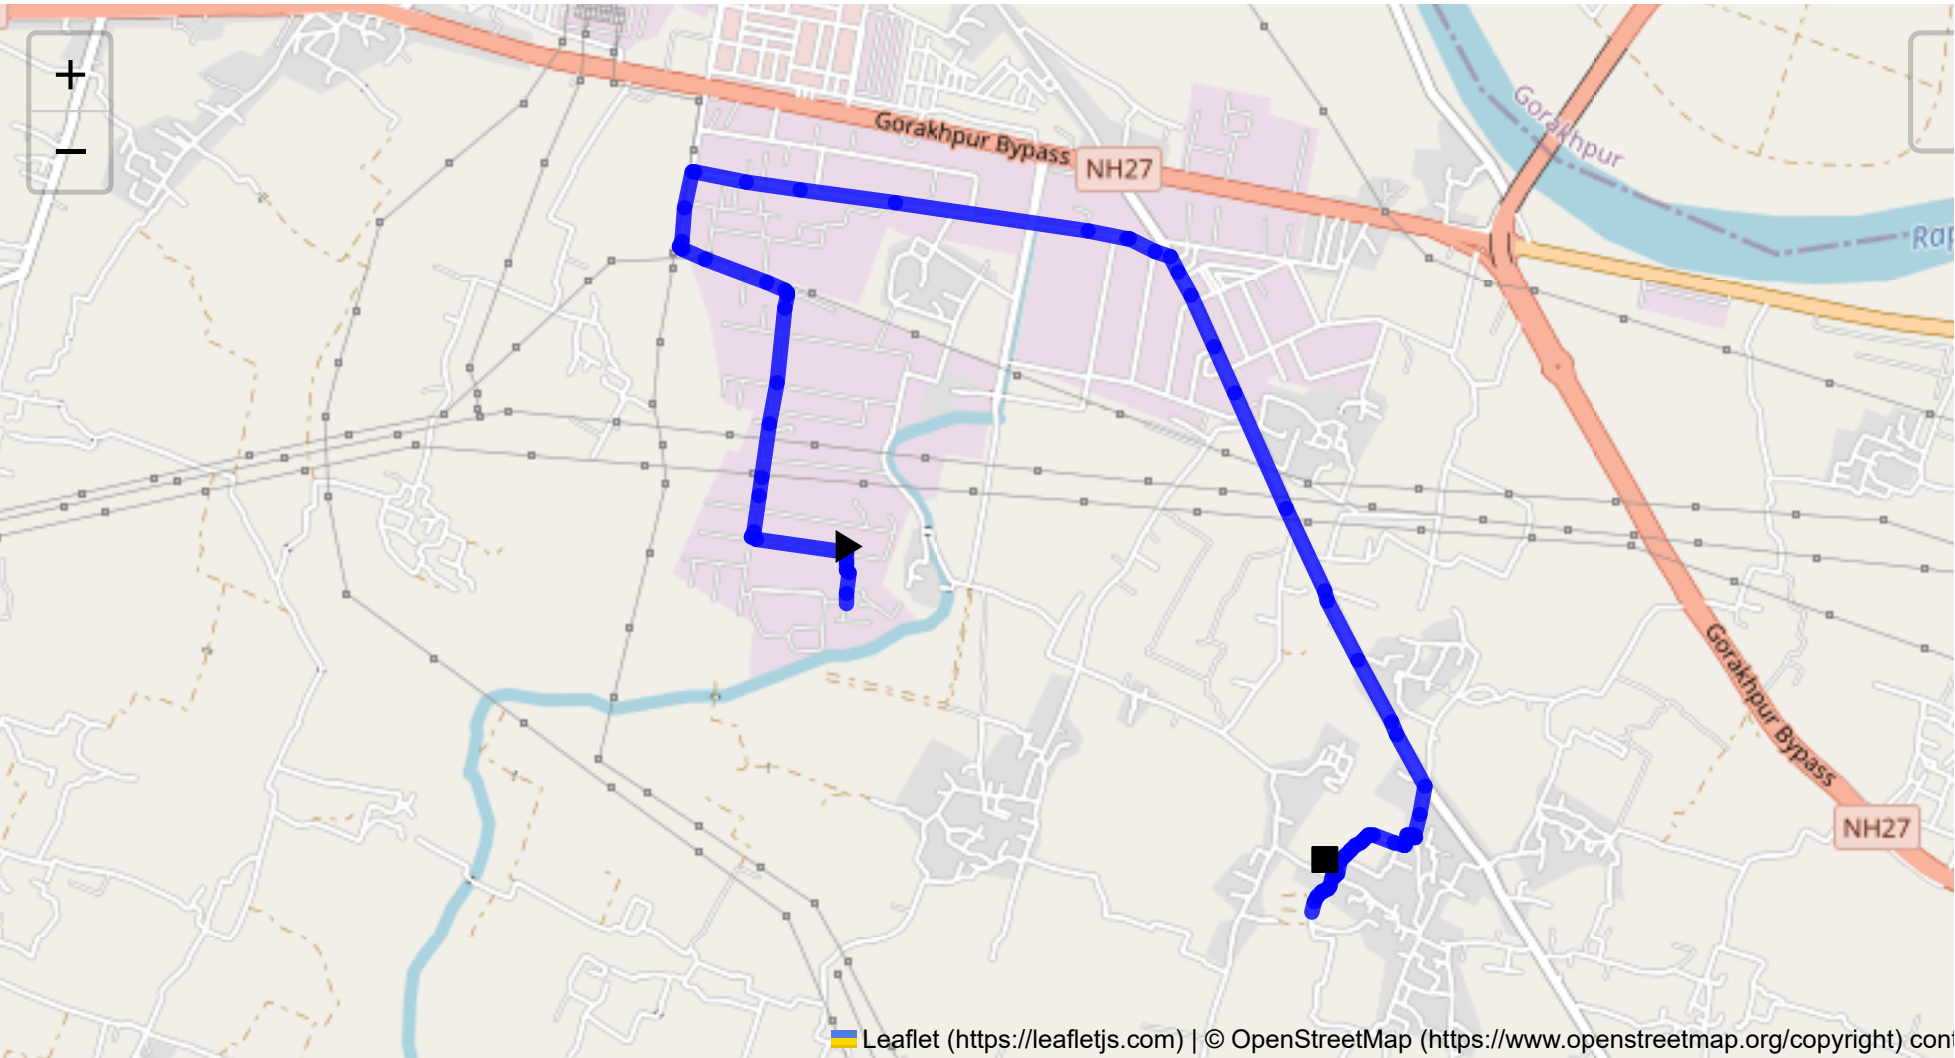
Route Summary:
Total Distance: 6.21 km
Estimated Duration: 0.3 hours
Adjusted Duration (Heavy Vehicle): 0.3 hours
Start: (26.735959, 83.229398)
End: (26.72659, 83.24526)
