INSPECTION

5. INSPECT KNOCK SENSOR

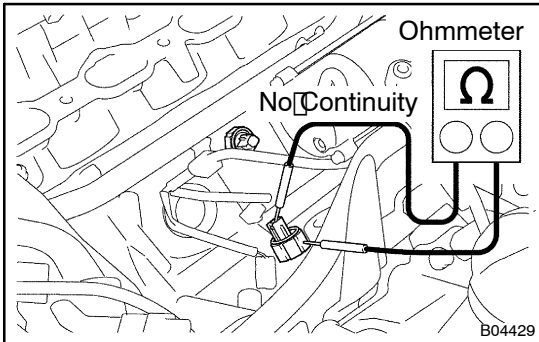
- (a) Disconnect the knock sensor connectors.
- (b) Using an ohmmeter, check that there is no continuity between the terminal and body.
