**POC Documentation**

# **AInspecto**

**AI Vehicle Inspection Module**

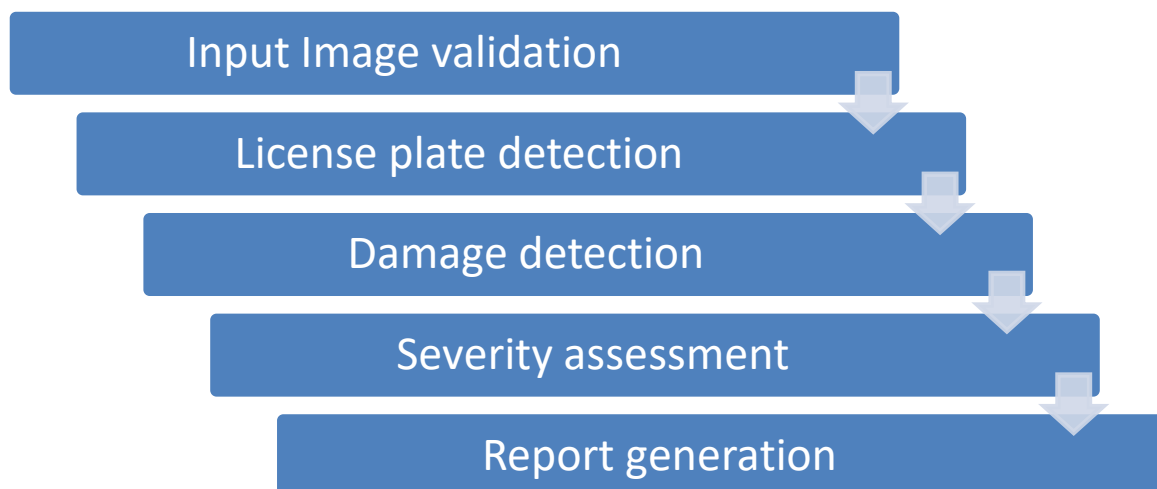
Flow chart consists of graphical representation of the features mentioned and their connectivity with each other providing a streamlined flow of events that can ensure the working of project to inspect the vehicle damages and generate a report. The sequential processing of events are shown in the below graphic.

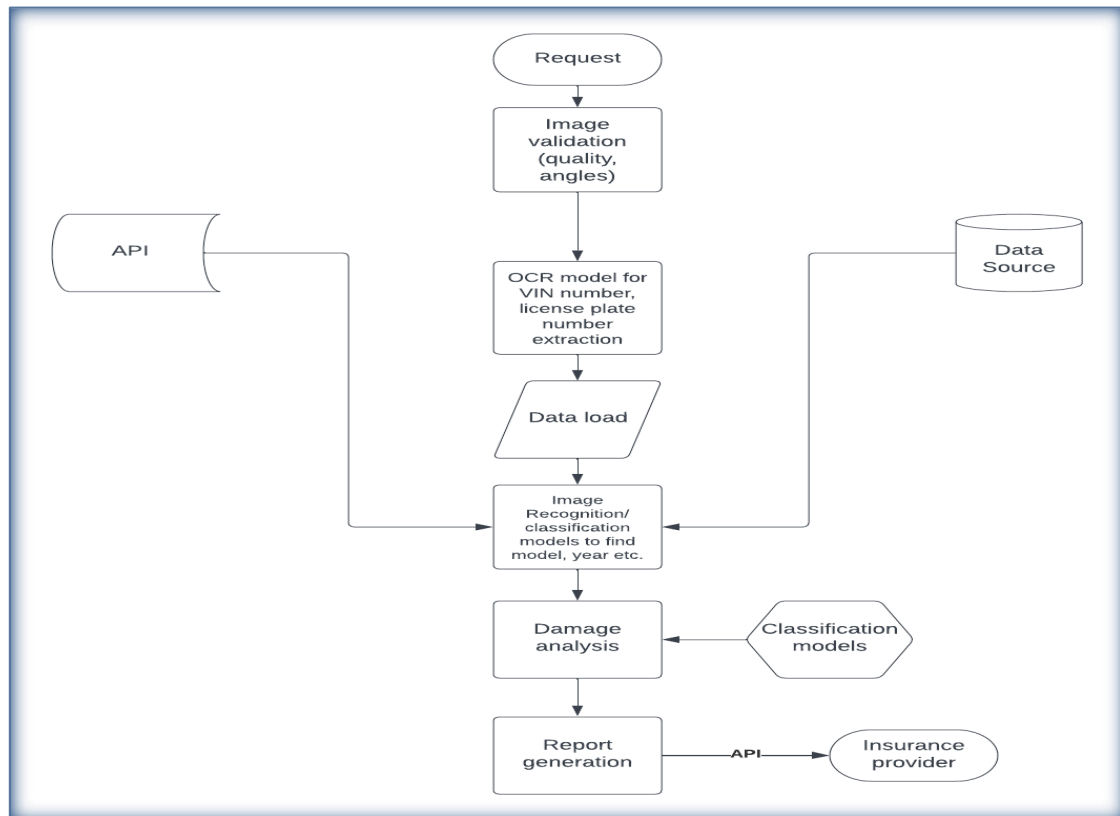
The technical flow chart of the project is shown below

This flow chart describes the features that will be added as API's which will be used by the insurance providers or intermediate platforms associated.

In brief, flow of the functionalities is explained as follows:

When there is a request from any insurance provider or its associated platforms for vehicle inspection, the first step is to validate the vehicle; so we request a back view image of the vehicle and detect the license plate with our model and read the license plate with easy OCR model, then verify this information with the insurance provider to validate the vehicle and owner details.

Then we request the 360 degree images of the vehicle from the user, further validations are performed on these images whether they belong to the same vehicle, quality of the images.

Once the validations are satisfied then these images are given to two different models to access damage severity and detect the damages. These results are tabulated and returned along with the damage detected images back to the insurance provider as API response.

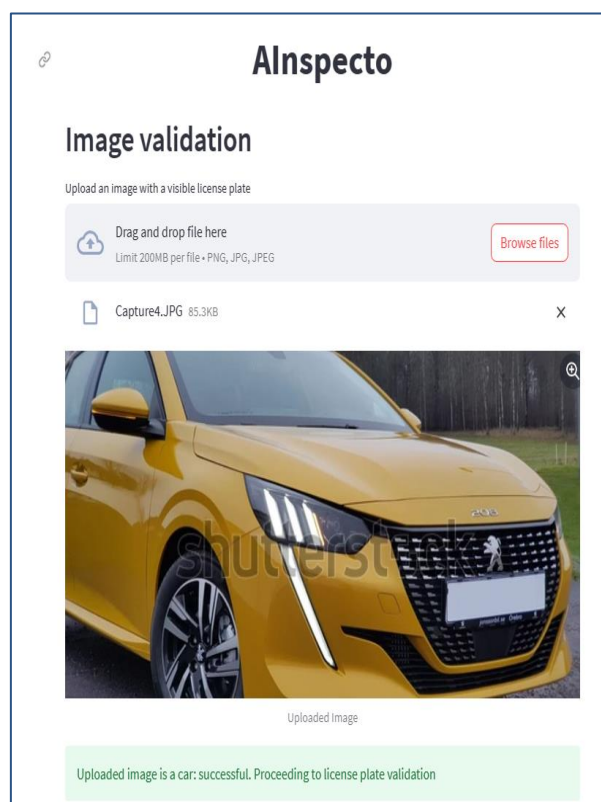
Success Scenario

In the success scenario the uploaded image is a car, so it will be proceeding to license plate detection and validations.

In failure scenario the uploaded image might not be a car, so there will be an error message to re upload the image to continue to license plate detection.

Initially when the back view image of the vehicle is requested for vehicle detail validation, there is a chance of uploading any random image not necessarily of a vehicle. So we are using a pre trained **VGG16** model that is trained on '**imagenet**' to verify whether the uploaded image is a car or not. If the uploaded image is not a car, user is requested to re-upload the image to continue. If the validation is satisfied then control moves to the next validation that is license plate detection.

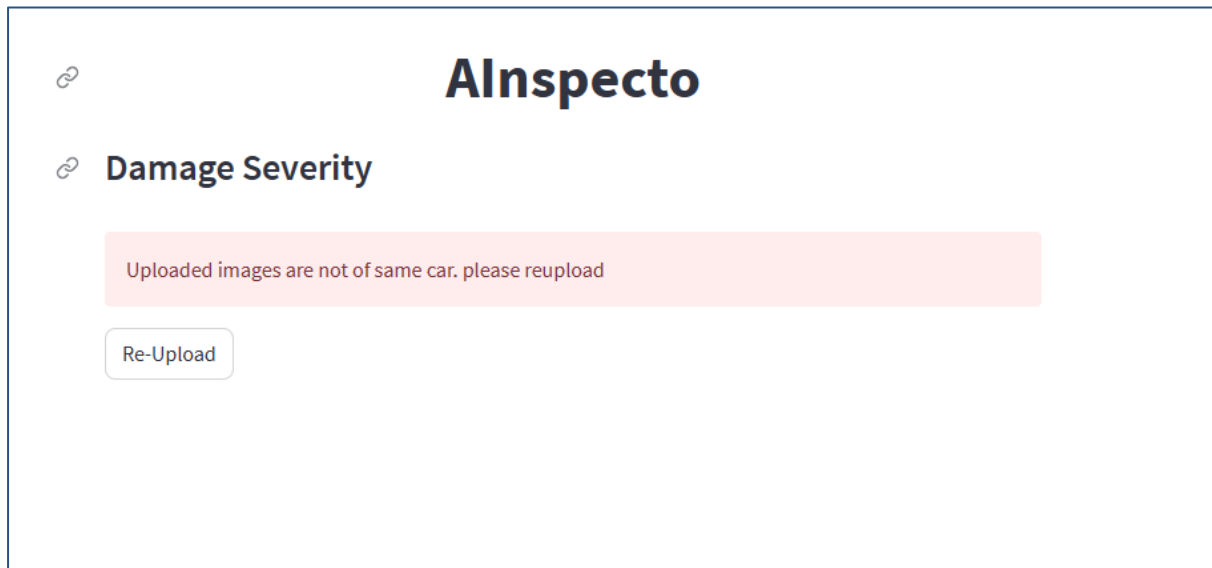
Here the images uploaded were not of the same car, so we have an error message to re-upload the images of same car to continue the damage assessment.

While uploading images of four sides of the vehicle, there can be a chance of uploading different car images. This issue has been addressed where we validated the given images with a pre-trained model and validate whether they are from the same car or not. If they are not of the same car then user has to re-upload the images to continue to damage assessment. If the images are of same car then it will proceed to damage assessment.

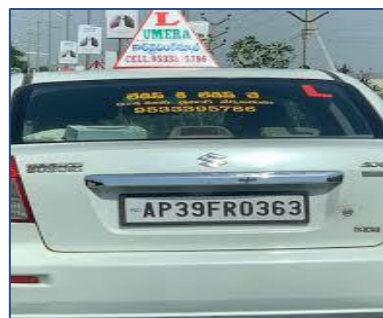
### License plate detection

Here are the images of the input image, cropped detected license plate and the details corresponding to the license plate.

License plate detection successful

License plate number:

AP39FR0363

One of the important modules in this project is the license plate detection and validation. After the input validation is satisfied image is fed into a YOLO v8 model which was custom trained to detect the license plates from any image having a visible license plate.

This detected license plate is cropped from the original image and will go through a series of image processing functions such as gray scaling, thresholding, resizing etc.

Then this is fed into an OCR model to read the plate number from the processed license plate. We have used Easy OCR pre-trained model to read the license plate and send the result to the insurance provider for vehicle validation and verification before moving to damage detection and assessment module.

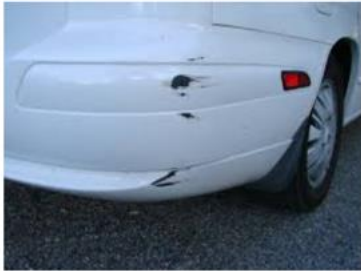
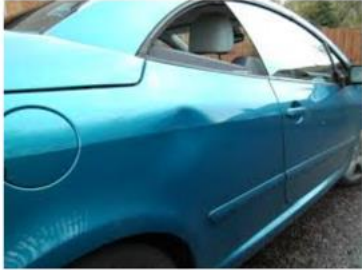
Damage Severity

Vehicle side	Result
0	left	minor
1	right	minor
2	front	minor
3	back	minor

Once the damages are identified then the images are processed through this model to identify the severity of the damage on each side. These results are merged with damage detection results and the final results are shown/send back to the user/insurance provider.

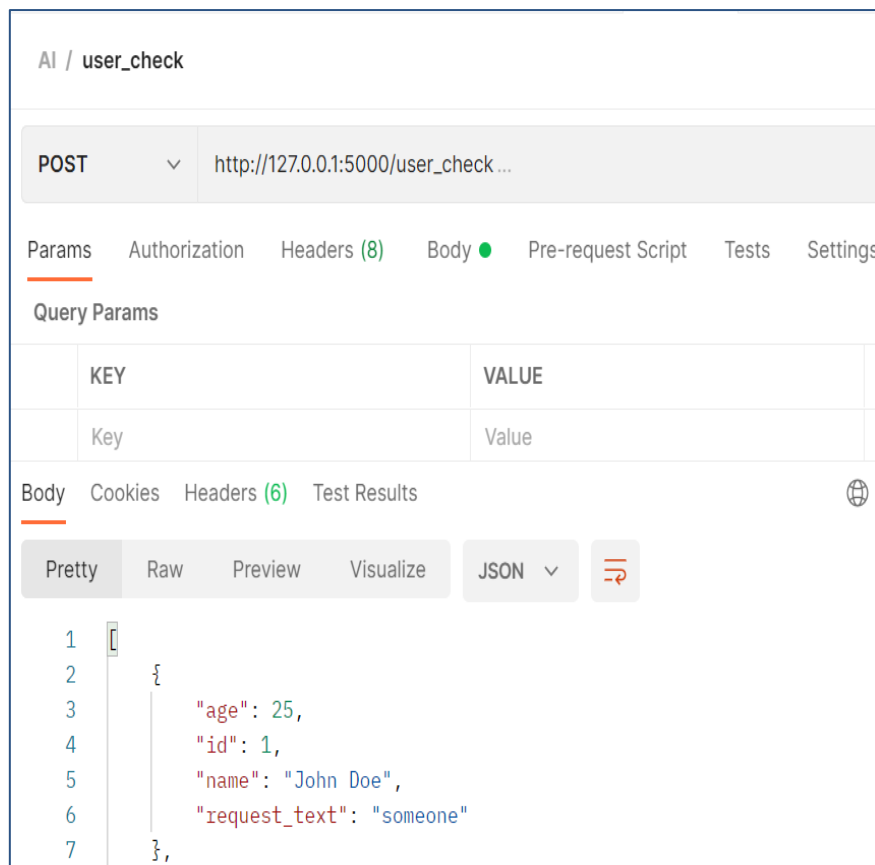
**Description:** This API receives the 'request\_text' from the JSON request and filters a sample data containing information about different users based on the input 'request\_text'.

**Output:** The output of the API is a JSON response containing the filtered data of users matching the 'request\_text'.

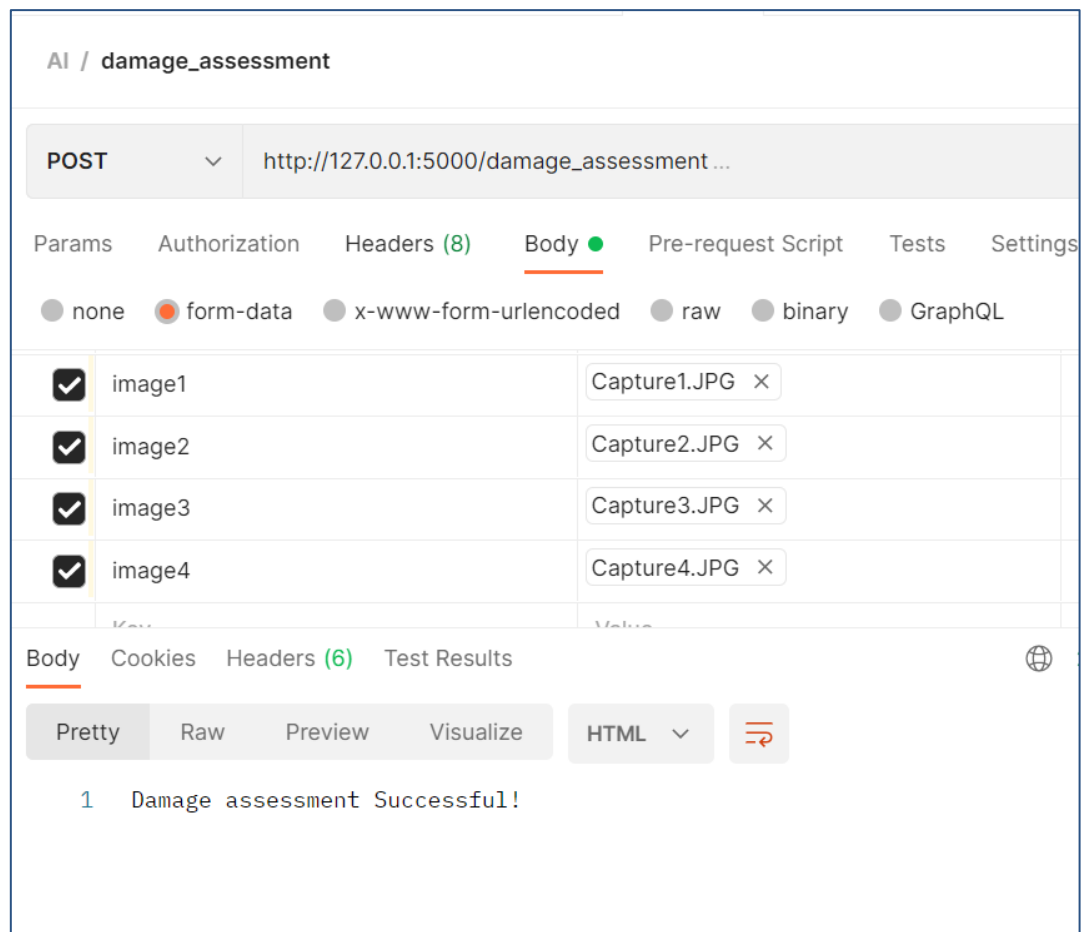
**Description:** The API performs damage assessment on the vehicle based on the uploaded images. It validates if all images are of the same car, and if so, proceeds to assess the damages using machine learning models.

**Output:** The output of the API is a JSON response containing a DataFrame with information about the detected damages and their severity on each side of the vehicle. It also saves the DataFrame as a temporary JSON file.

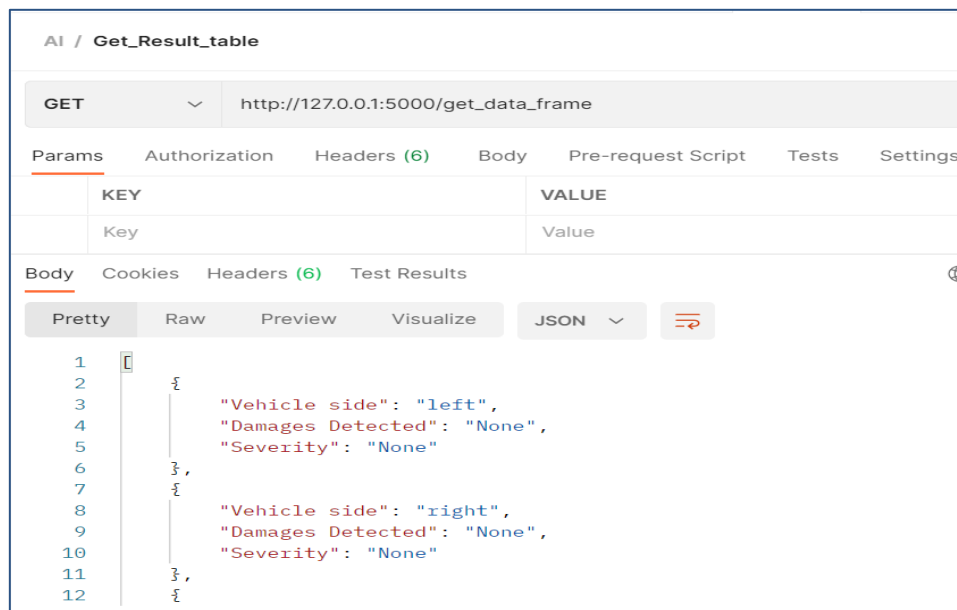
**Description:** This API retrieves the DataFrame containing information about the detected damages and their severity on each side of the vehicle.

**Output:** The output of the API is the JSON representation of the DataFrame containing the assessment results.

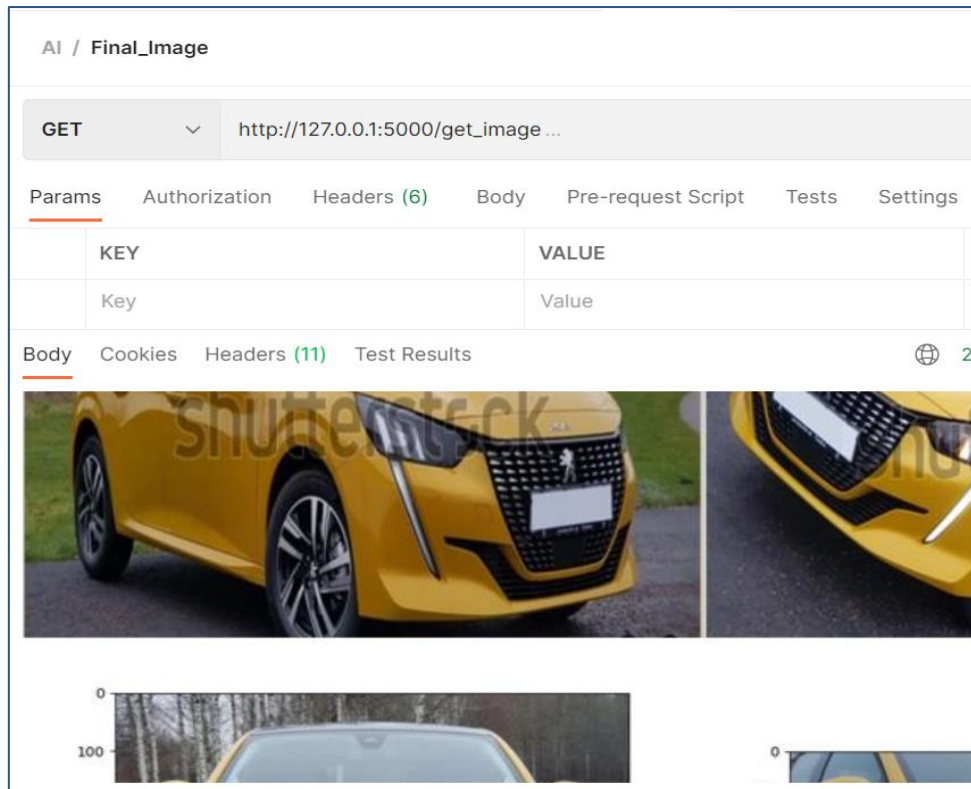
**Description:** This API retrieves the images of the vehicle showing the detected damages on each side.

**Output:** The output of the API is a collage image that combines the images of the vehicle's sides, with detected damages marked on each side. If a specific result image is not found, the input image for that particular side is returned instead. The collage image is saved as 'collage.jpg'.
