## **Technical Service Information**

## FORD C-3 FRONT SEAL POP-OUT

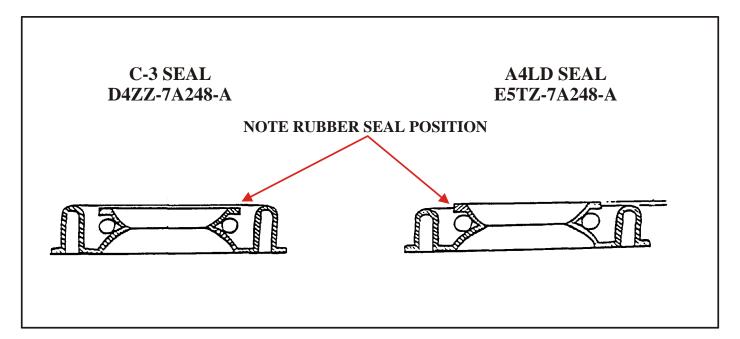
Figure 1

**COMPLAINT:** C-3 font seal pops out after overhaul or seal replacement.

CAUSE: One cause can be the use of a a4ld front seal Used in place of the c-3 front seal. See figure 1

(A4LD seal)note that the lip of The seal protrudes past the metal base of the Seal housing. When. The seal is installed the Rubber portion of the seal restricts the drain Passage

behind the seal. In figure 1 (C-3 seal) The seal lip is below the metal base of the seal.

**CORRECTION:** Install a C-3 front seal (D4ZZ-7AZ48A) in C-3 transmissions.
