## A.8 Haiti - 2010 - Earthquake

### Case study:

This project built progressive shelter in two phases: a first emergency response (structure covered with tarpaulin) and a second durable solution (permanent housing with cement cladding). The project included safer construction awareness activities and safer construction trainings. The shelter project was the beginning of an integrated programme that also included water and sanitation, hygiene promotion, health, disaster preparedness and livelihoods projects.

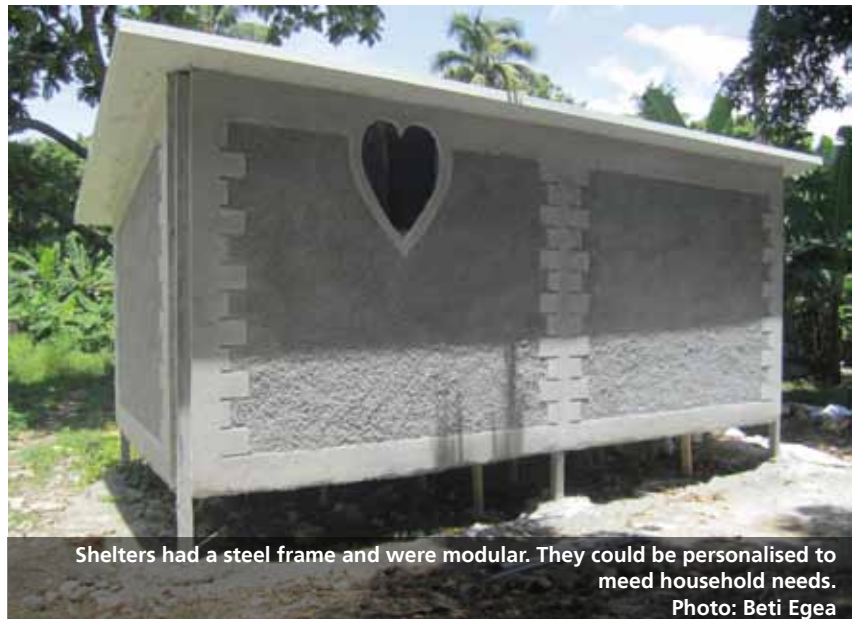
Shelters had a steel frame and were modular. They could be personalised to meet household needs.  
Photo: Beti Egea

The shelter had a galvanised steel frame with a mono-pitch roof and a raised floor. The shelter was 3 x 6m on plan and had 6 columns spaced on a 3m grid, fixed to rectangular reinforced concrete foundations using a base plate and four ordinary bolts per base. The shelter could be demounted and foundation bolts cut to reuse the frame.

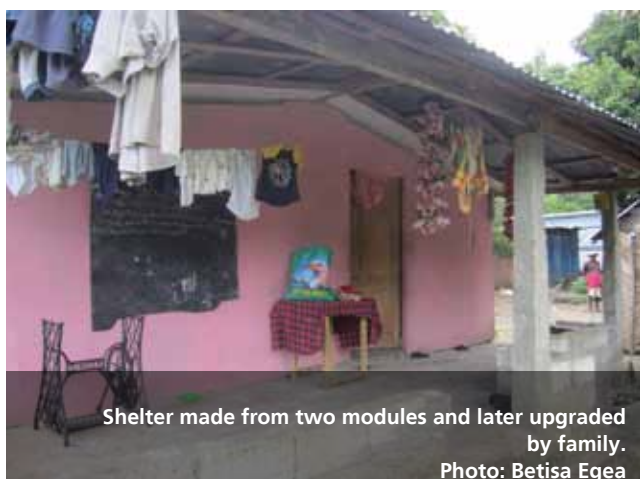
Shelter made from two modules and later upgraded by family.

The shelters were adapted according to the number of people in the family. The basic module is 18m<sup>2</sup>. Families with up to 5 members received one module, families over 5 members received two modules and families with over 10 members received three modules.

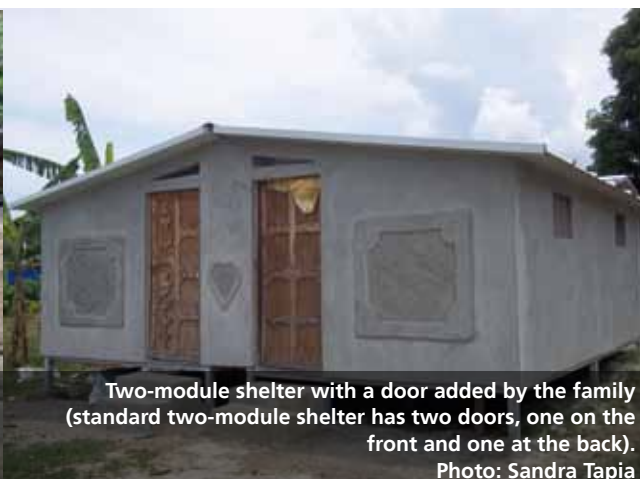
Two-module shelter with a door added by the family (standard two-module shelter has two doors, one on the front and one at the back).

- The traditional Haitian house has several exterior doors. Many beneficiaries added doors to their shelter.
