Technical Service Information

THM 4T60-E 3RD GEAR STARTS, NO A/C, NO VOLTAGE TO "E" TERMINAL

02-18

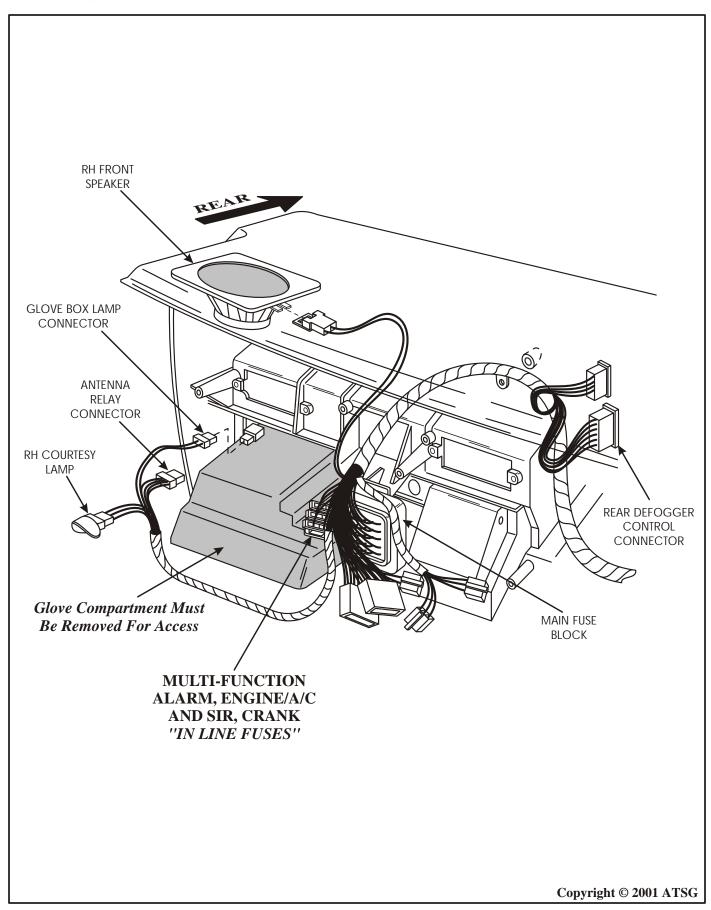
Figure 1

CAUSE: The cause may be, a blown "*In-Line*" fuse behind the instrument panel as illustrated in

Figure 1, that also controls voltage to terminal "E" at the transaxle.

CORRECTION: Remove the glove compartment for access to the "In-Line" fuses, and replace the A/C fuse,

as shown in Figure 1.
