A.12 Haiti – 2010 – Earthquake

Case Study: **Keywords:** Dispersed, Construction materials, Housing repair and retrofitting, Training, Guidelines and training materials .

Haiti

Rural south-eastern Haiti

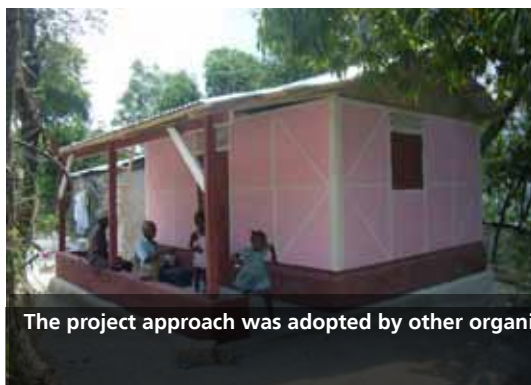
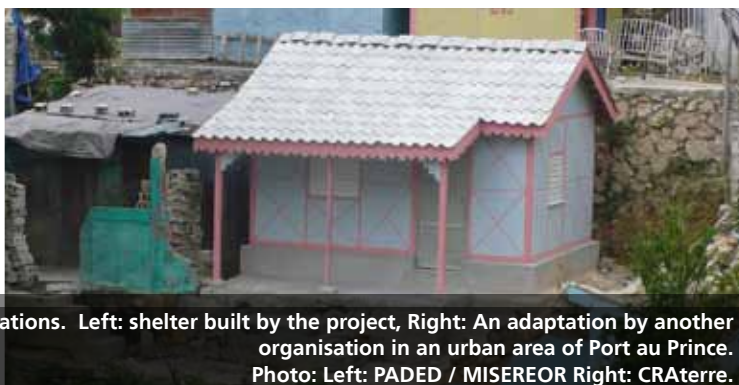
The project approach was adopted by other organisations. Left: shelter built by the project, Right: An adaptation by another organisation in an urban area of Port au Prince. Photo: Left: PADED / MISEREOR Right: CRAterre.

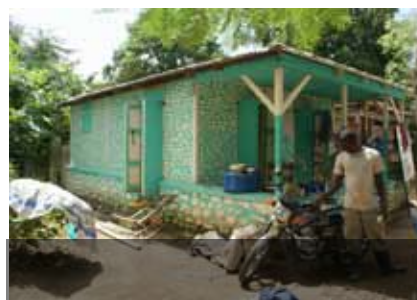
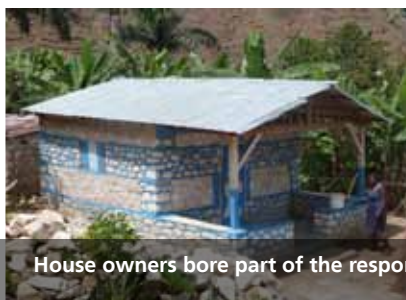
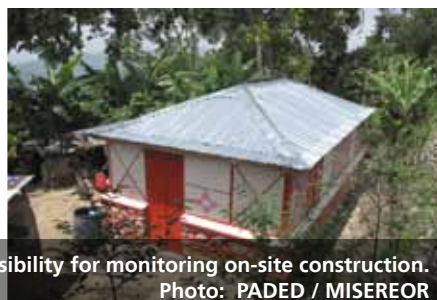
House owners bore part of the responsibility for monitoring on-site construction. Photo: PADED / MISEREOR

During the house repairs, the inhabitants were given a guided tour of a damaged house to point out defects and reasons for failure. With this new knowledge, people were able to take on part of the responsibility for the quality of construction and repairs to their own houses.

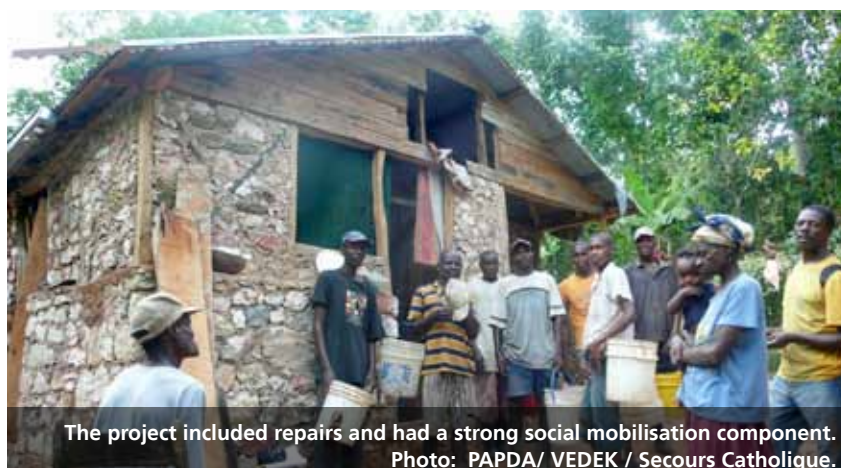
The project included repairs and had a strong social mobilisation component.
Photo: PAPDA/ VEDEK / Secours Catholique.
