Technical Service Information

THM 3T40 (125C) TCC FILTER ADDED

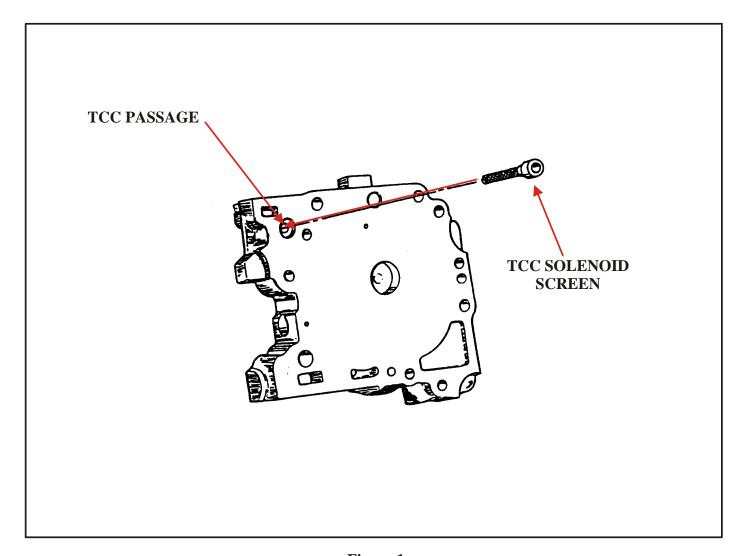
Figure 1

A TCC filter has been added to the TCC signal passage in the auxiliary valve body, beginning in March, 1987 (See Figure 1). This will reduce the possibility of sediment entering the TCC solenoid.

If the solenoid gets contaminated with sediment, it could result in a complaint of engine stalling when selector is placed in drive or reverse.

The filter cannot be used in previous models because of a machining process needed on the auxiliary valve body.
