System on Chip Architecture

Lab 3 Report

Daniele Castro S253244
System-on-chip architecture
Politecnico of Turin

Abstract—In this lab I have implemented a simple web server using the MCU STM32F051R8 on the discovery board and the WiFi module SPWF01SX.11 communicating with the microcontroller and using AT commands. Web pages are updated by sending HTML code through UART (RS-232) with TTL voltage levels.

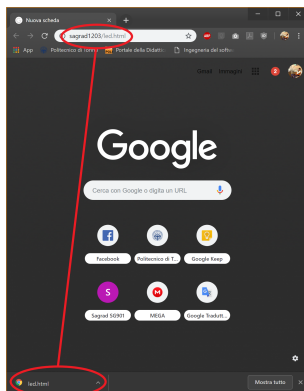
Fig. 1. wrong code download

The main problem with the behaviour of this template was that the HTML code sent appeared to be corrupted: full of strange non ASCII characters. Such characters were so many that some browsers (like chrome) did not visualize the retrieved HTML file and downloaded it, like in this picture:
