Technical Service Information

THM 3T40 (125C) DIFFERENTIAL LOCKING SWITCH

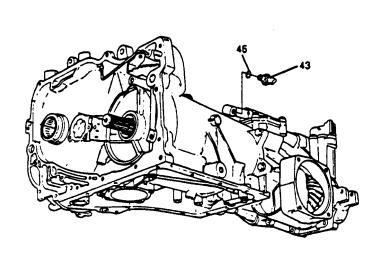
COMPLAINT: 1. AWD LOCK - indicator will remain on, but differential will not lock.

2. ANTI-LOOK - indicator will remain on, and ABS operation would be disabled.

CAUSE: The cause may be an inoperative and/or intermittent Center Differential Locking Switch

(See Figure 1) due to moisture entry during the manufacturing process.

43 CENTER DIFFERENTIAL LOCKING SWITCH 45 SEAL, O-RING ELECTRICAL CONNECTOR HOUSING

CORRECTION: Replace the Center Differential T&cking Switch with a new one, now available under OEM

part number 8665329.
