Final Report January 11, 2022

P01-1605: Peterson Ranch Working Waterway Habitat Enhancement Project

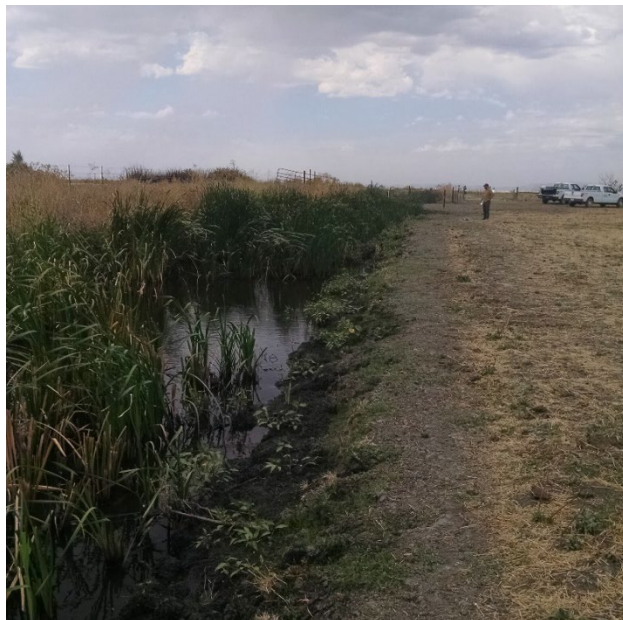
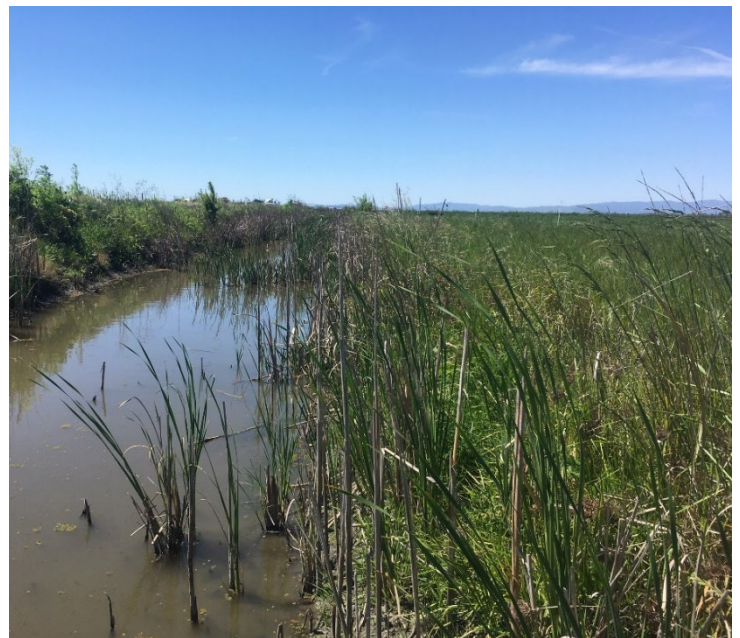
**Figures 2a and 2b:** Site 3 (east side), CRAM photo taken in September 2017 (above left) and again in April 2020 (above right).
