Technical Service Information

AUDI 01F FILLER TUBE DOES NOT HAVE A DIP STICK

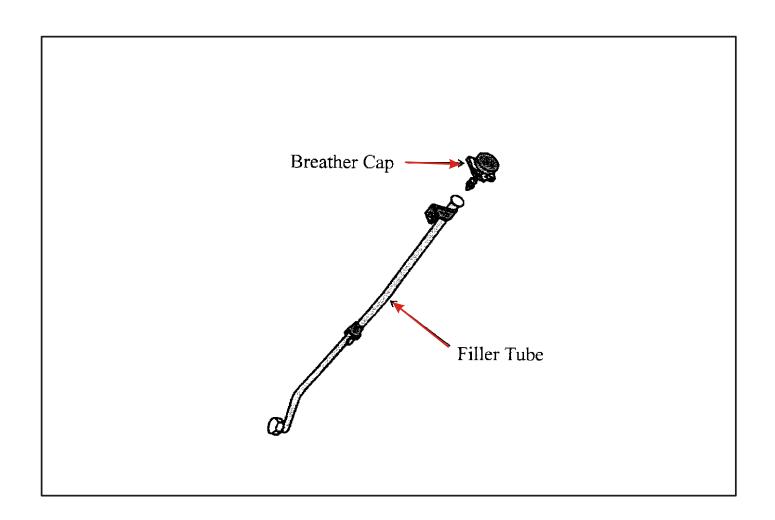
COMPLAINT: Late model Audi 100 series are equipped with an 01F transaxle that has a filler tube with out a

dipstick.

CAUSE: The factory chose to use the filler tube as a vent by providing a breather cap located on the top of

the tube as seen in figure 1.

CORRECTION: Dip stick can be purchased through Audi under the part number 01F 321 431 A for approximately

\$18.00 dollars (See Figure 2). This dip stick is to be used as a tool to obtain the correct fluid level. This dip stick CANNOT be left in the tube as the transaxle would no longer have a vent. In the event that you need to fabricate a tool to check the fluid level with, the total length of the dip stick

is approximately 24" long with the full mark at approximately 2VA".
