Technical Service Information

ISUZU / HONDA

4L30-E

4TH GEAR STARTS, HARSH 3RD GEAR OR HARSH DOWNSHIFTS

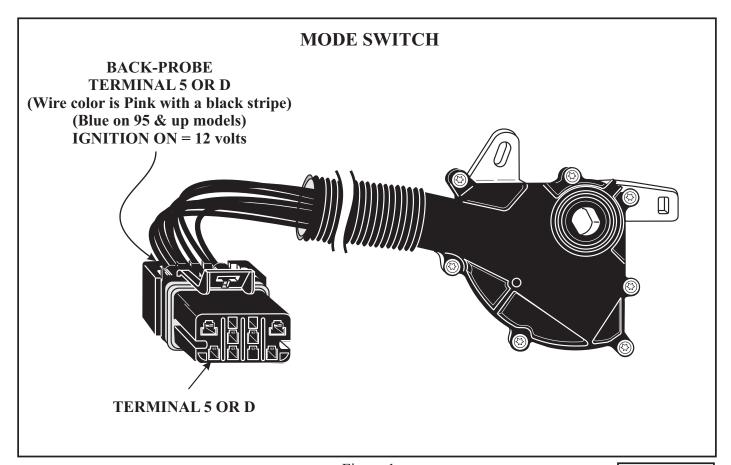
COMPLAINT: Isuzu or Honda vehicles, equipped with the 4L30-E transmission may exhibit 4th gear starts in the Drive position or a harsh upshift to 3rd, or harsh downshifts when slowing to a stop. This may or may not be accompanied by trouble codes 82 or 56, for 1990-93 models, 53 or 54 on 1994-95 models, or P0705 or P0706 on 1996 and up models.

The cause may be, a defective Mode Switch, or a missing fused battery input to the Mode switch. **REASON:** The reason for the complaint is that computer strategy on 1990-93 models may create 4th gear starts when there are problems in the Mode Switch circuit. Computer strategy on vehicles built after 1993 may create 4th gear starts or high line pressure, which can create the harsh upshift to 3rd and or harsh downshifts.

CORRECTION: Locate terminal 5 or D as shown in Figure 1 to verify fused battery input to the switch. **NOTE:** A quick check for this fused input would be to verify if the Reverse lights are working when you select Reverse. If the lights are working, the fused input is good. If there is no fused input to terminal 5 or D, replace the appropriate fuse as shown in Figure 2. If there is fused input to terminal 5 or D, check the Mode switch, from the face side of the connector as shown in Figure 3, to verify continuity in all ranges. Replace or repair as necessary.
