ELECTRICAL INSPECTOR PAKISTAN

PROFILE & PROJECTS

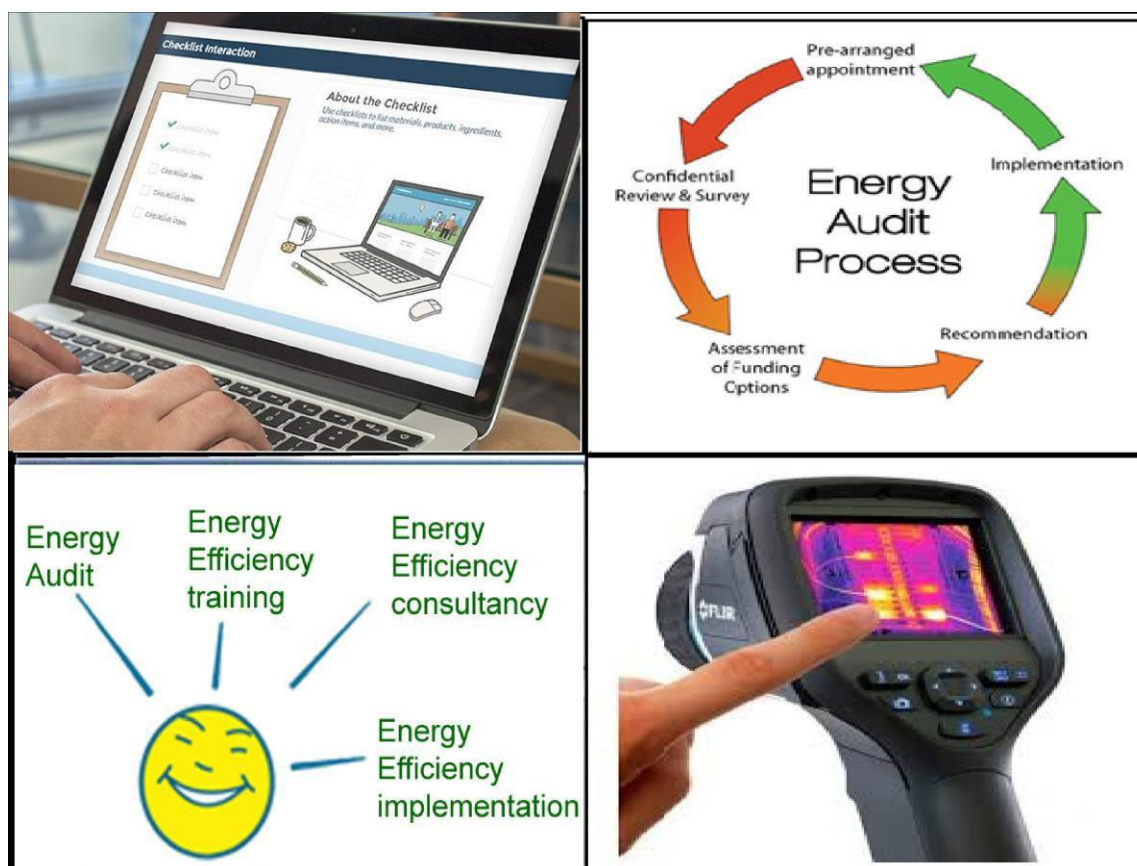
- Assessment of compressors on energy saving.
- Evaluation of compressors and comparison its energy consumption with local compressors which are installed alongwith the compressor.
- Monitoring of Ampere reading of each compressor on hourly intervals.
- Report will clearly mention the number of units (KWH) each compressor took (on hourly basis of course).
- Monitoring and notifying following data.

Comparison of Morgan's Kirloskar Compressors and PPCO's Local Compressors				
Compressor Name	Morgan's Kirloskar KIA	PPCO's Local KIA	Morgan's Kirloskar SITE	PPCO's Local SITE
Model No.	KC6/KCX6	P.P.CO	KC6/KCX6	P.P.CO
Refrigerants Used	Ammonia	Ammonia	Ammonia	Ammonia
Tank	600	500	600	600
IL Line Current A	182	129	84.93	76.06
VLL Line Voltage V	395.3	395.3	399.5	399.5
PF Power Factor	0.99	0.99	0.99	0.99
Root-3 Constant	1.732	1.732	1.732	1.732
Real Power KW	123.36	87.44	58.18	52.10

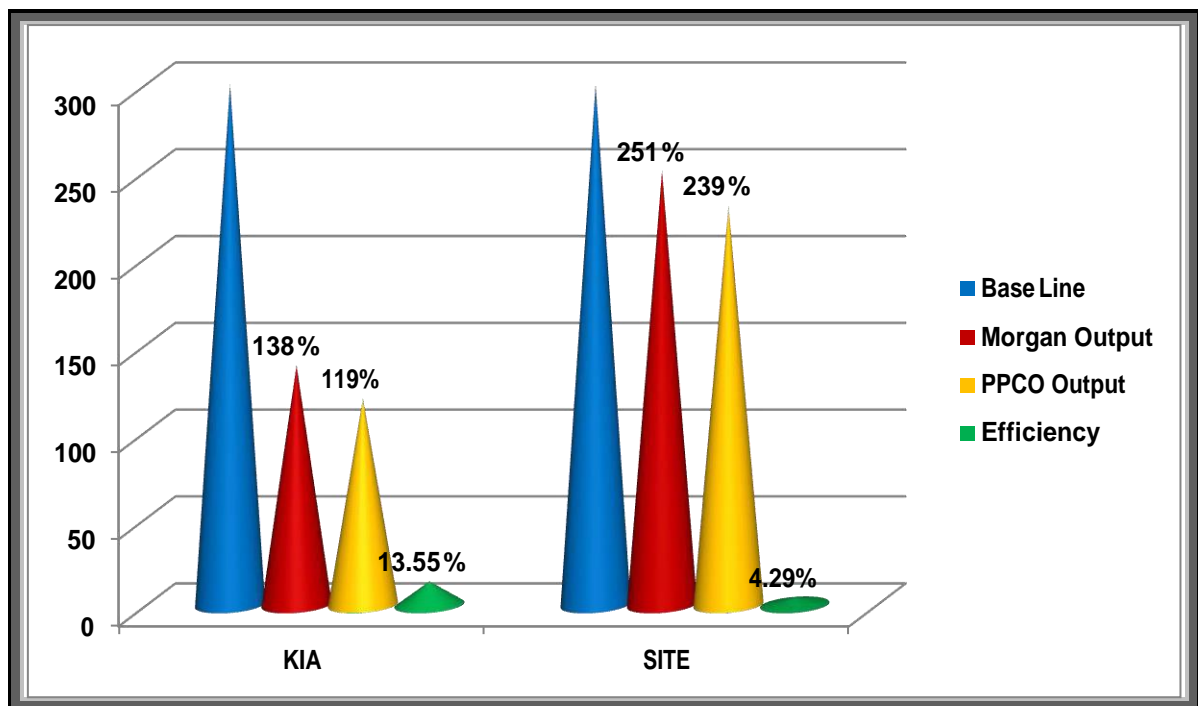
Graph Chart Showing Efficiency Comparison of Both Compressors.

The percentage share of all determined by above calculations comparing efficiency of both compressors installed at two different locations i.e KIA & SITE Area, it is seen that Compressor is 13.55 % & 4.29 % more efficient than PPCO's Local Compressor respectively. The observations calculated above are also demonstrated in the graphic chart below. This will help management to understand the existing level energy consumed by both compressors. Hence the organization, if desired, can take the necessary targeted action towards improvement of energy efficiency and conservation accordingly.

As above based on Summary Graph, there is **BLUE** color is a base line percentage, **RED** color is the output value line for Morgan' Kirloskar Compressors in Blocks/KWh, similarly **YELLOW** color is the output value line for PPCO' Local Compressors in Blocks/KWh, whereas **GREEN** color indicates the efficiency difference of compressors over PPCO's Local compressors. The difference of efficiency in both locations is due to many abnormal factors like supply interruption, variation in voltages, quality of motors, drums, water, salt, competency of operators, ON/OFF intervals, ignorance of ice hardness etc.

Horse Power HP	165.36	117.21	77.99	69.84
Energy KWh in 24 Hr	2960.69	2098.51	1396.28	1250.45
Pe Kw at 35'C	117.1	Specs N/A	117.1	Specs N/A
Pe Kw at 40'C	125.8	Specs N/A	125.8	Specs N/A
Speed rpm	850	425	600	430
Blocks/24 Hr	408	250	350	300
Kwh/Block	7.26	8.39	3.99	4.17
Block/Kwh	0.13781	0.11913	0.25067	0.23991
Efficiency by Kwh/Block	13.55	%	4.29	%
