CORROSION OF PRESTRESSING CABLES AND ITS EFFECT ON THE LOAD CAPACITY OF BRIDGES

Ing. Denis Kopásek

Department of Concrete Structures and Bridges

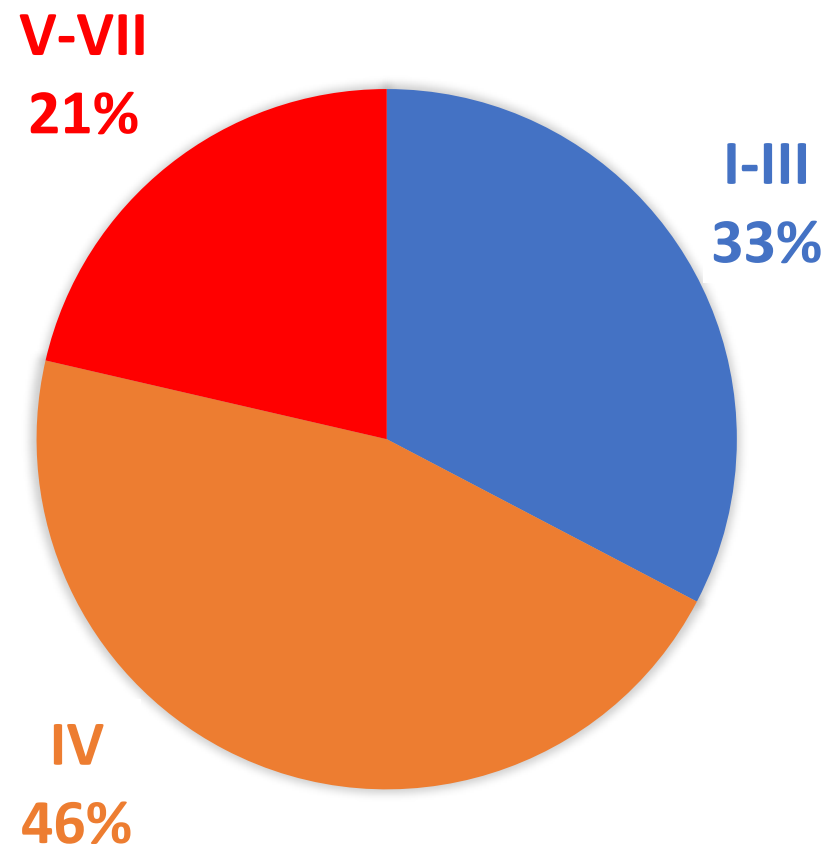
DIVISION OF BRIDGES IN SLOVAKIA ACCORDING TO THEIR STRUCTURAL-TECHNICAL CONDITION

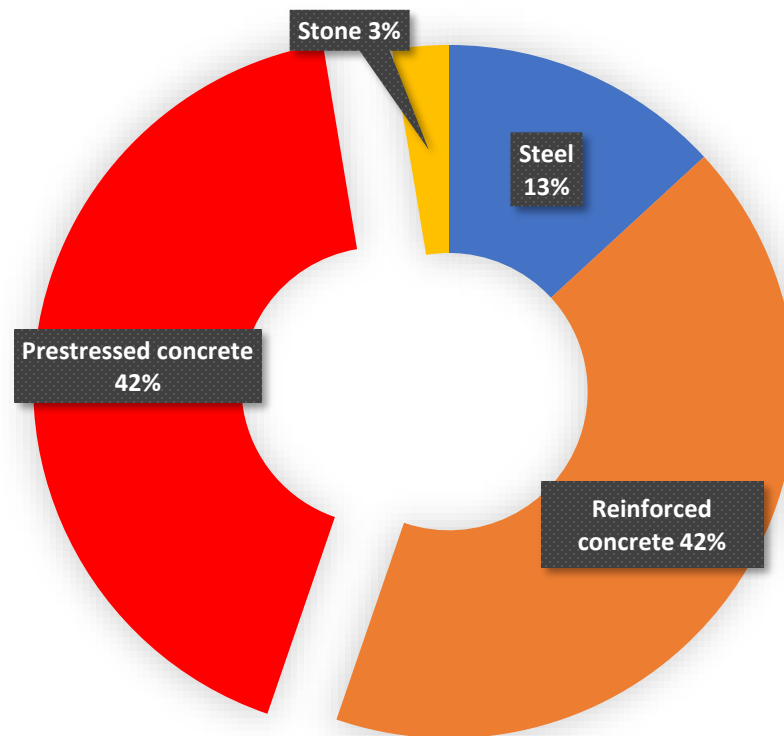
Percentage of bridges in disrepair by material

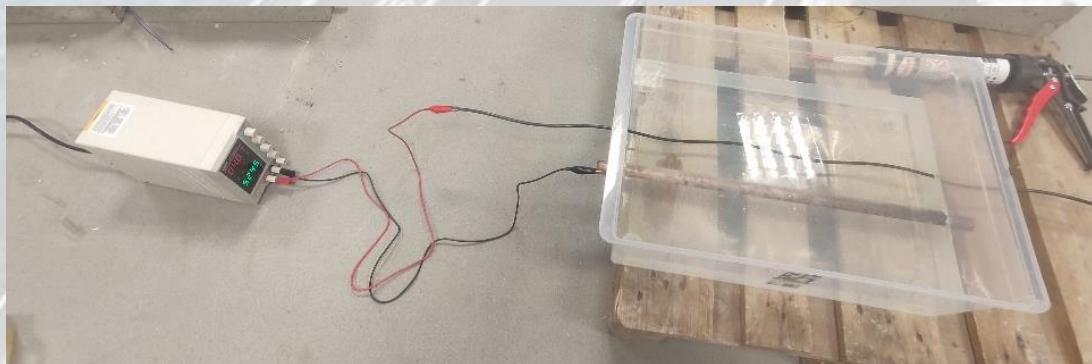
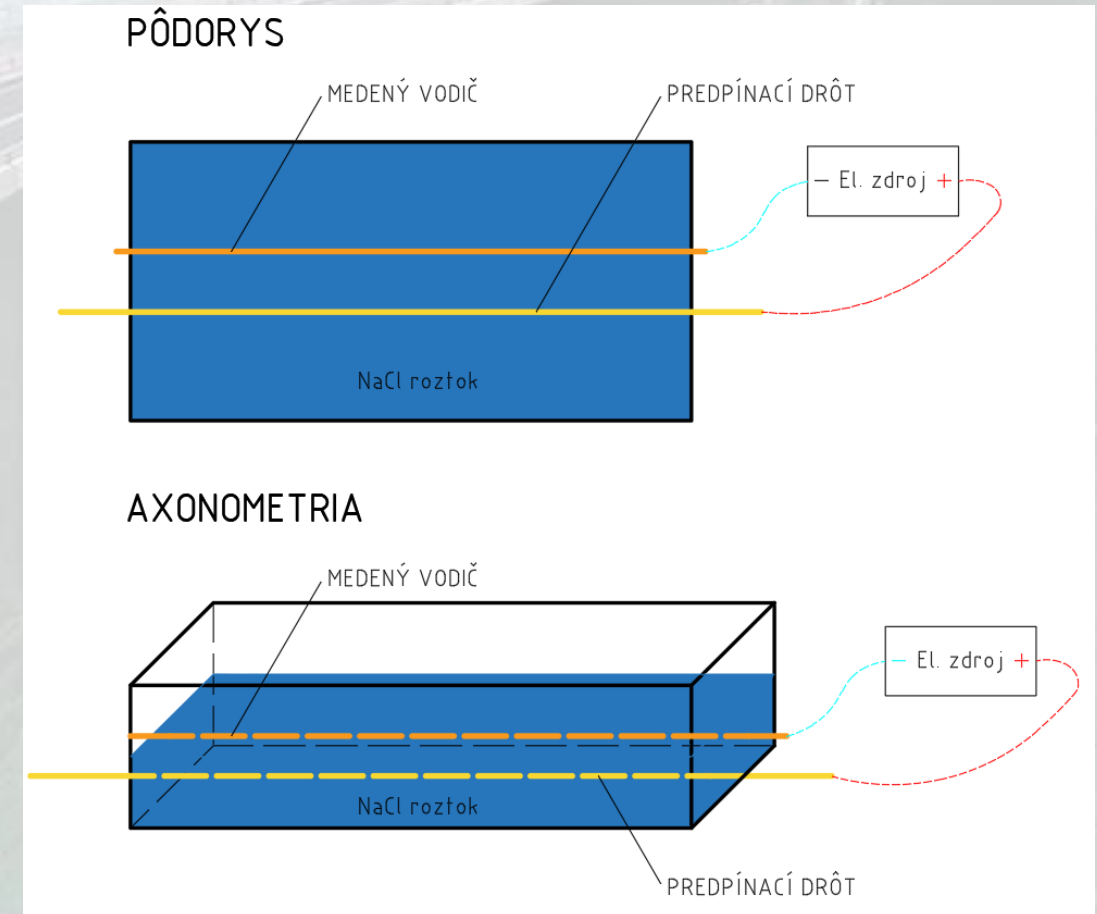
Accelerated corrosion experiment

- Accelerated corrosion involves the use of sodium chloride (NaCl) and electric current, which together simulate the corrosive process of materials (metals). It is a method of artificially accelerating the natural corrosion process. This process is called electrochemical corrosion

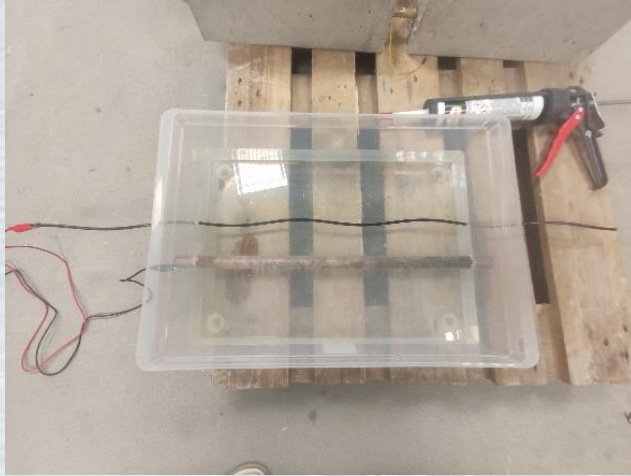
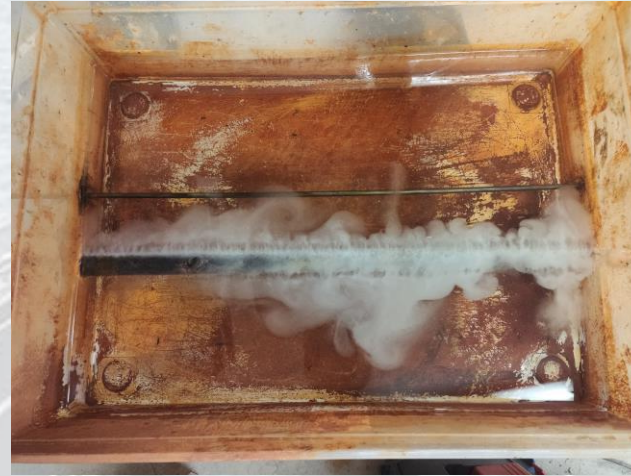
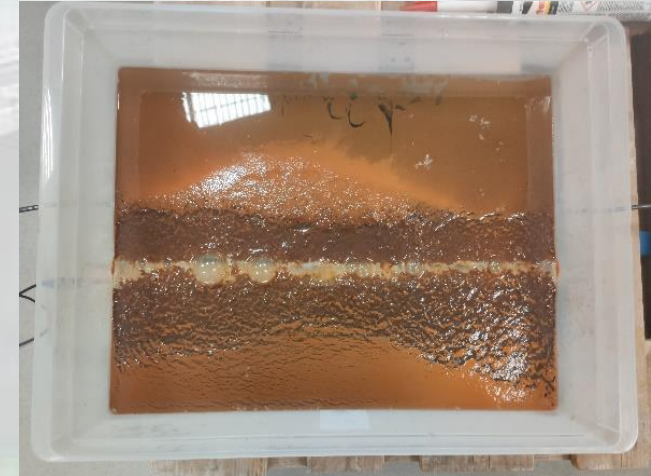
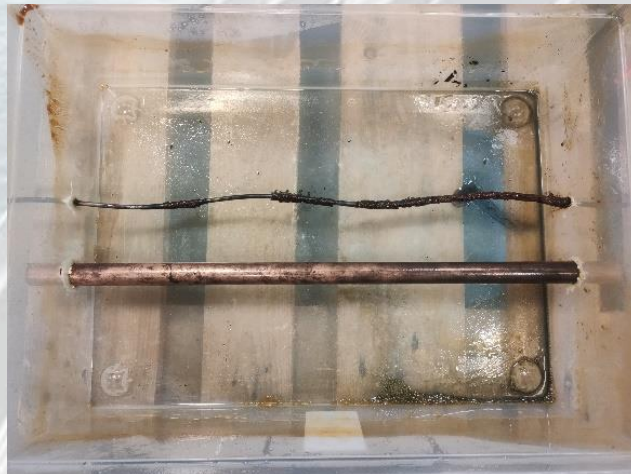
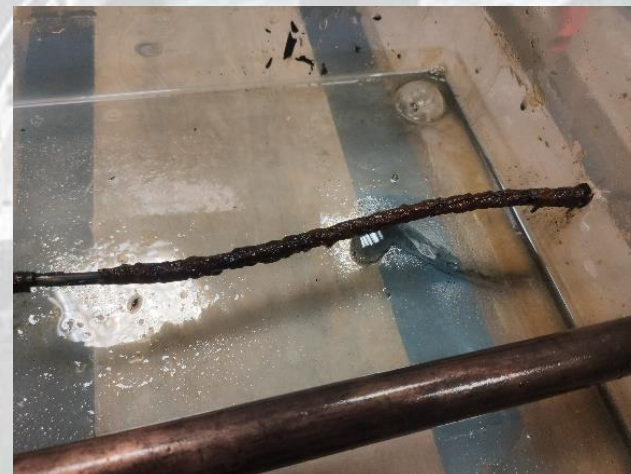
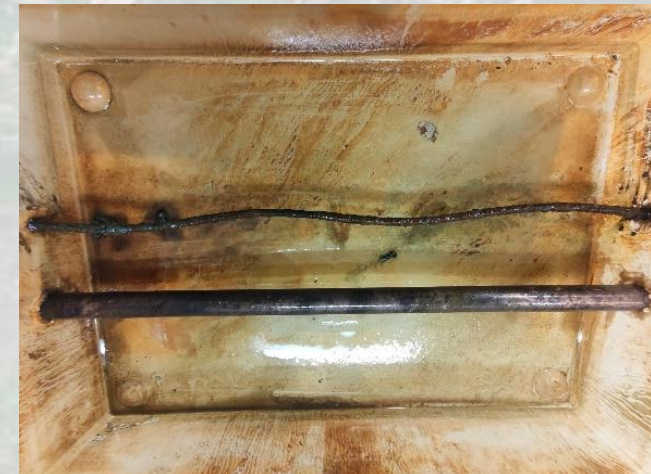
The course of the corrosion experiment a)before starting, b)during, c)after finishing, d, e, f)corrosive residues on the corroded reinforcement

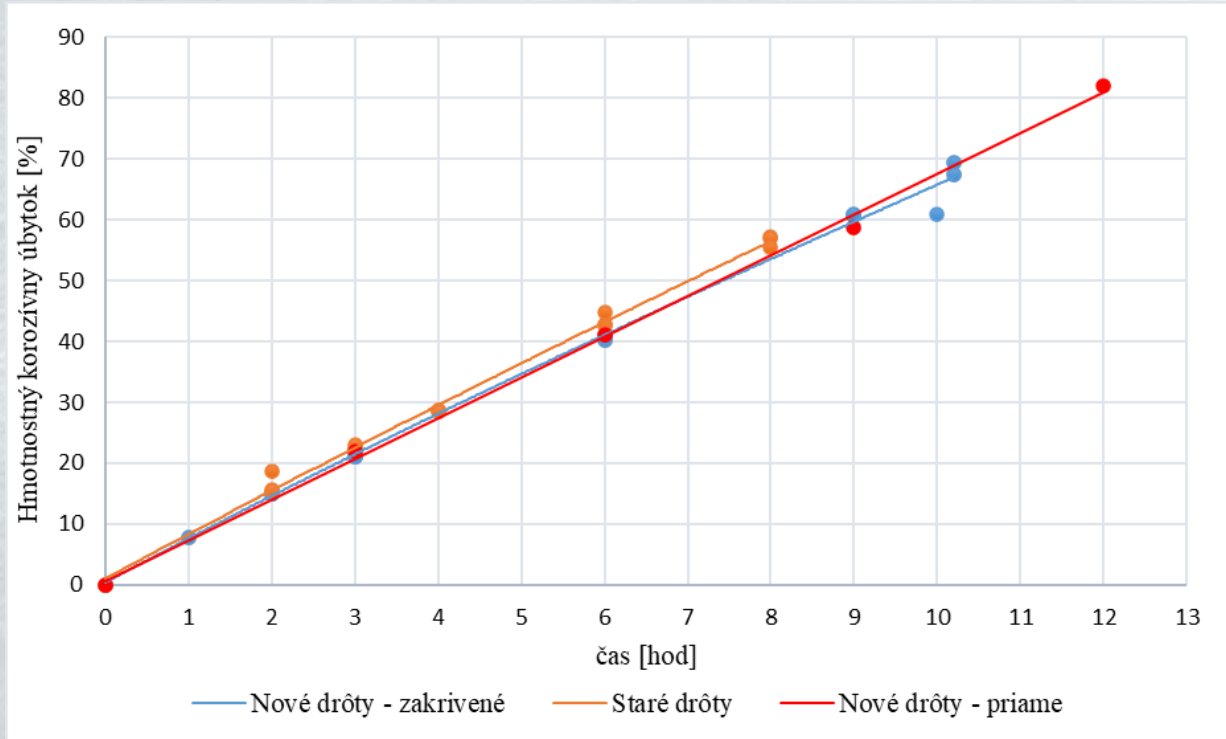
Corrosion mass loss versus corrosion time

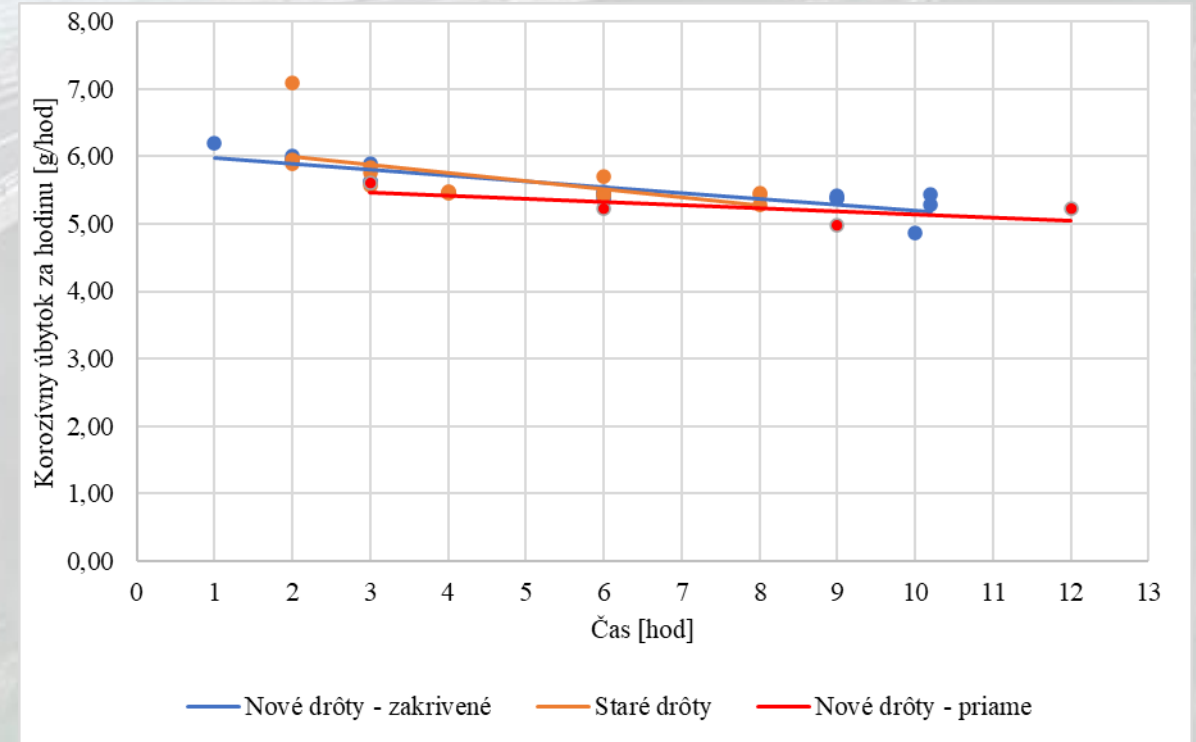
Corrosion rate per hour to the length of the corrosive process

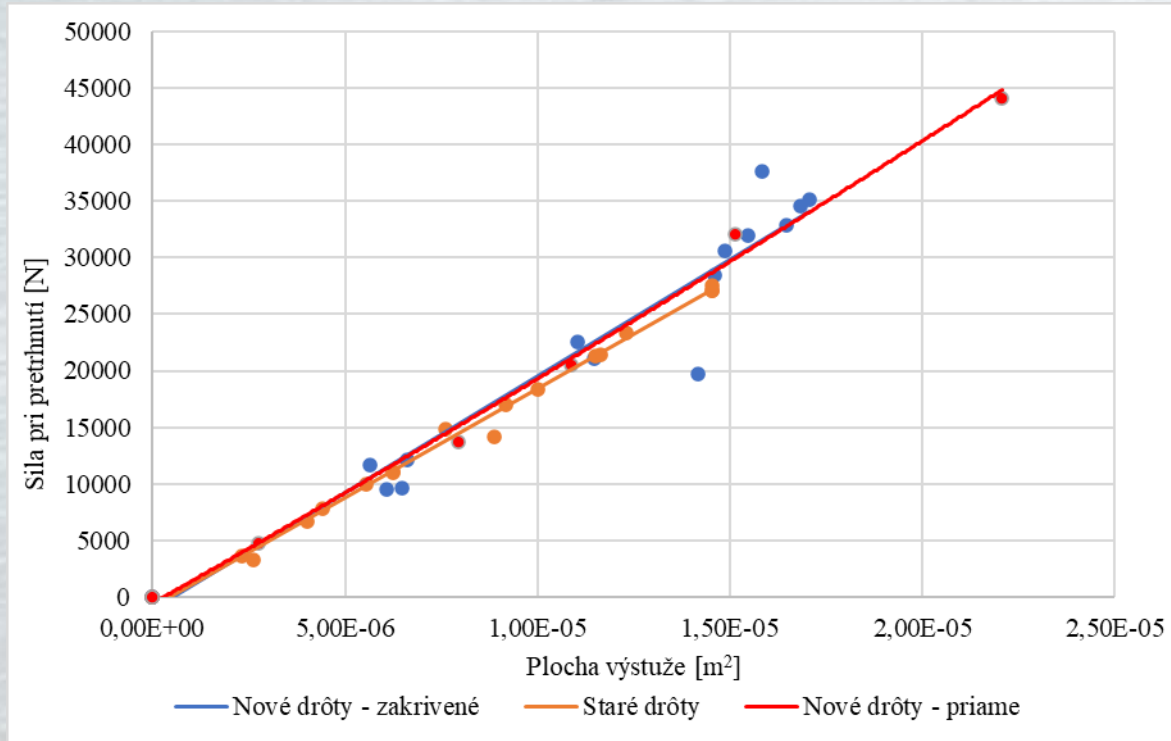
Breaking force to reinforcement area

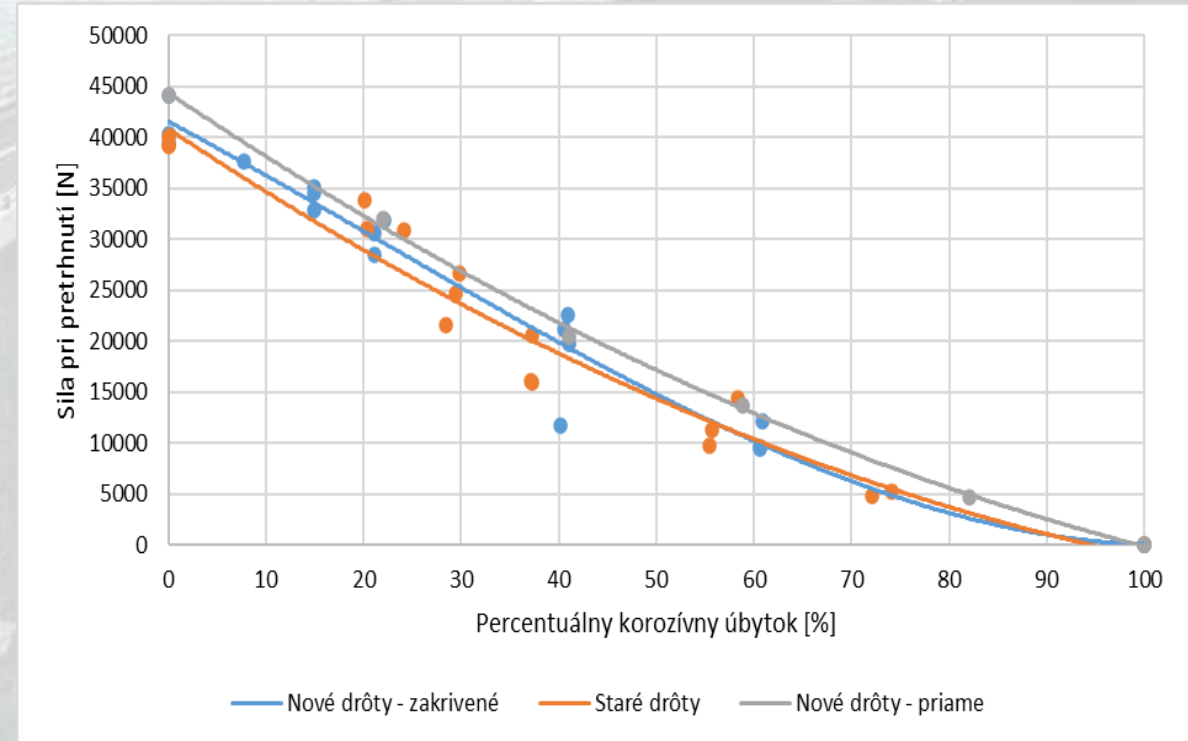
Breaking strength due to corrosive mass loss

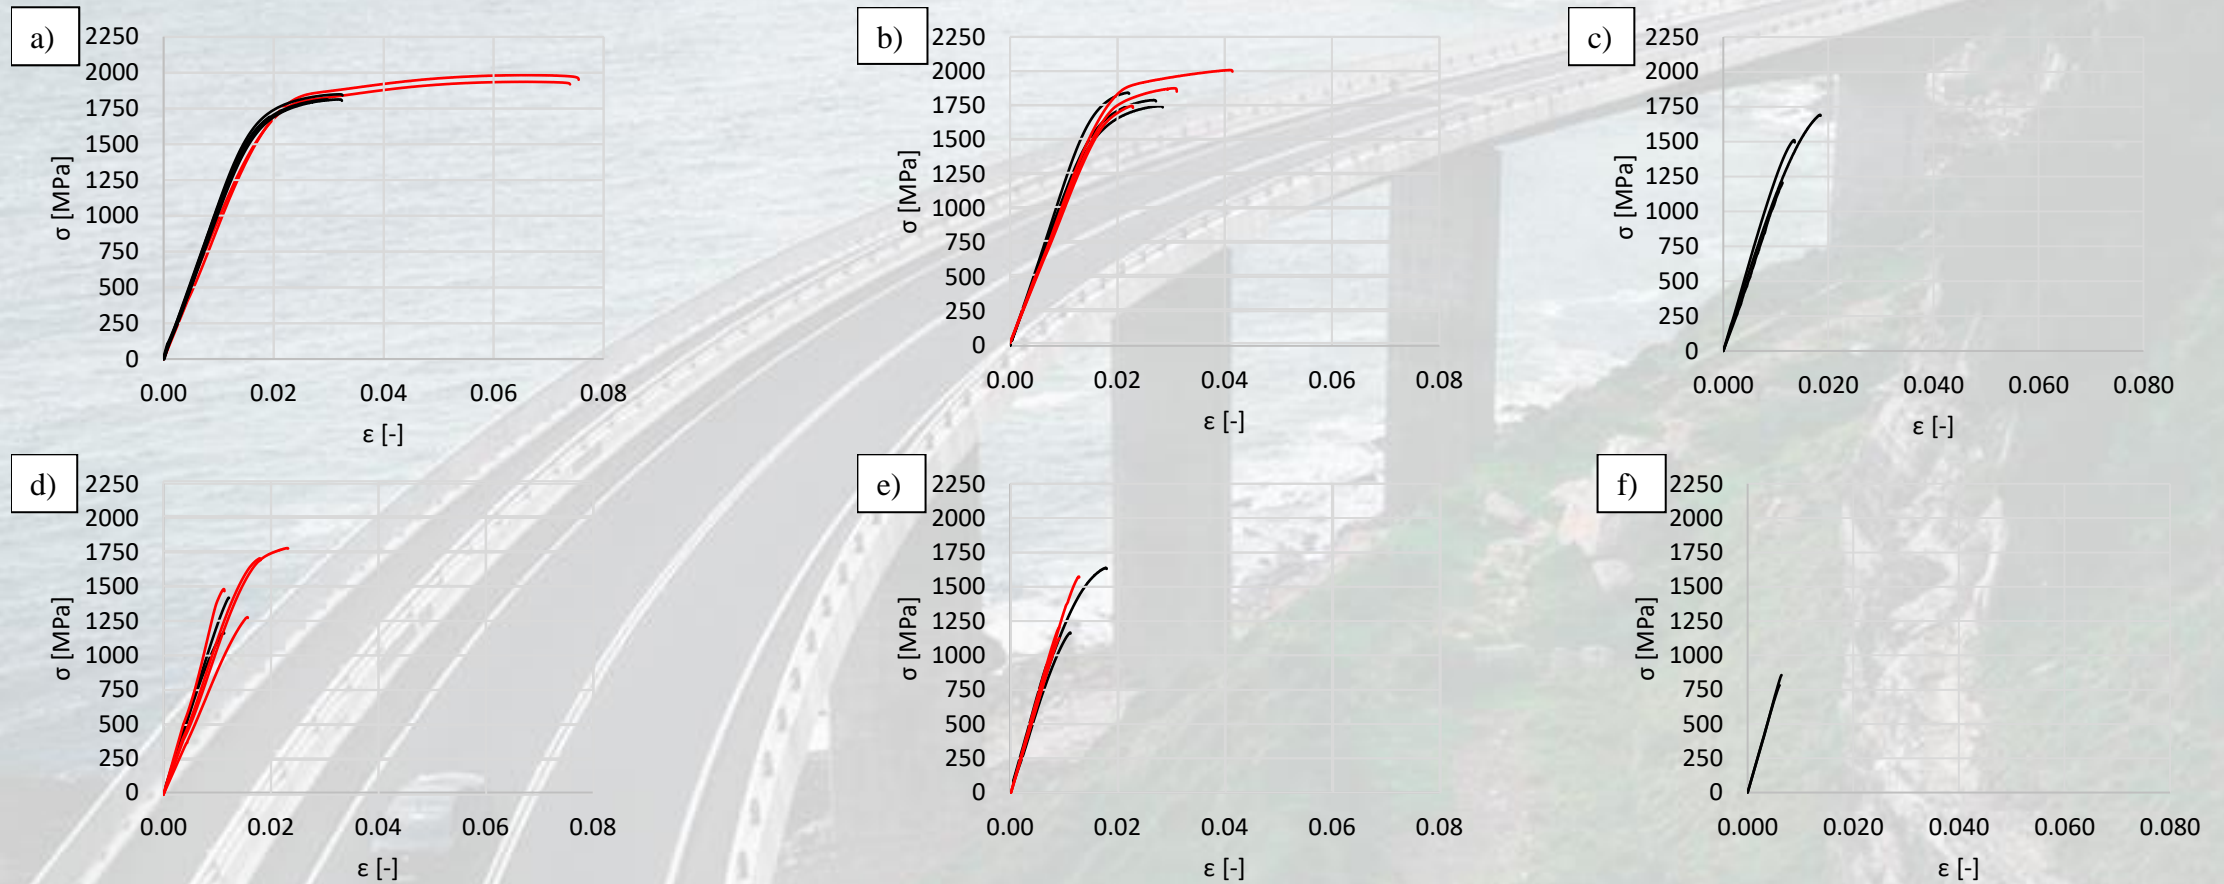
Prestressing reinforcement diagram - mass corrosion loss
a)0%, b)20%, c)30, d)40%, e)60%, f)80%
