Technical Service Information

FORD/MAZDA CD4E

PERSISTENT GEAR RATIO ERROR OR TCC SLIP CODES

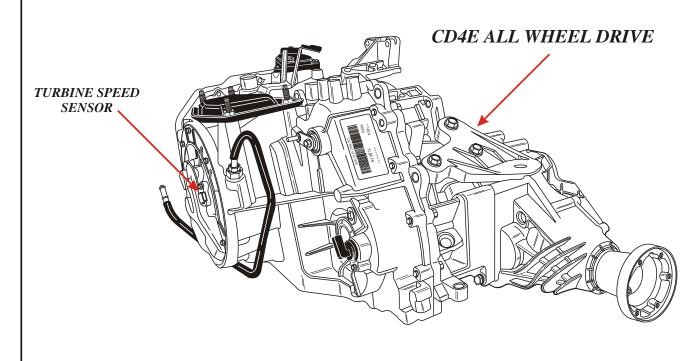
The cause, believe it or not, is the replacement Turbine Speed Sensor. The replacement TSS was redesigned and has an *enclosed* pickup as seen in Figure 2. The previous design TSS has an *exposed* pickup also seen in Figure 2.

It seems, when the pickup was enclosed, the air gap between the TSS and the reverse clutch hub was increased. When the signal was checked and compared to the previous sensor signal, the new sensor signal exhibited a voltage difference but, when checked with an oscilloscope the previous sensor puts out a wider pattern than the current design sensor which means, the computer has more time to read the signal with the previous design sensor. In other words, with the current design turbine sensor, the computer does not have enough time to read the signal and may miss alternate signal pulses which causes the above complaint, on some models only.

CORRECTION: Ford Motor Co. has now released a new design white TSS with a "green" connector that is to be used on 1994-1997 Probe vehicles, as shown in Figure 2. The new design white TSS with the "black" connector is to be used on "All Other" models using the CD4E transaxle, as shown in Figure 2. Install the proper TSS depending on the model that you are working on and service part numbers are shown below.

Turbine Shaft Sensor, 1994-1997 Probe Only, Green Connector F7RZ-7M101-KA

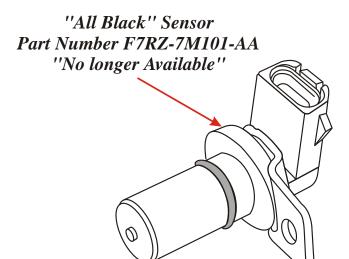
550 - 950 Ohms

White With "Black" Connector Part Number 1S7Z-7M101-KA "All Other" Models

625 - 1150 Ohms
