## Manual Re-Programming of Rabbit PLC in Endurance S-250 Control Panel Using the Rabbit Field Utility

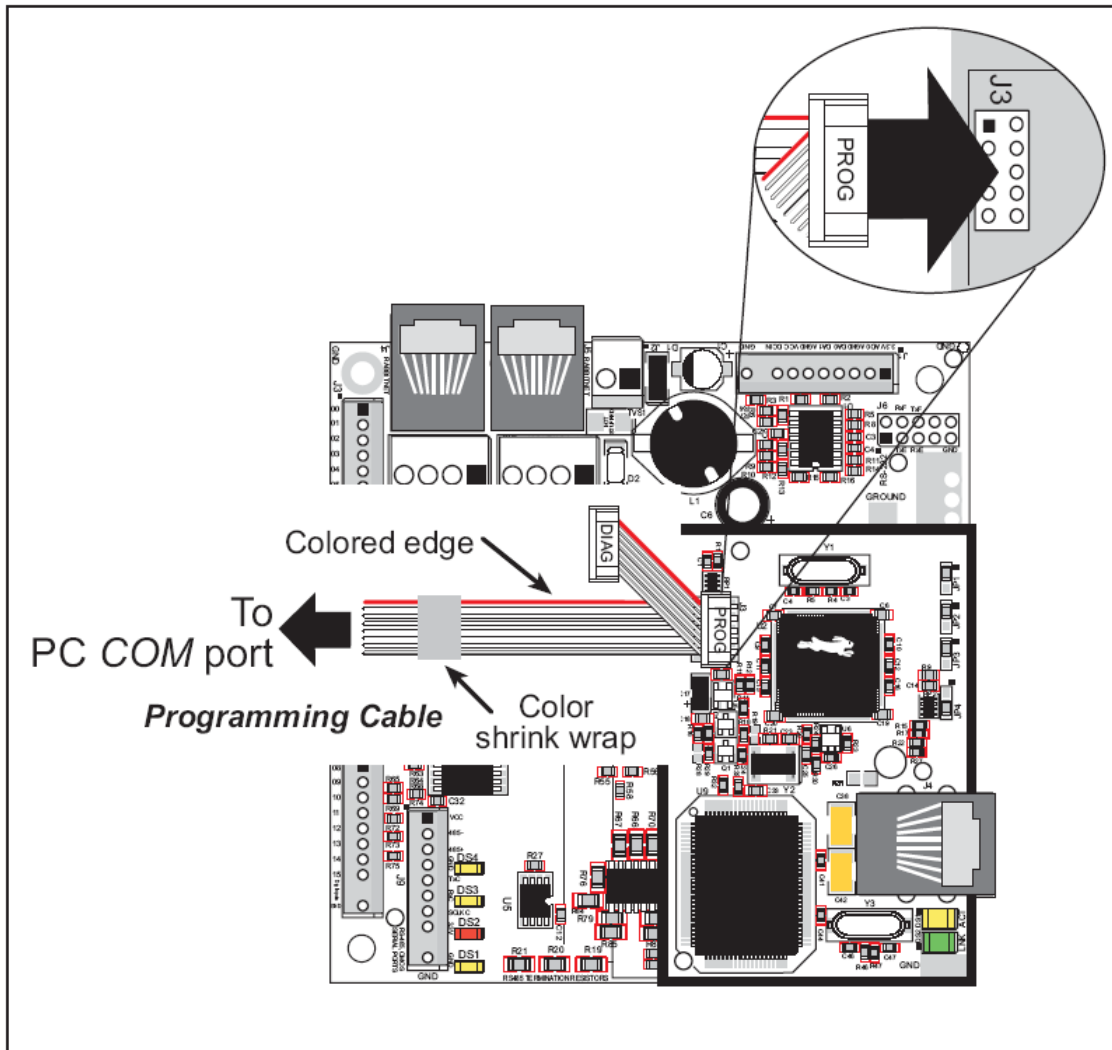
1. Connect the programming cable to the PLC board as shown below.

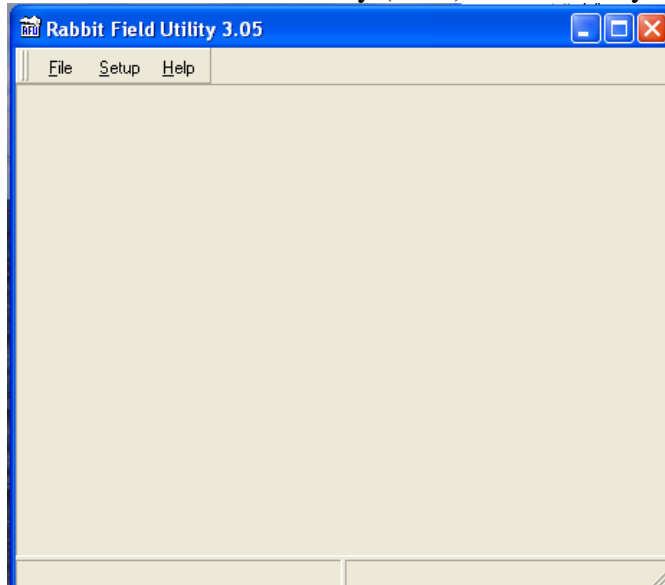
3. Start the Rabbit Field Utility (RFU) software on your computer.

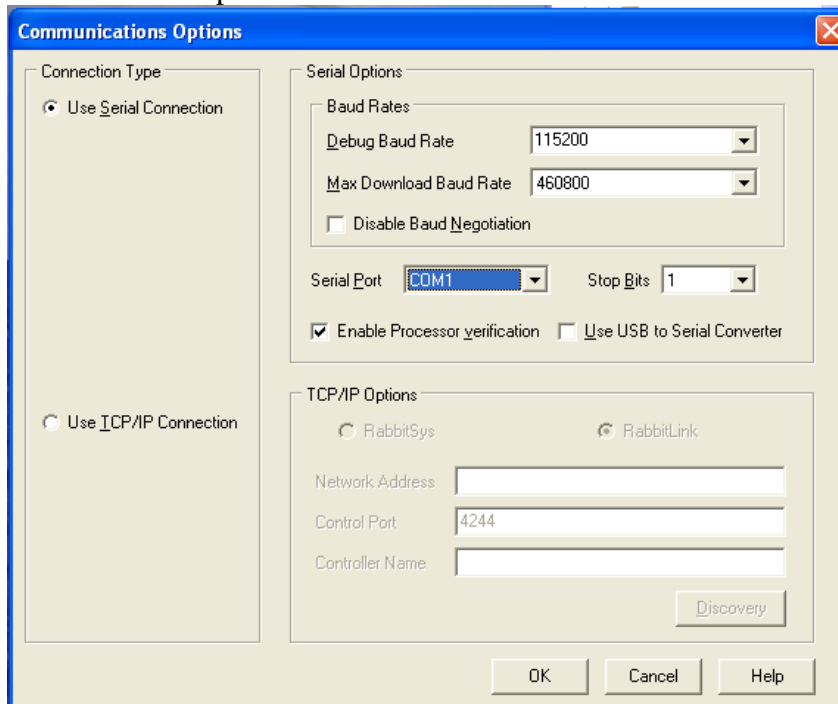
4. Place the turbine in a Halt state by turning the key switch to OFF (For older panels, pull out the Halt switch located in terminal block 37). Be sure the PLC is powered up.
5. In the RFU Setup menu select Communications.

- a. Select the proper Serial Port from the drop down menu (if you don't know which one to use, you can use the Control Panel to find out, or use trial and error if there are only a few choices).

- b. Be sure the Connection Type selection is Use Serial Connection
  - c. If using a USB to serial converter:
    - i. Select the “Use USB to Serial Converter” check box
    - ii. Deselect the “Enable Processor verification” check box.
  - d. Click OK
6. From the Setup menu select “File Locations...” For each of the three entries be sure they point to the proper file included with the RFU package you received as follows:
- a. Cold Loader: coldload.bin
  - b. Pilot BIOS: pilot.bin
  - c. Flash table: Flash.ini
- When all the fields are correct, click OK.
7. From the FILE menu select “Load Flash Image...”

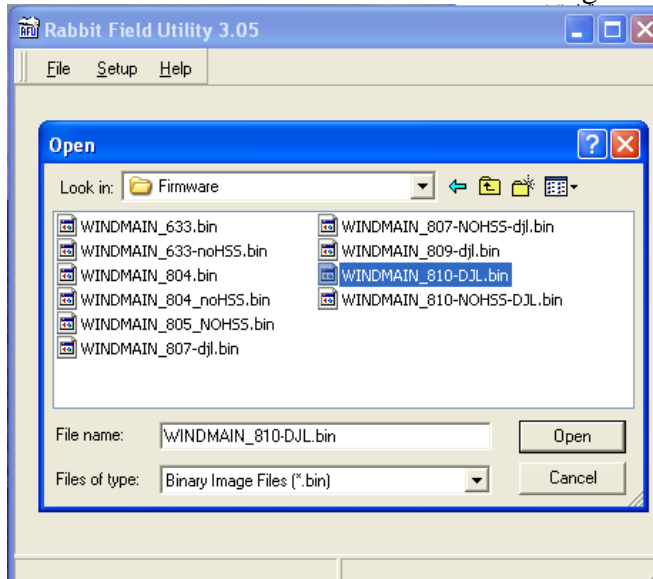
- a. Select the proper file (of the type WINDMAIN\_nnn.bin) and click Open.
8. A pane with a progress bar should appear showing progress of the upload. If a dialog box appears indicating “No Rabbit Processor Detected” check that the programming cable is properly connected, the controller is powered up, and you have selected the proper serial port and try again.
9. When the firmware upload is complete, disconnect the programming cable from the PLC, cycle power to the turbine and it should restart. Check for the proper version of the firmware using the ERI software interface.
