NISSAN/INFINITI/MERCURY ALTIMA/MAXIMA/G20/I30/QUEST/VILLAGER HARSH SHIFTING CODE P0745

05-15 Page 1 of 10

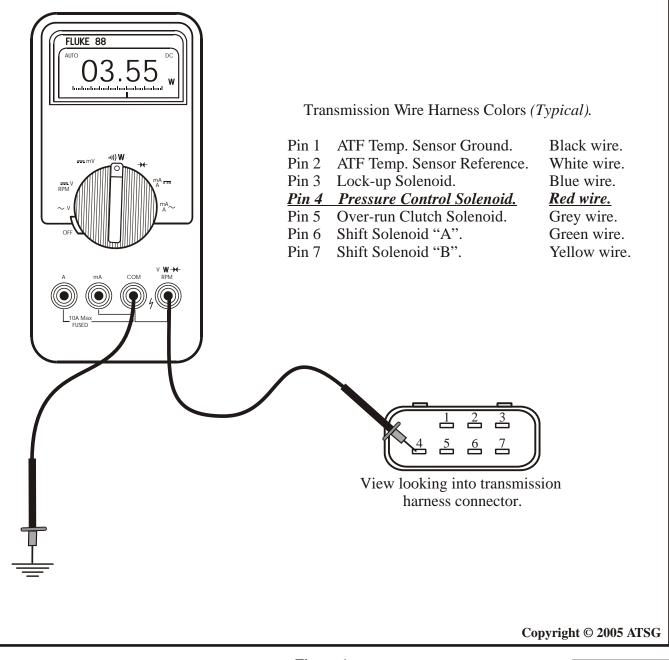
Figure 1
AUTOMATIC TRANSMISSION SERVICE GROUP

The pressure control solenoid resistance should measure between 3-5 ohms. Disconnect the transmission solenoid harness connector. Place the red lead of your D.V.O.M to terminal 4 in the harness connector. Place the black lead of your D.V.O.M. to a good ground. If resistance is between 3-5 ohms, proceed to Step 2. If resistance is below 3 ohms, check the wire in the internal harness for a short to ground. If the wire does not indicate a shorted circuit, replace the pressure control solenoid. If the resistance is over 5 ohms check the wire in the internal harness for an open circuit. Check the connector at the pressure control solenoid for a poor connection. If the connector is good and solidly connected and the wire does not indicate an open circuit, replace the pressure control solenoid.

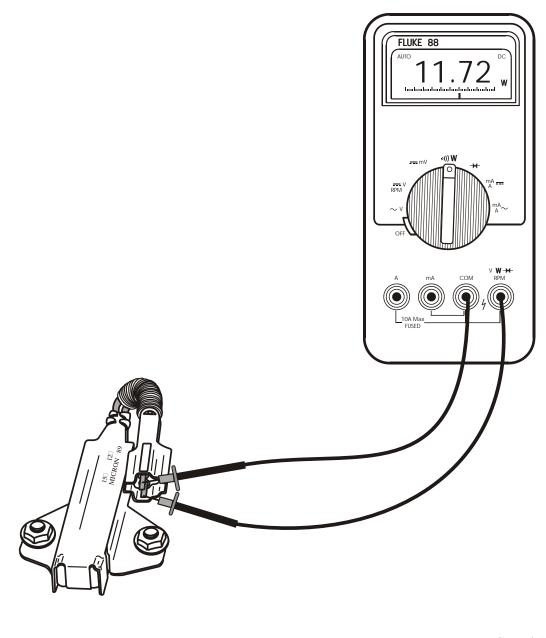
The dropping resistor should measure between 11.2 and 12.7 ohms. Make certain either the ignition is in the "OFF" position, or remove the negative battery cable. Disconnect the two terminal dropping resistor connector. Place the red lead of the D.V.O.M. to one terminal on the dropping resistor, place the black lead of the D.V.O.M. to the other terminal. If the meter does not indicate a resistance between 11.2 and 12.7 ohms, replace the dropping resistor. If the meter does indicate a resistance between 11.2 and 12.7 ohms, proceed to *Step 3*.

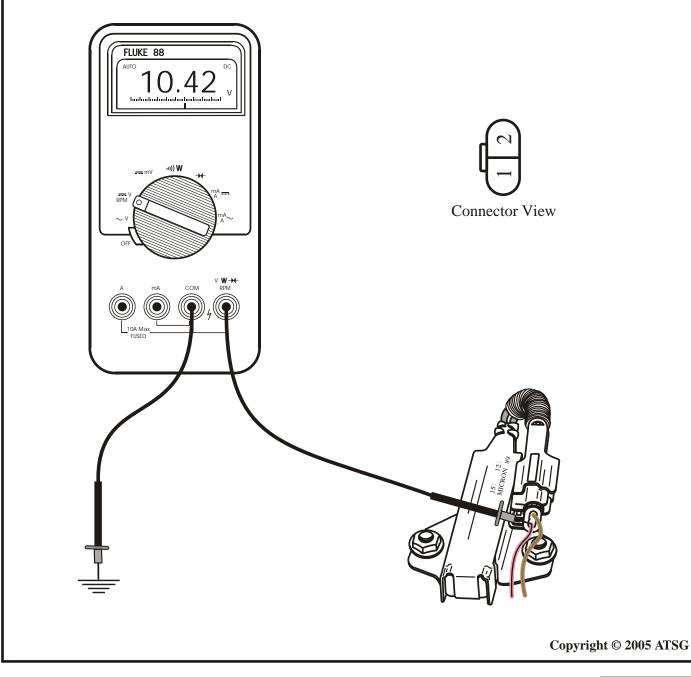
Figure 3

To check the voltage that comes from the computer to the dropping resistor, make sure the dropping resistor harness is properly connected. Using the red lead of a D.V.O.M. Back-probe the wire at pin 1 of the dropping resistor. Place the black lead of the D.V.O.M. to a good ground, and set the meter to read D.C. volts. Have an assistant get into the car and turn the ignition to the "ON" position. Check the voltage reading. The meter should indicate between approximately 6 and 12 volts. Have your assistant begin depressing the accelerator pedal. The voltage reading on the meter should decrease all the way to full throttle. Once full throttle has been reached, the voltage reading should be approximately .45 volts. If there is no voltage reading on the wire at pin 1, go to *Step 4*. If the voltage reading at pin 1 is correct at closed throttle, but then drops to approximately 5 volts and remains, or is constantly 5 volts, proceed to *Step 5*.

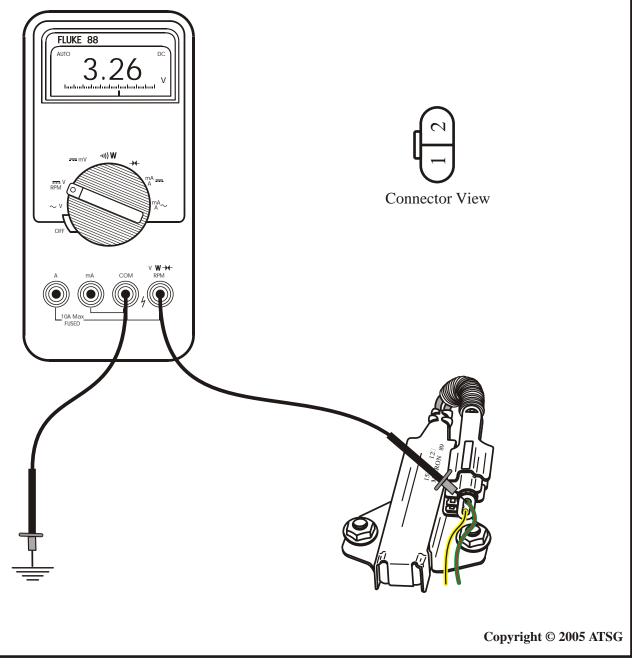
Figure 4
AUTOMATIC TRANSMISSION SERVICE GROUP

To check the voltage that goes from the dropping resistor to the pressure control solenoid, make sure the dropping resistor harness is properly connected. Using the red lead of a D.V.O.M. backprobe the wire at pin 2 of the dropping resistor. Place the black lead of the D.V.O.M. to a good ground, and set the meter to read D.C. volts . Have an assistant get into the car and turn the ignition to the "ON" position. Check the voltage reading. The meter should indicate between approximately 2.5 and 3.5 volts. Have your assistant begin depressing the accelerator pedal. The voltage reading on the meter should decrease all the way to full throttle. Once full throttle has been reached, the voltage reading should be approximately .45 volts.
