Technical Service Information

REVERSE SHUDDER 1984 300ZX TURBO

APPLIED MODEL: 3584 300ZX turbo with automatic transmission. APPLIED VIN:

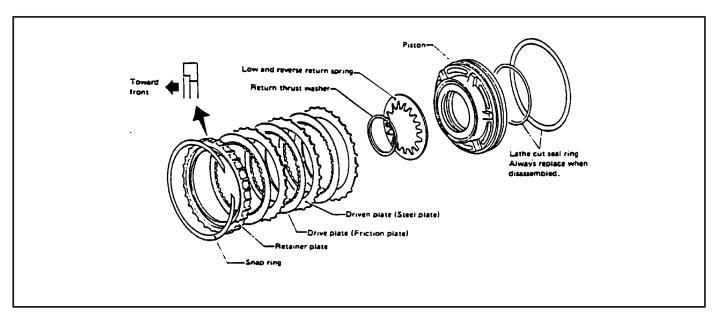
Figure 1

Some 1984 300ZX Turbo models with automatic transmissions may exhibit a shudder while backing up in reverse gear. To eliminate this condition, the number of drive and driven plates in the low and reverse brake of 4N71B turbo automatic transmissions have been increased from 7 to 8 <u>beginning with</u> the Applied VIN below. Because of the additional plates, the transmission case has also been modified.
