VEHICLE RECALL

G-01504
March, 2001

SUBJECT: SAFETY RECALL (U.S., EXPORT)
TRW Drag Links With 24-DL Size Ball Sockets On
Certain 2000, 4000, 5000 and 9000i model series, built
from 7/16/1999 through 9/1/1999.

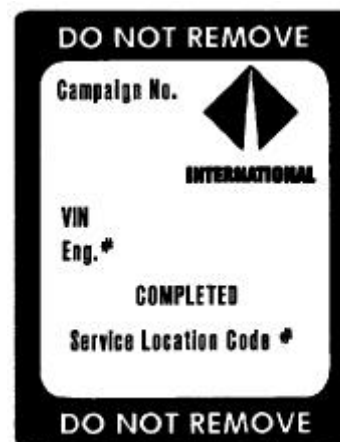
Each vehicle corrected in accordance with
Campaign letter **G-01504** will require a CTS-1075
Campaign Identification Label.

Attach the CTS-1075 label on a clean
surface next to the vehicle identification
number (VIN) plate.
