Technical Service Information

FORD 5R110W NO TCC AND OR DTC P0741

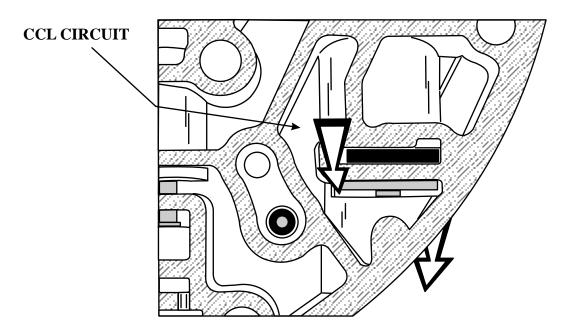
CAUSE: The cause may be, that during the Pump rebuild, the Torque Converter Control Valve sleeve

was mis-assembled and pushed too far into the bore opening the CCL circuit, which is the

regulated apply circuit for the Torque Converter Clutch, to an exhaust.

CORRECTION: Refer to Figure 1 for a view of the in-correct and correct installation of the retainer, and

ensure that the feed holes in the sleeve are visible. Refer to Figure 2 for a breakdown of the

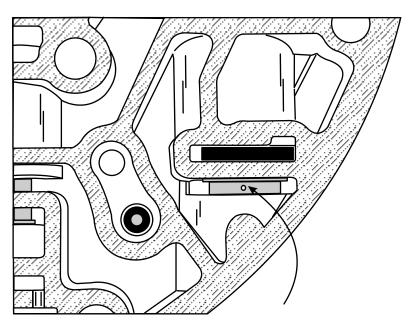
INCORRECT RETAINER LOCATION

Summary: The CCL circuit, which is regulated Converter apply pressure, will be drained at the end of the Converter Control Valve sleeve

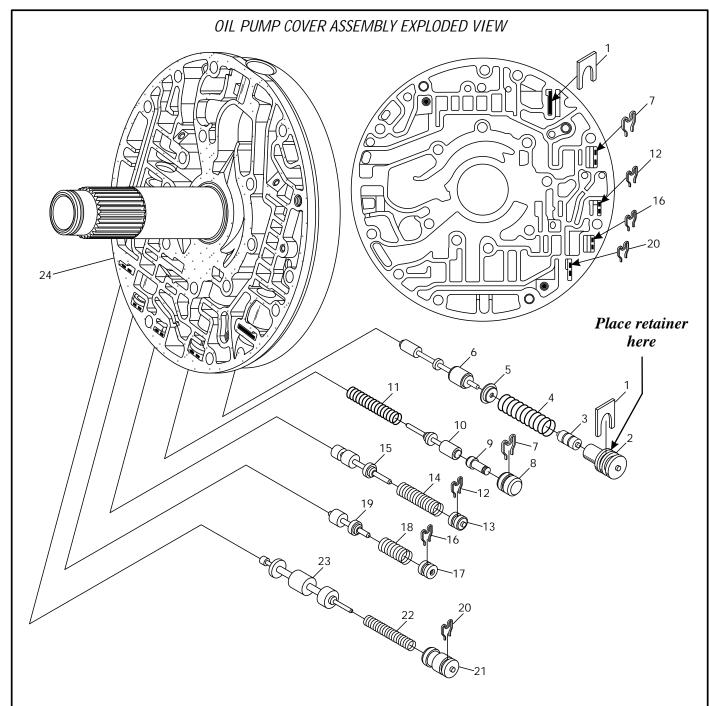
CORRECT RETAINER LOCATION

When the retainer is installed correctly, the feed holes in the Converter Control Valve sleeve can be seen $^{\rm Copyright}$ © 2008 ATSG
