THM 4T65-E UPDATE HANDBOOK

INTRODUCTION THM 4T65-E UPDATE HANDBOOK

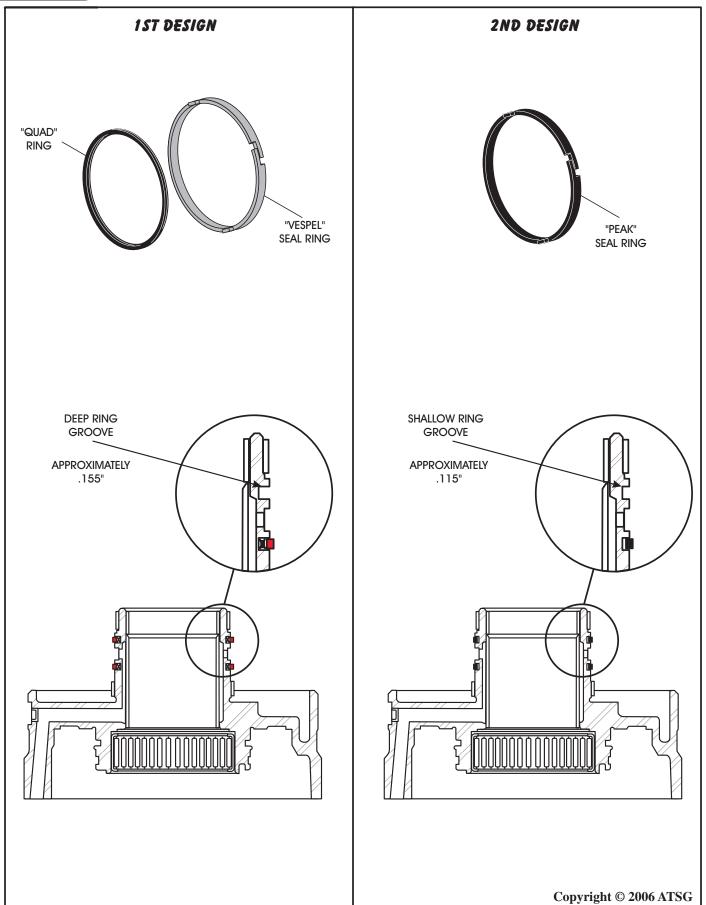
Figure 21

CHANGE: During the 1998 model year, and implemented as a running change, GM Powertrain eliminated the rubber "Quad-Ring" that was used as an expander for the Vespel sealing rings on the driven sprocket support, as shown in Figure 21. There was also a change of material for the sealing rings that occured at the same time. "Vespel" material was eliminated, and "Peak" material was implemented, as shown in Figure 21.

- (1) RUBBER QUAD-RING The rubber quad-ring, that was used in the seal groove under the "Vespel" seal ring as an expander, was eliminated (See Figure 21).
- (2) VESPEL SEALING RINGS The Vespel material sealing rings were replaced with a "Peak" material at the same time (See Figure 21). The "Vespel" seal rings are Brown in color, and the "Peak" seal rings are Black in color.
- (3) DRIVEN SPROCKET SUPPORT The seal ring grooves were not machined as deep on the second design sprocket support, to accommodate the new design seal rings without the rubber quad rings. The groove depth on 1st design is approximately .155", and groove depth on the 2nd design is approximately .115". Refer to Figure 21.

The second design driven sprocket support and the "Peak" 2nd clutch sealing rings will back service *all* previous models of the 4T65-E.

The first design driven sprocket support *must* be used with the rubber quad-rings.

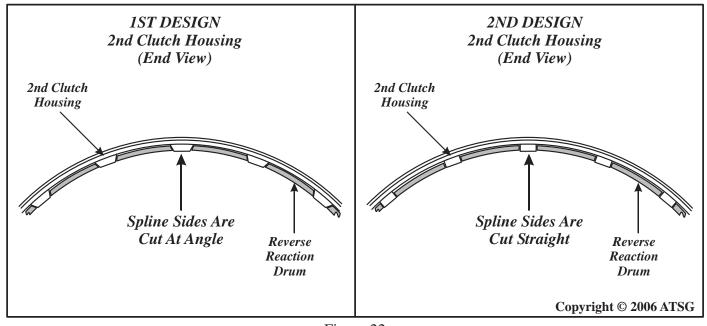
Figure 22

- (1) REVERSE REACTION DRUM Received some very slight dimensional changes on the splined end that enters the 2nd clutch housing. The sides of the slots that spline into the 2nd clutch housing were machined straight, as shown in Figure 22, and can be easily identified with the round holes stamped in the drum, as shown in Figure 23.
- (2) 2ND CLUTCH HOUSING Received some very slight dimensional changes on the internal splines, where the reverse reaction drum mates with the 2nd clutch housing. The sides of the splines in the 2nd clutch housing were machined straight, to accommodate the revised slots in the reverse reaction drum, as shown in Figure 22. There are no other means of identification on the 2nd clutch housing.

The early style reverse reaction drum with the regtangular holes and angle cut slots, *will* fit into the late style 2nd clutch housing, but may create a "rattle" in 1st gear that goes away on the 1-2 shift, and *will* wear in a very short period of time. "Not a recommended procedure".

There is a Service Package that includes both parts, and is available from GM, under OEM part number 24213402

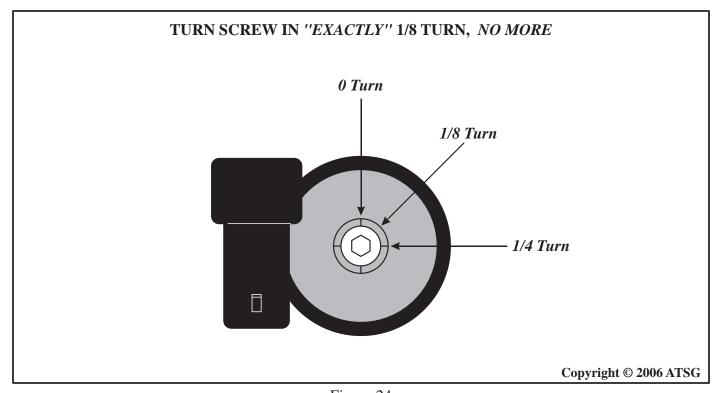
Figure 24

Some General Motors vehicles equipped with the THM 4T65-E transaxle, may exhibit a shudder on take off, a soft 1-2 upshift and/or a delay when the selector lever is placed into reverse. These conditions may also set Diagnostic Trouble Code 1811, which is "Maximum Adapt" and "Long Shift".

The cause may be, a defective Pressure Control Solenoid (PCS), and/or a worn line boost valve and sleeve assembly in the valve body, creating less than desired line pressure rise.

CORRECTION: Replace the Pressure Control Solenoid with the *updated* PCS, available from OEM under part number 10478146. Before installing the new PCS, turn the adjusting screw on the end of the solenoid in exactly 1/8 turn, as shown in Figure 24.

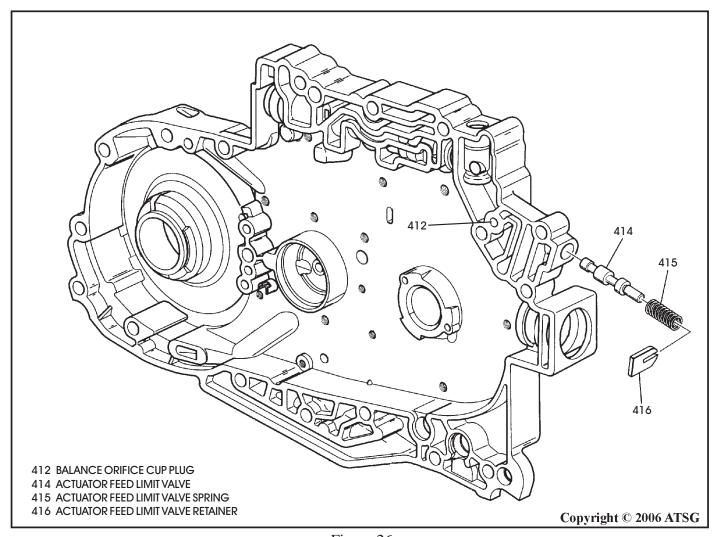
Figure 26

A complaint of second gear starts with a shift into third and no fourth. Gear ratio codes may or may not be present. Computer command signals to the solenoids for first, second, third and fourth have been verified. Solenoids have been replaced, and in some cases even the valve body.

One cause may be a stuck Actuator Feed Limit Valve, located in the channel plate, as seen in Figure 26. With this valve stuck, solenoid feed oil to shift solenoid 1-2/3-4 is either blocked or has insufficient flow rendering the solenoid inoperable as if the solenoid failed in the stuck off position mechanically. Shift solenoid 2-3 is not fed with Actuator Feed oil allowing it to continue to function as designed and thereby causing only second and third gears to be available, irregardless of the proper shift commands being provided by the computer. Also, inspect the orifice cup plug (412), as shown in Figure 26, for any debris that may be clogging the orifice.

CORRECTION: Free the Actuator Feed Limit valve.

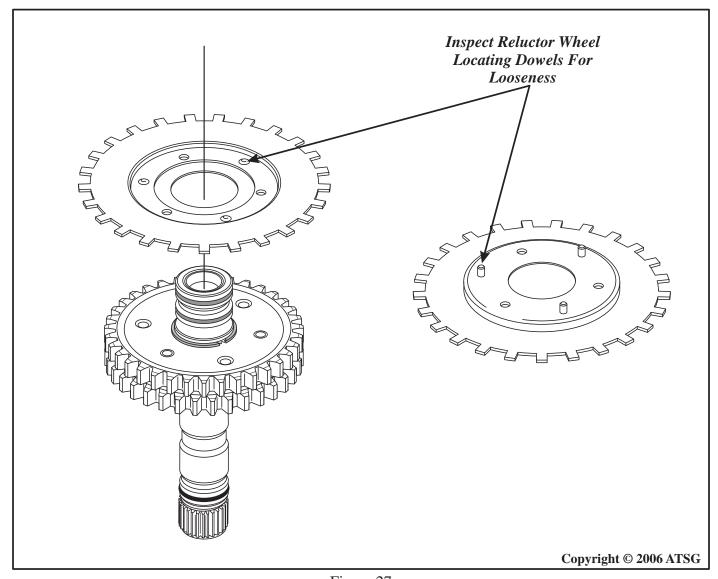
Figure 27

CAUSE: The cause may be, the locating dowels (rivets) being loose in the input speed sensor reluctor

CORRECTION: Replace the input speed sensor reluctor wheel with updated OEM part number 24212217.

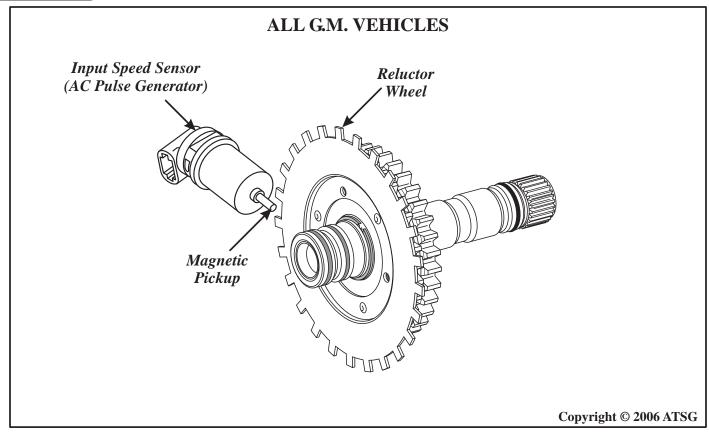
Figure 28

One cause may be, that an incorrect Input Shaft Speed Sensor was installed into the vehicle. All General Motors applications utilize an AC Pulse Generator as shown in Figure 28, while all Volvo applications use a two wire Hall Effect Sensor, as shown in Figure 29. Both will install into the channel plate and plug into the wire harness without incident. *These speed sensors will not interchange*.

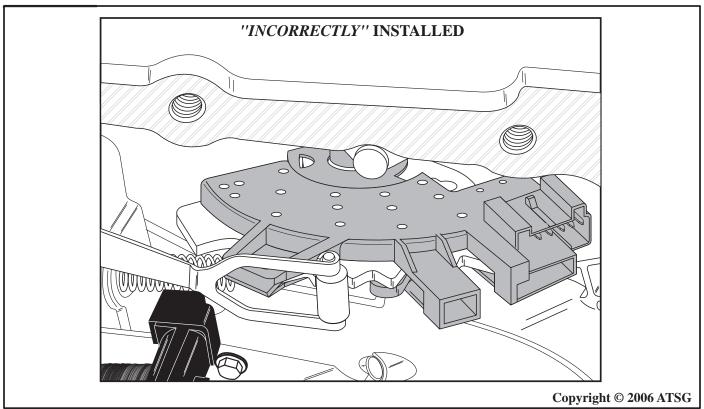
Figure 38

When the detent spring was installed during the overhaul, it was not indexed in its proper location at the IMS which can be seen in Figure 38. When this is done the IMS can move across the detent lever 1/4" in either direction. Therefore movement of the shift lever is not synchronized with the IMS causing the above complaints.

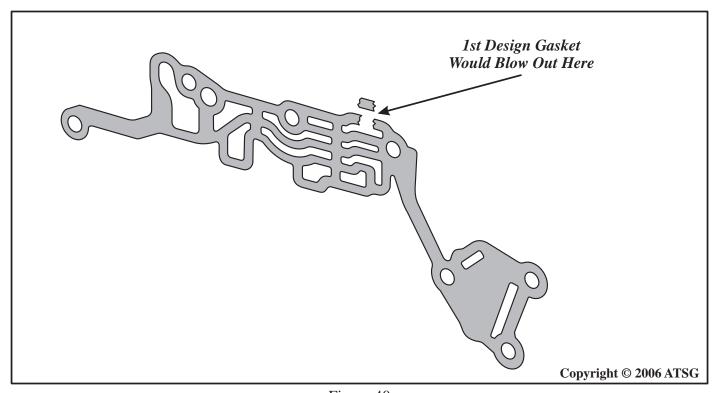
Figure 40

REASON: The 1st design gasket would "blow out", as illustrated in Figure 40, which would allow full line pressure to be aimed right at the vent, and this was not a good thing. The top passage was eliminated in the 2nd design gasket, as shown in Figure 41. Unfortunately, this created more concerns of gaskets blown out due to excessive pressure. This required the 3rd design gasket which now has 2 slots in this area, as shown in Figure 41.

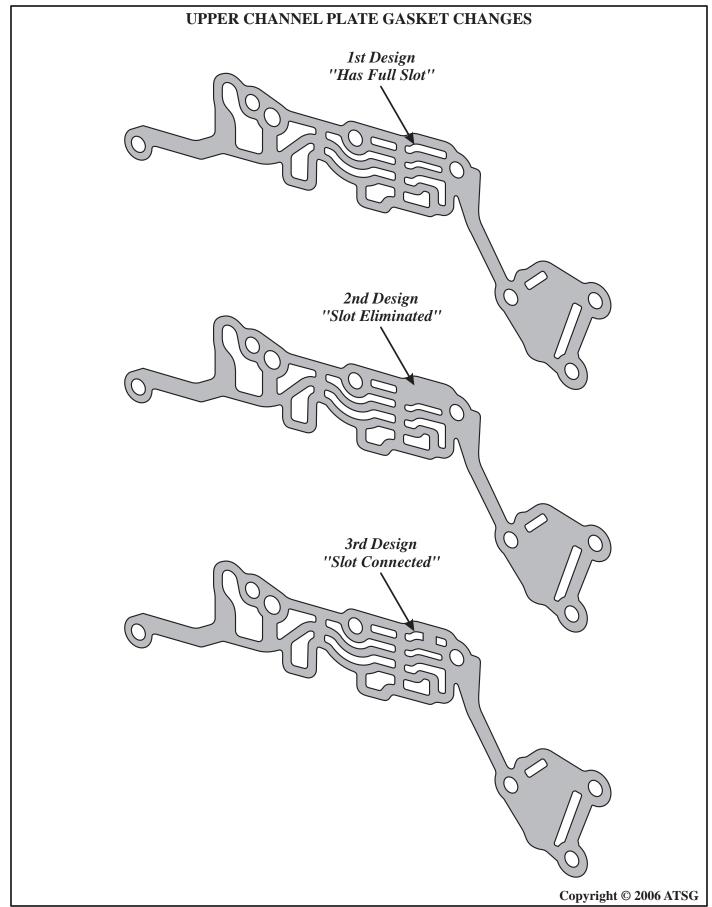
Figure 41

CHANGE: The upper channel plate gasket has now been changed twice which now creates three different design levels. All three design levels are illustrated in Figure 41.

This was a running change at the assembly plant, and the 3rd design gasket will replace all previous gaskets for all models (See Figure 41). The 3rd design gasket is now included in the aftermarket gasket sets.

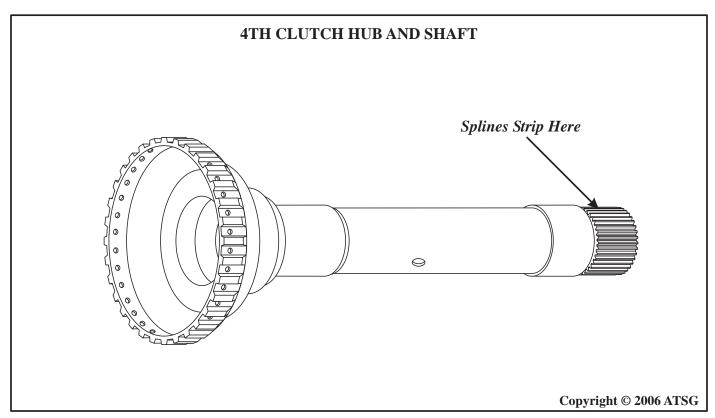
Figure 42

CAUSE: The cause may be, stripped splines on the 4th clutch hub and shaft where it splines into the

CORRECTION: Replace the 4th clutch hub and shaft assembly with a new one. Extra care should be

exercised when inspecting this area on your normal overhaul, as this is a very common wear

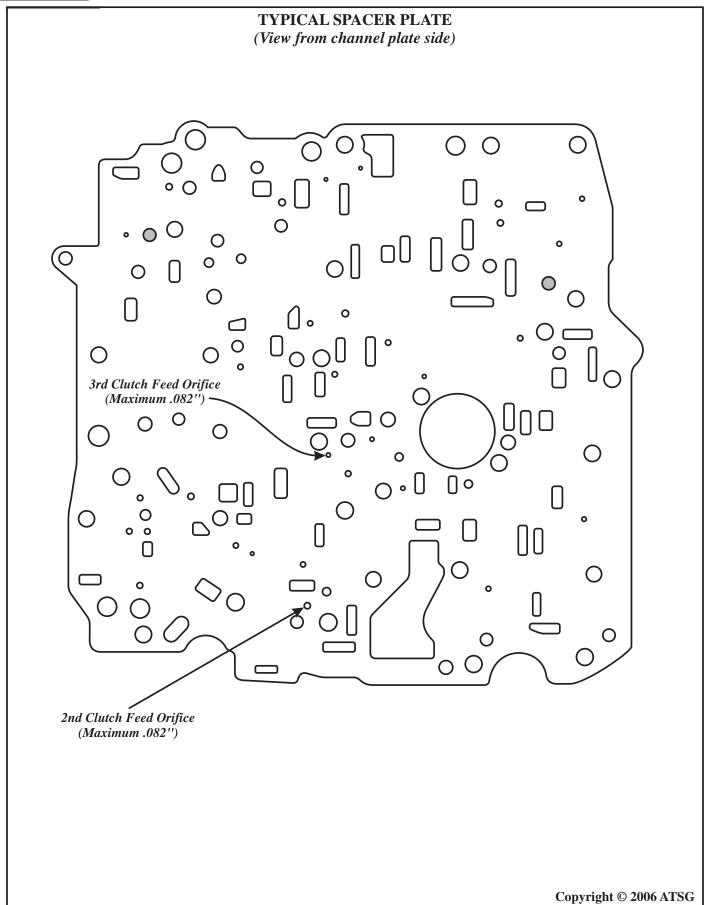
Figure 49

Further modification to the valve body spacer plate can also be made to allow the 2nd clutch and 3rd clutch cavities to fill quicker. Opening the 2nd and/or 3rd clutch feed orifices in the spacer plate .010" larger than original, as shown in Figure 49, will also allow a larger volume of oil the the clutch pack. The original orifice size is .070".

Special Note: Spacer plate orifice modification is not a recommended procedure as part of a normal overhaul. This should be considered as an option, only after all other possibilities have been eliminated. Never exceed .082" total orifice size.

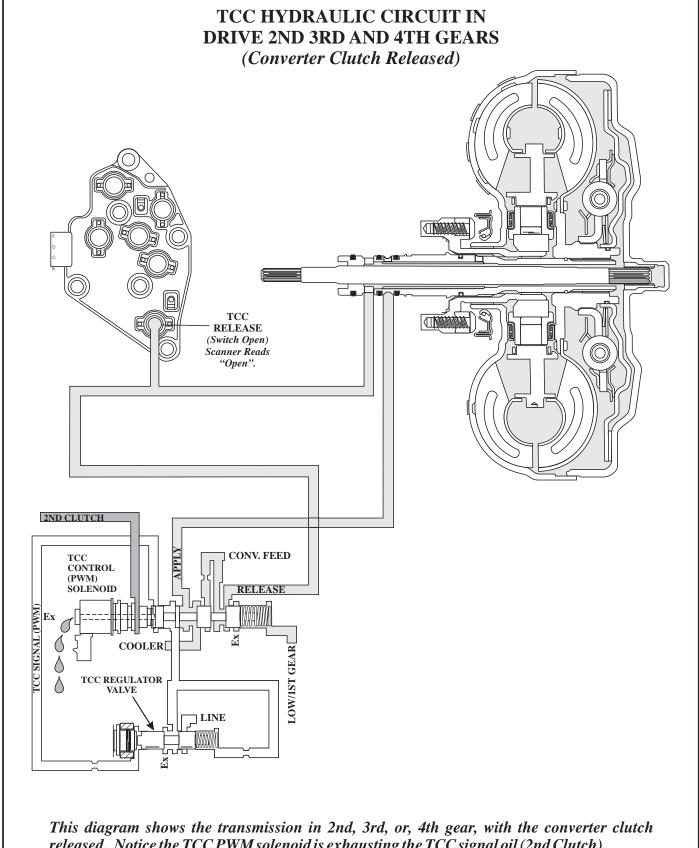
CAUSE: The cause may be, a leaking bore plug "O" ring on the Torque Converter Regulator Valve

train. Refer to Figure 54 to see a partial hydraulic circuit of the Torque Converter Regulator valve when the TCC is released. Refer to Figure 55 to see a partial hydraulic circuit of the Torque Converter Regulator valve when the TCC is applied. Notice, when there is a leak in the TCC Signal Circuit, the torque converter regulator valve may move to the left causing insufficient converter apply pressure, allowing the Torque Converter Clutch to slip, causing

CORRECTION: Refer to Figure 56 and 57 for the valve locations in the valve body and replace the "O"ring on

the Torque Converter Regulator Valve bore plug, item number 328, as shown in Figure 56.

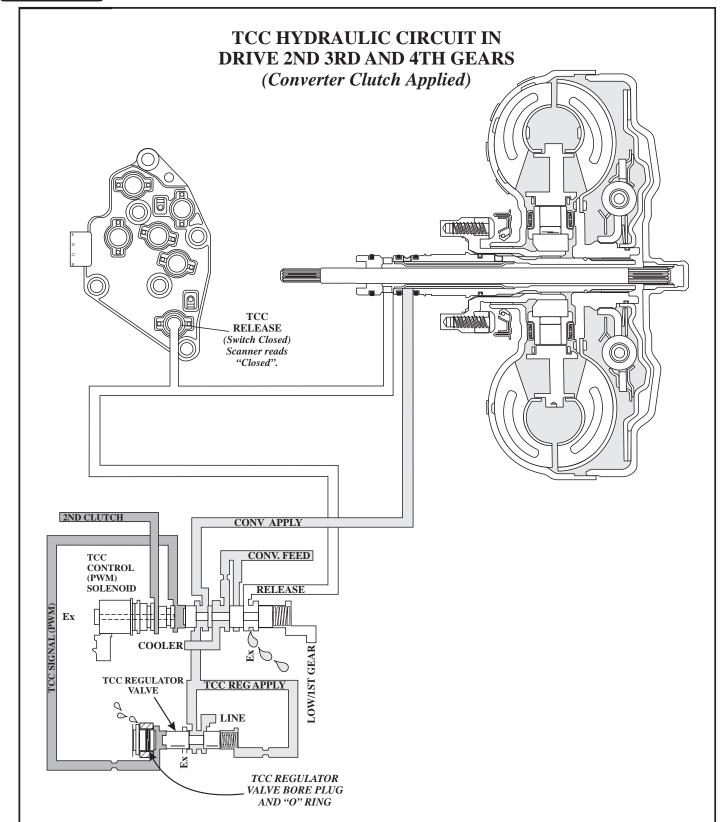
This diagram shows the transmission in 2nd, 3rd, or, 4th gear, with converter clutch applied.

Notice the TCC PWM Solenoid is energized, and TCC signal oil is pushing TCC valve to the right. This same signal oil strokes the TCC regulator valve to the right. A leaking "O"-ring on the bore plug for the TCC regulator valve may cause the TCC regulator valve to limit the amount of converter apply pressure by allowing the valve to move to the left.

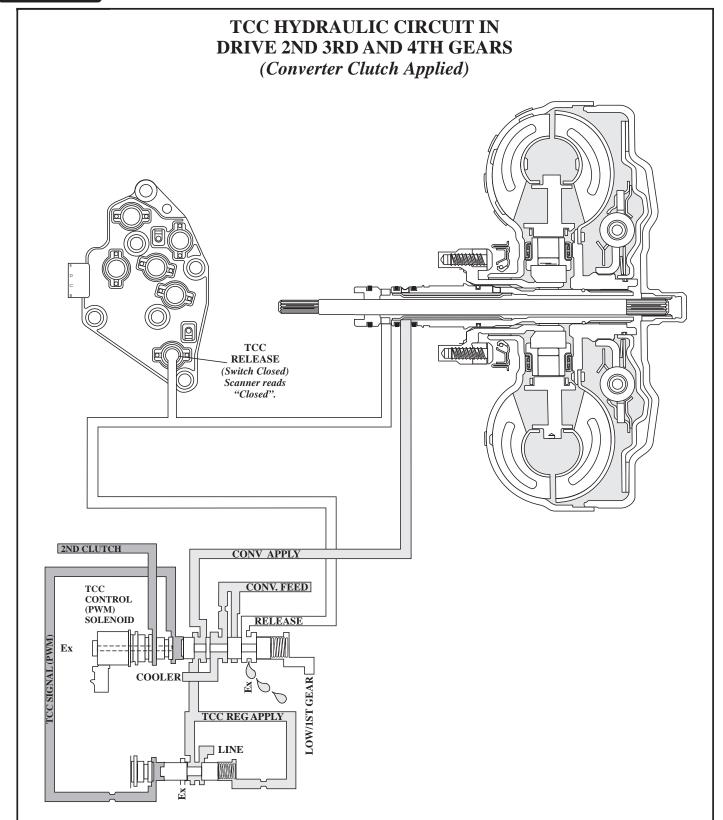
This diagram shows the transmission in 2nd, 3rd, or, 4th gear, with converter clutch released. Notice the TCC PWM solenoid is exhausting the TCC signal oil (2nd Clutch) and pressure is not high enough to overcome spring pressure on the TCC valve, so the release oil is not exhausted.

This diagram shows the transmission in 2nd, 3rd, or, 4th gear, with converter clutch applied. Notice the TCC PWM Solenoid is energized and not exhausting the TCC signal oil, (2nd Clutch) and TCC signal oil is pushing TCC valve to the right, causing release oil to exhaust at the valve.

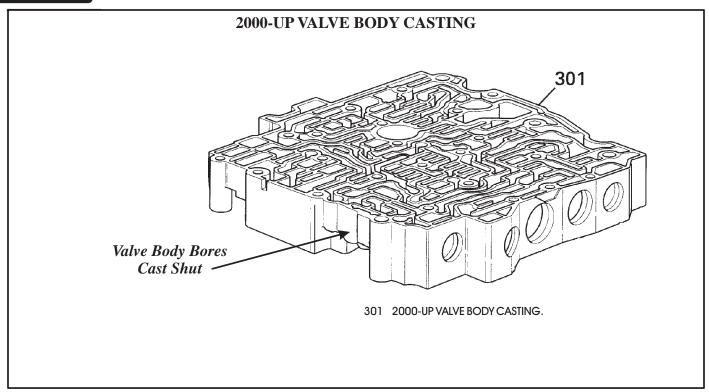
Figure 68

- (1) SERVO BOOST VALVES Complete valve trains eliminated, as shown in Figure 68.
- (2) VALVE BODY CASTING Servo boost valve bores are now cast shut, as shown in Figure 68.

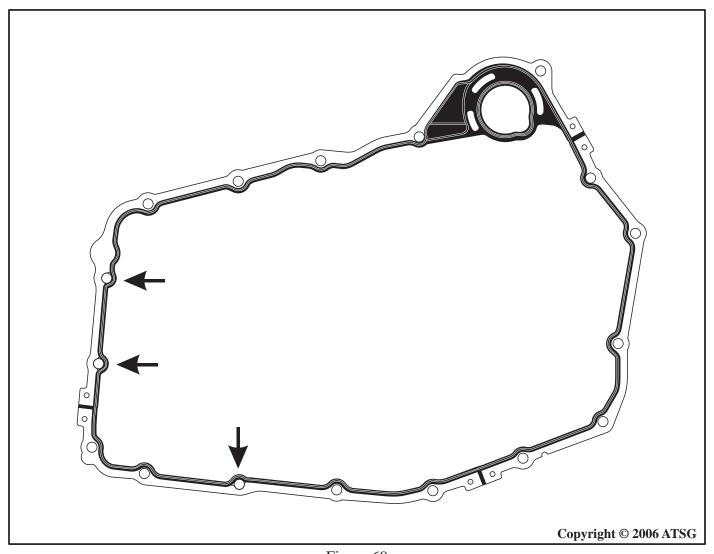
Figure 69

COMPLAINT: Vehicle returns after rebuild with a fluid leak. After investigation, you discover that the

structural side cover is cracked around one of the three retaining bolt locations, shown on the

CAUSE: The cause may be, the structural side cover retaining bolts were not torqued properly.

Explanation: The three gasket bolt hole locations, shown in Figure 69, do not have any metal support around the inside perimeter of the gasket, on the side the arrows are on. This allows zero support on the inside perimeter, and if overtorqued, will crack the structural side cover,

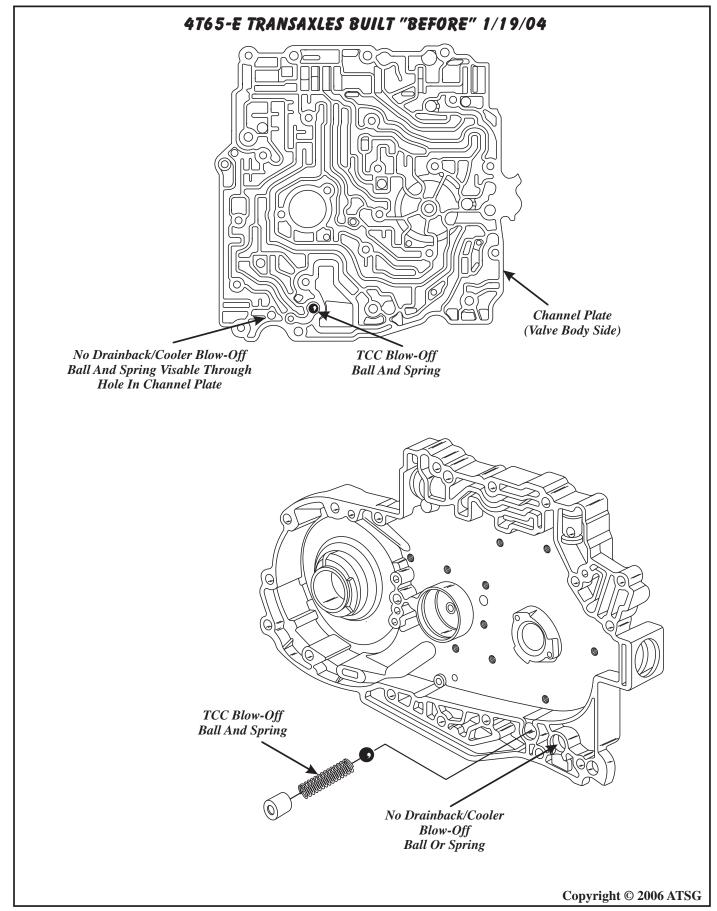
Figure 70

- (1) CHANNEL PLATE Drainback ball, spring, and retainer added to the channel plate next to the torque converter blow-off ball and spring. Channel Plates built "Before" January 19, 2004 are shown in Figure 70, and the Channel Plates built "After" January 19, 2004 are shown in Figure 71.
- (2) RETURN COOLER FITTING The January 19, 2004 and later cooler line case fittings both have the same threads, which is 9/16-18 UNF, and the return line cooler case fitting does not contain a ball and spring. Refer to Figure 72.

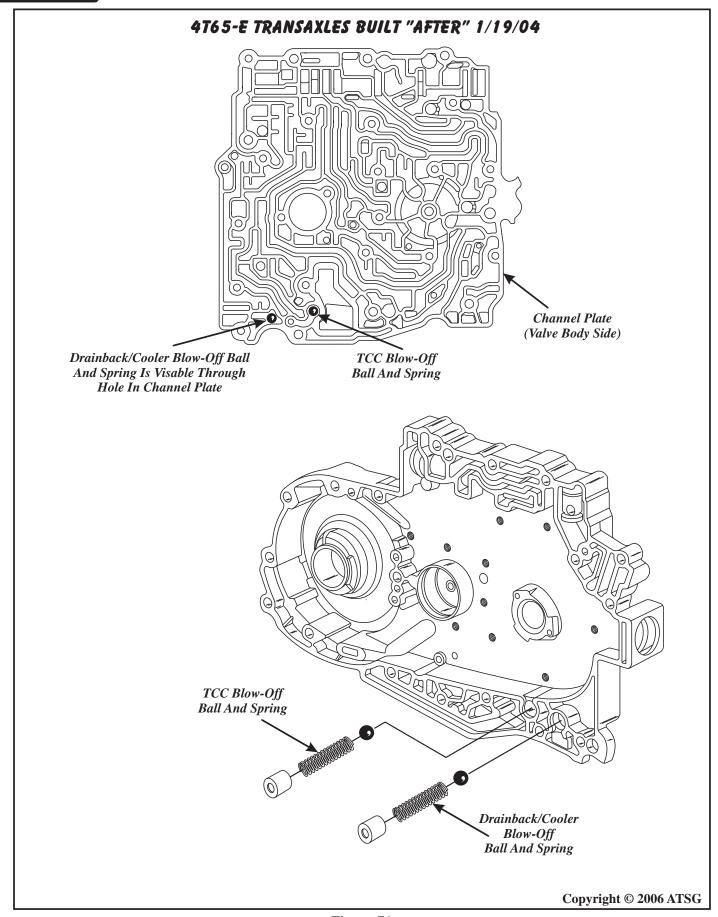
Figure 71

CHANGE: Beginning on January 19, 2004, all 4T65-E transaxles were built with the drainback ball removed from the return cooler line fitting, and relocated in the channel plate next to the torque converter blow-off ball and spring. Refer to Figure 71.

When Channel Plate replacement is required, make certain that the 'Drainback/Cooler Blow-Off ball and spring is present, and in the proper location for the model year transaxle you are rebuilding.

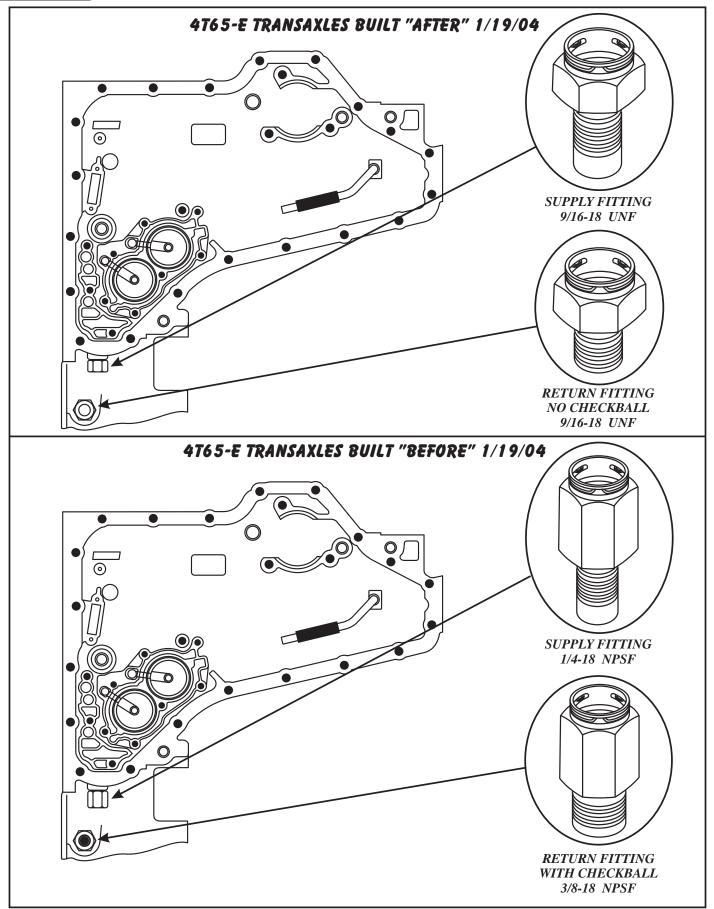
Figure 72

The prior to January 19, 2004 cooler line case fittings have different threads. The supply cooler line case fitting has a 1/4-18 NPSF thread. The return line cooler case fitting has a 3/8-18 NPSF thread, and contains the drainback ball and spring. Refer to Figure 72.

- (1) If a prior to January 19, 2004 Channel Plate, without the drainback ball and spring, is installed on a transaxle built after January 19, 2004, the result will be severe converter drainback.
- (2) If a January 19, 2004 and later Channel Plate is installed on a transaxle built before January 19, 2004, the result will be 2 drainback balls in the circuit, and severe restriction of lube oil.
- (3) If a prior to January 19, 2004 Channel Plate, without the drainback ball and spring, is installed on a transaxle built after January 19, 2004, with the intention of installing the return line cooler case fitting with the drainback ball, this can not be accomplished as the thread sizes are different between case and fitting. Refer to Figure 72.

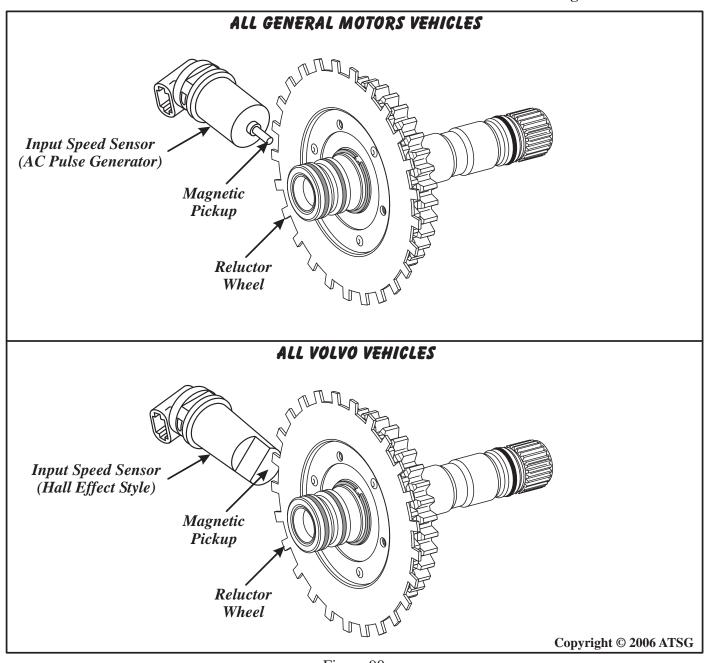
Figure 90

In Figure 90, the top illustration shows the Permanent Magnet type which is found in all GM vehicles, and has a small metal tip protruding from the sensor, while the bottom illustration shows the Hall Effect type found in all Volvo vehicles, which has no metal tip protruding from the sensor.

Although a *typical* Hall Effect Speed Sensor has three wires, the Volvo version is a two wire Hall Effect Speed Sensor. The third wire is contained inside the sensor. It is easy to put the wrong sensor in either version transaxle, as the connectors are identical. This will cause an incorrect signal and transmission gear ratio problems. Operation of both type of Input Speed Sensors is found on Page 105.

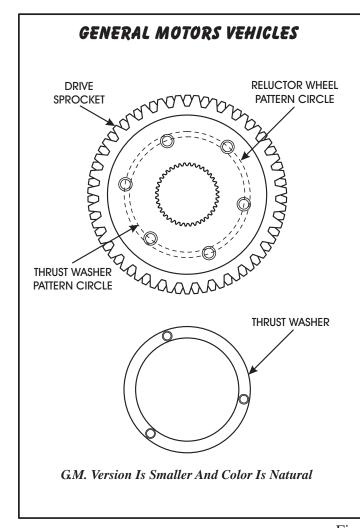
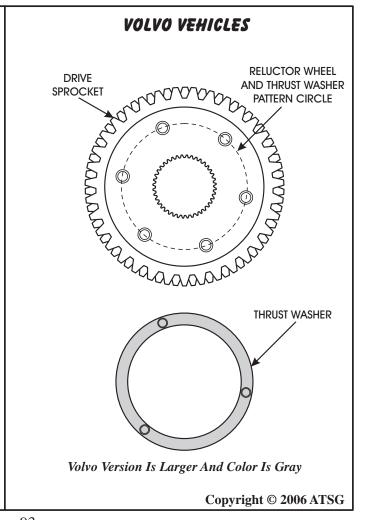
Figure 93

The Drive Sprocket to Drive Sprocket Support Thrust Washer is also different, between the General Motors version and the Volvo version of the 4T65-E transaxle, as shown in Figure 93. The Volvo thrust washer is a larger diameter and Gray in color, as shown in Figure 93. The General Motors thrust washer is a smaller diameter and Natural in color, as shown in Figure 93.

This also changes the drive sprocket pattern where the holes are drilled to accept the washer tabs. The General Motors drive sprocket actually has two different drill pattern circles, as shown in Figure 93. The thrust washer fits the smaller drill pattern circle, and the reluctor wheel fits into the larger drill pattern circle, as shown in Figure 93. The Volvo drive sprocket has only one drill pattern circle, and the washer goes in one set of holes and the reluctor wheel goes in the other set, as shown in Figure 93.

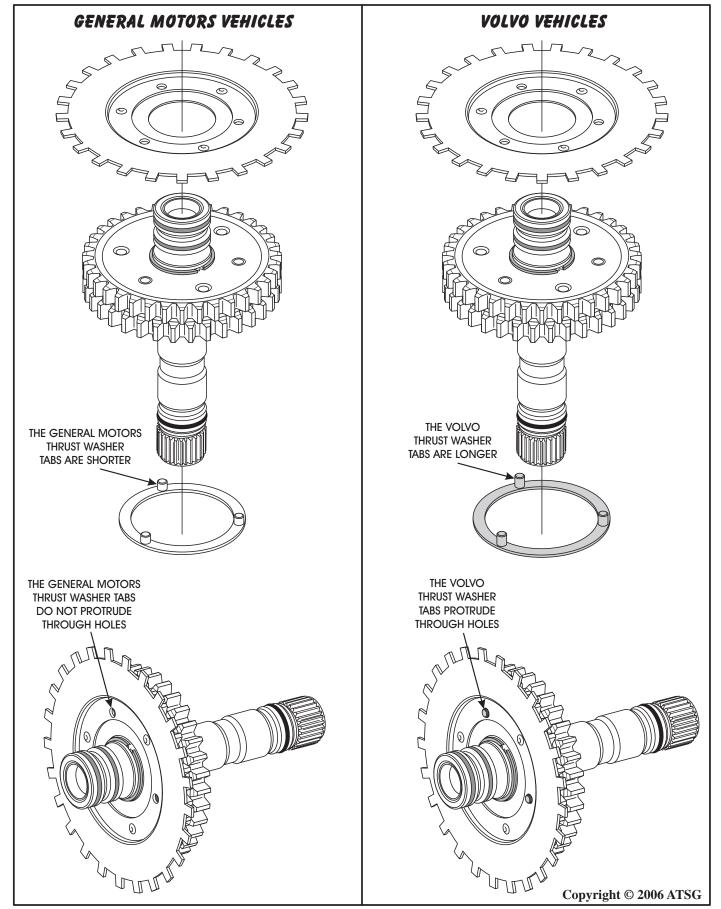
Figure 94

The washer tabs are also longer on the Volvo version thrust washer, as shown in Figure 94. With both the reluctor wheel and thrust washer installed, the Volvo washer tabs will protrude through the holes in the reluctor wheel, as shown in Figure 94. The General Motors thrust washer does not protrude through the reluctor wheel holes. Obviously these thrust washers will not interchange.
