Safety Recall

G—00510A

Subject: Replacing the Bendix EC-17 1030R electronic control unit (ECU) for air brakes on 2000, 4000, 5000, 8000 and 9000 model STRAIGHT TRUCKS with code 04091

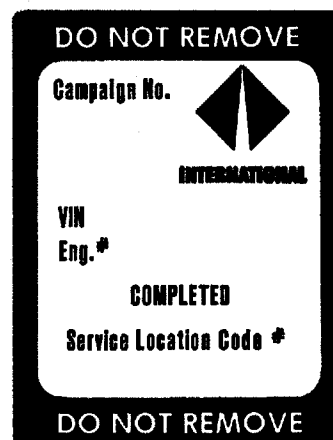
Each vehicle corrected in accordance with this Campaign will require a CTS-1075 Campaign Identification Label.

Attach the CTS-1075 label on a clean surface next to the vehicle identification number (VIN) plate.
