# VEHICLE RECALL

G-00509

**SUBJECT: SAFETY RECALL (U.S., EXPORT)**

**Replacement of the Bendix EC-17 1030R electronic control unit (ECU) for air brakes on 3400, 3600 and 3800 buses built at the Springfield Assembly Plant from 3/01/1998 through 6/16/2000.**

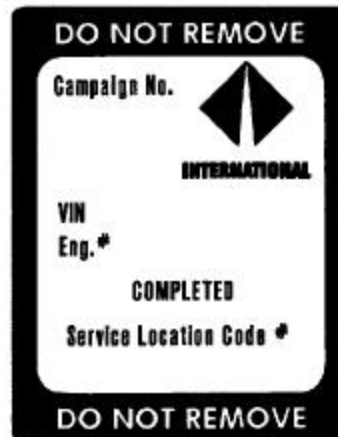
Each vehicle corrected in accordance with Campaign letter **G-00509** will require a CTS-1075 Campaign Identification Label.

Attach the CTS-1075 label on a clean surface next to the vehicle identification number (VIN) plate.
