CHRYSLER A604 (41TE) UPDATE HANDBOOK

AUTOMATIC TRANSMISSION SERVICE GROUP 9200 S. DADELAND BLVD. SUITE 720 MIAMI, FLORIDA 33156 (305) 670-4161

CHRYSLER A604 (41TE) "UPDATE HANDBOOK"

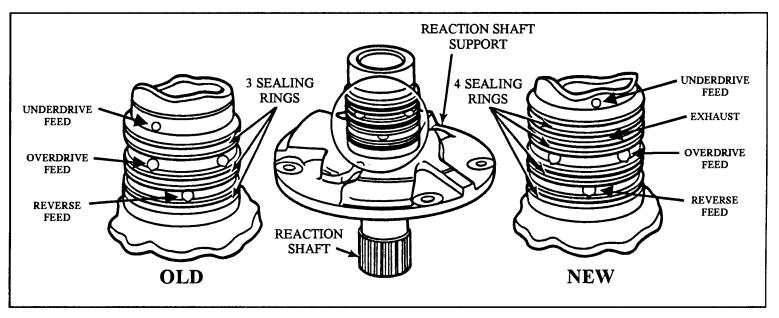
Figure 1

CHANGE: Beginning in April, 1989 a new Reaction Shaft Support (Stator) was introduced, with the addition of another ring groove and sealing ring. The old support has 3 sealing rings, and the new support has 4 sealing rings (See Figure 1).

- (1) REACTION SHAFT SUPPORT The new support is longer, and has 4 sealing rings, where the old support only has three (See Figure 1).
- (2) INPUT SHAFT/CLUTCH HUB The new Input Clutch Hub bore is machined deeper to accommodate the additional length of the reaction shaft, created by the added sealing ring (See Figure 2). The "O" Ring grooves are also cut shallower than the old input clutch hub, which increases the groove diameter, and provides improved compression or "Crush", between the "O" rings and the input clutch retainer. (See Figure 3).

ALWAYS UPDATE to the four ring reaction shaft support. There is now available a repair package, OEM part number 4549248, that includes the following:

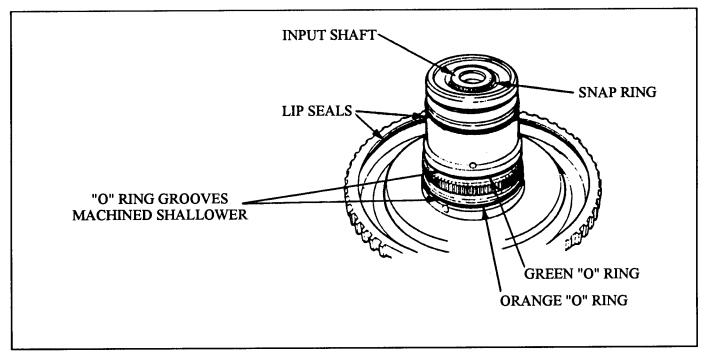
Figure 3

- (3) INPUT SHAFT/CLUTCH HUB "O" RINGS The new "O" Rings are "Teflon Coated" for greater tear resistance during the assembly process. The coatings also identify the locations for the "O" Rings. The orange ring goes to the front, and the green one goes to the rear (See Figure 3). The early "O" rings were black.

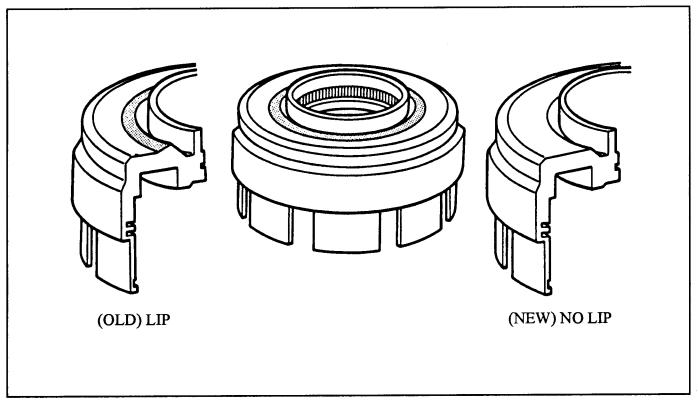
Figure 4

- (4) INPUT CLUTCH RETAINER The Input Clutch Retainer was modified, by machining off the "Lip" (See Figure 4), to allow more travel of the overdrive/reverse piston. The old Input Clutch Retainer can be machined at the local machine shop if necessary.

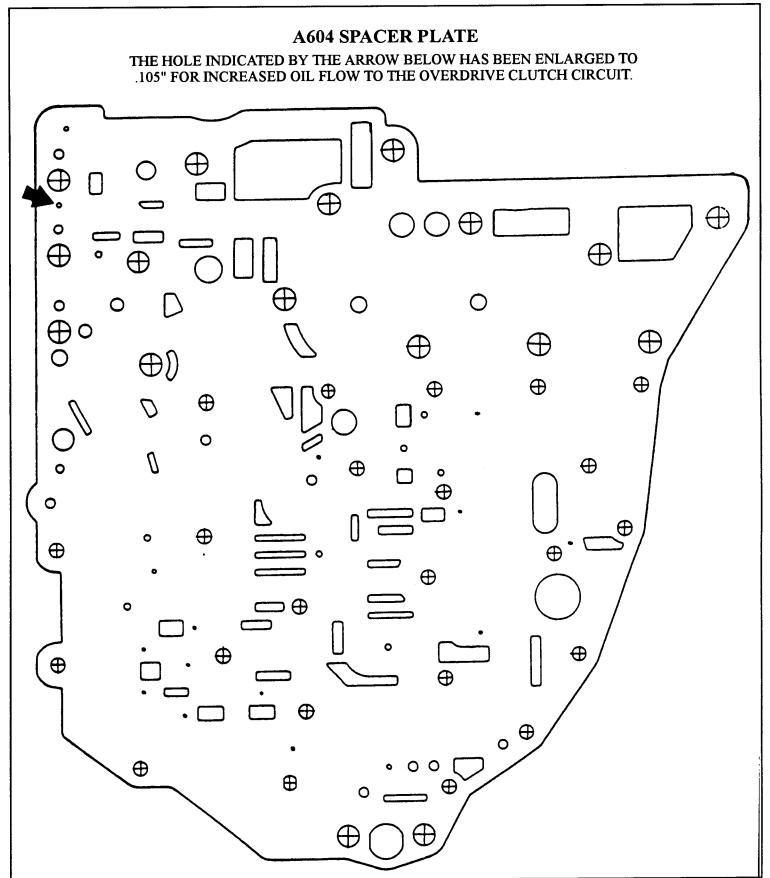
Figure 5

- (5) SPACER PLATE The new Spacer Plate has a larger (.105") overdrive clutch feed orifice to provide increased oil flow to the overdrive clutch circuit (See Figure 5).

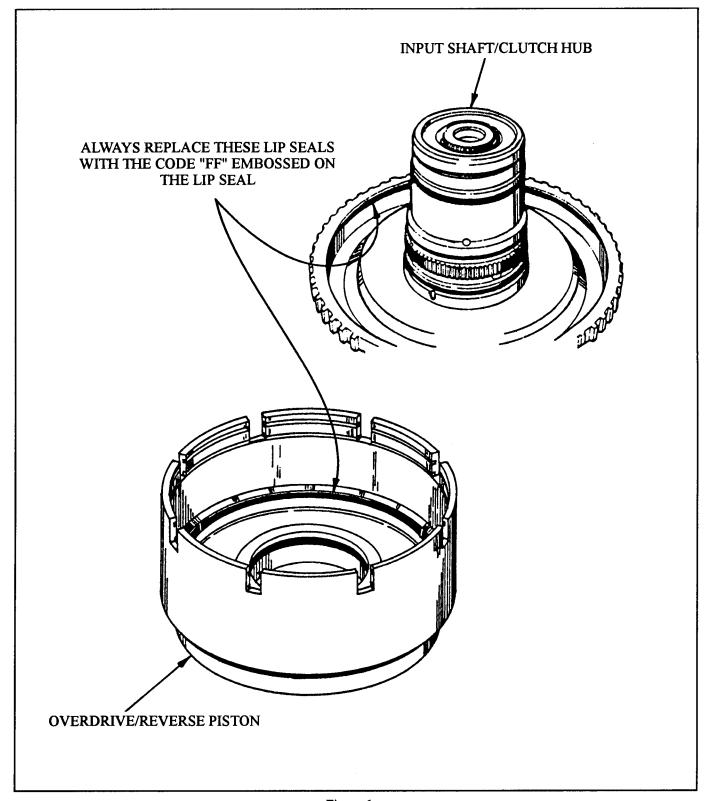
Figure 6

CHANGE: The lip seals in the Overdrive/Reverse Clutch Piston and the Input Shaft/Clutch Hub are now replaced with lip seals made of different material (See Figure 6).

THE NEW LIP SEALS EMBOSSED WITH THE CODE "FF" WILL RETROFIT BACK TO ALL PREVIOUS MODELS, AND SHOULD BE USED DURING OVERHAUL.

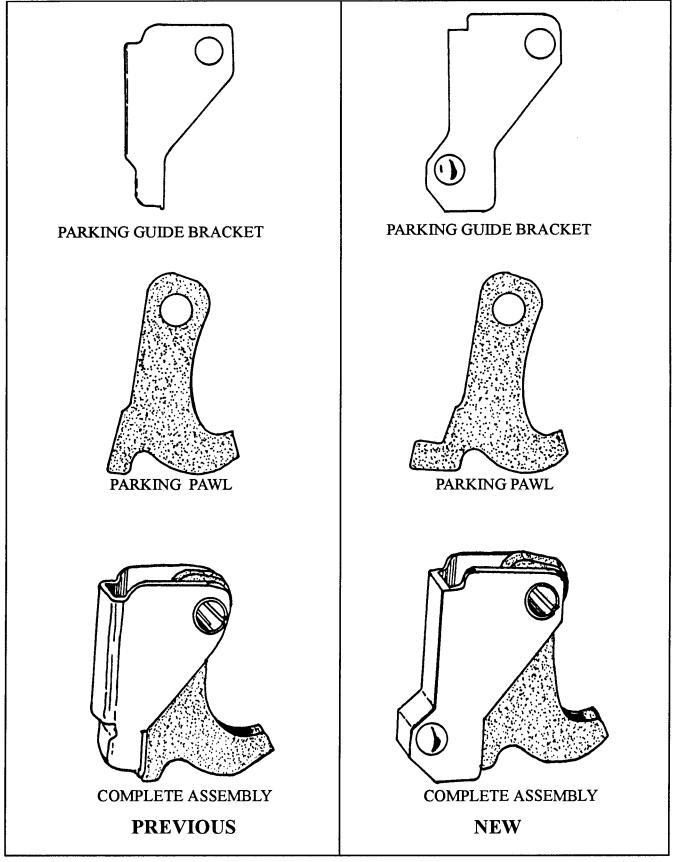
- (1) PARKING GUIDE BRACKET Previously the Parking Guide Bracket was a stamped steel unit, and has been replaced by a high quality casting, along with dimensional changes. See Figure 7 for identification.
- (2) PARKING PAWL The new Parking Pawl, or "Boot", also required some dimensional changes. The heel of the new "Boot" is wider than the previous models, as shown in Figure 7.

The new parts will retrofit back to all previous models, but both pieces must be replaced as an assembly. (See Figure 7).

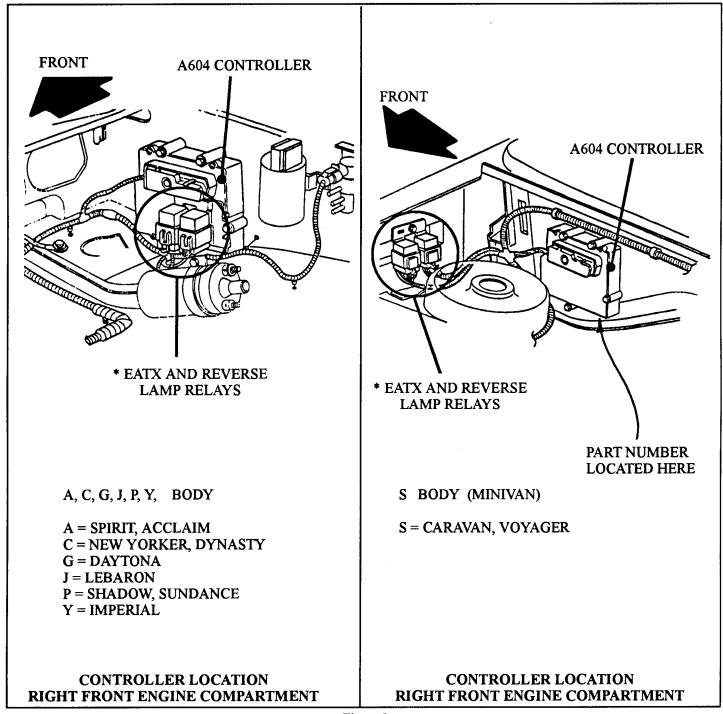
Figure 8

- (1) TRANSAXLE CONTROLLER Controllers can be identified by the OEM part number that is printed on a sticker. This sticker can be located on the bottom of the transaxle controller as shown in figure 8. If the sticker is missing, scanners will also provide controller identification by providing the OEM part number of the controller that is in the vehicle. Refer to the chart on the following page for a brief overview of past controllers.

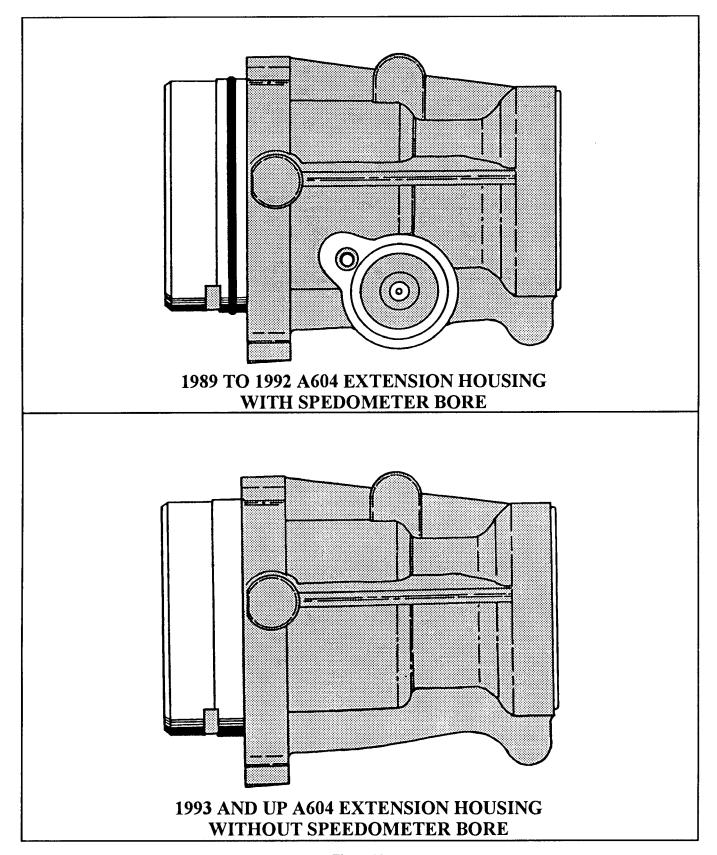
Figure 10

1993 to present controllers received a logic change to use the output shaft speed sensor as the source for vehicle speed. Refer to figure 10 which shows the elimination of the speedometer from the extension housing in 1993.

The locations of the controllers will vary depending on the model of the vehicle. Refer to figure 8 for the different locations. Figures 8 and 9 also shows the locations of the EATX relay, as their location will vary depending on the model of the vehicle.
- (2) TRANSAXLE EXTENSION HOUSING 1993 extension housings no longer have a speedometer bore. The speedometer assembly is no longer needed since the transaxle controller will now look at the output shaft speed sensor for this information (See Figure 10).

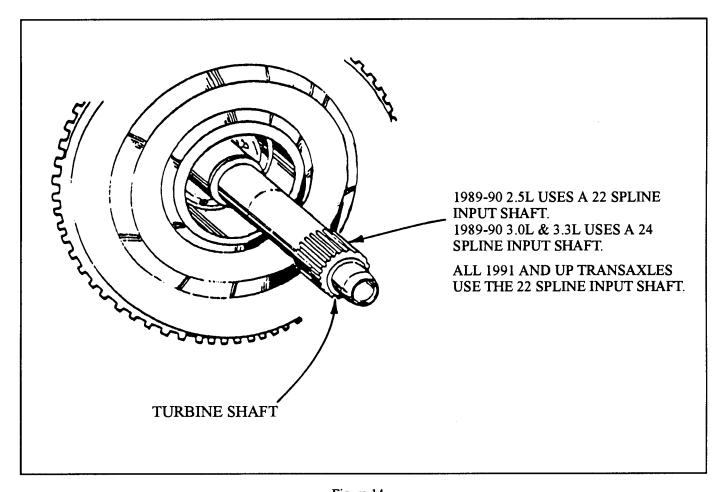
Figure 14

(2) TURBINE SHAFT SPLINES - 1989-1990 2.5 Litre engine uses a turbine shaft with 22 splines for the torque converter, and the 1989-1990 3.0 and 3.3 Litre engines will use the a 24 spline turbine shaft (See Figure 14).

NOTE: All 1991 and up A604 transaxles will use a 22 spline input shaft to fit a new torque converter with a torsional vibration damper (See Figure 14).

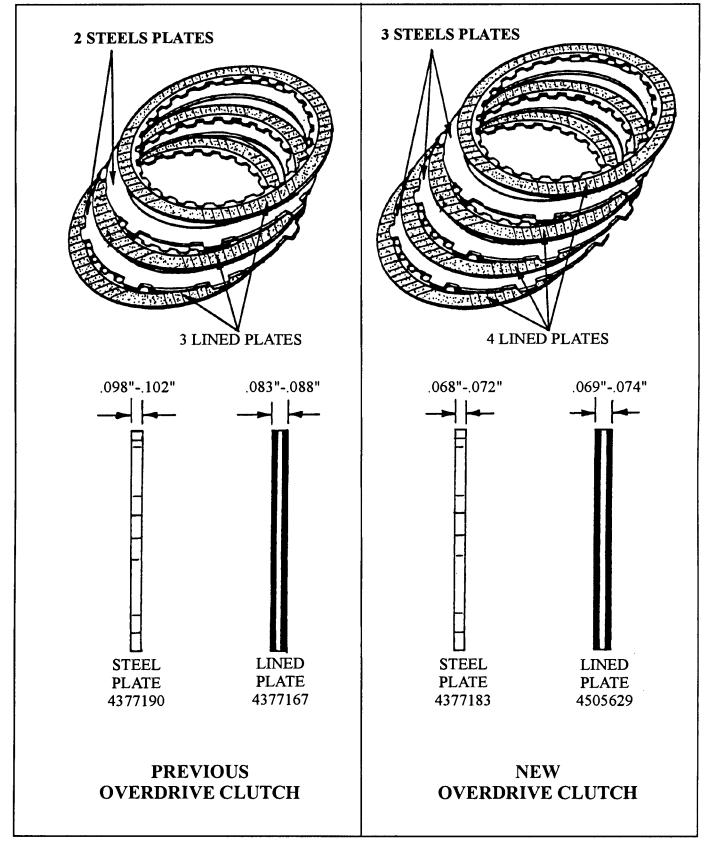
Figure 15

(1) OVERDRIVE LINED PLATES - Now uses 4 lined plates instead of the previous 3 lined plates, and the lined plates for 1990 models are .014" thinner than the 1989 lined plates (See Figure 15), to help accommodate the extra lined plate. The 1989 lined plates measure .083"-.088" thick, and the new lined plates will measure .069"-.074" thick (See Figure 15).

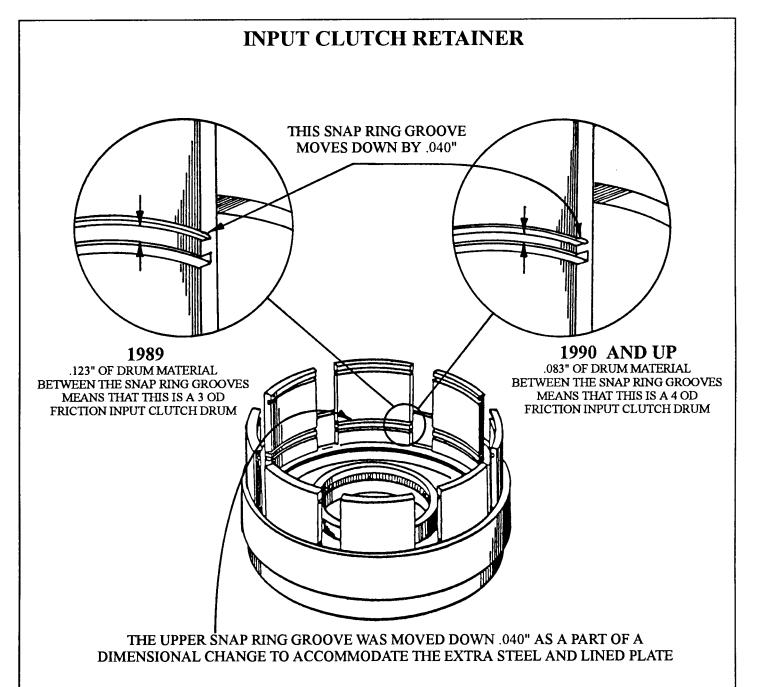
- (3) INPUT CLUTCH RETAINER The underdrive/overdrive reaction plate tapered snap ring groove was moved "Down" by .040" (Can be detected visually) to make room for the added lined and steel plates (See Figure 16). This also necessitated a change to be made to the underdrive/overdrive reaction plate as explained below. Another change that occurred at the same time is the underdrive clutch outer lip seal groove depth is .040" "Shallower" to accommodate a new underdrive clutch outer lip seal (See Figure 17).

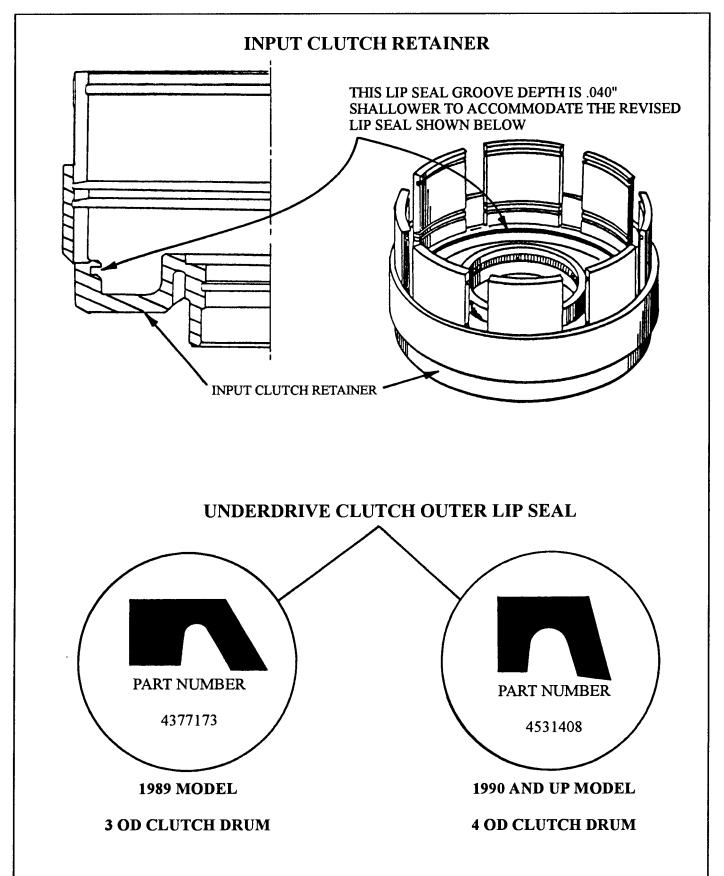
Figure 17

- (4) UNDERDRIVE CLUTCH OUTER LIP SEAL The lip seal cross section has been reduced by .040" (Smaller in Overall Diameter) to accommodate the change in the depth of the groove in the input clutch retainer (See Figure 17). The OEM part number is printed on the seals for identification. The 1989 (Large) is 4377173, and the 1990 (Small) is 4531408. This will confirm that you have the proper seal for this location (See Figure 17).

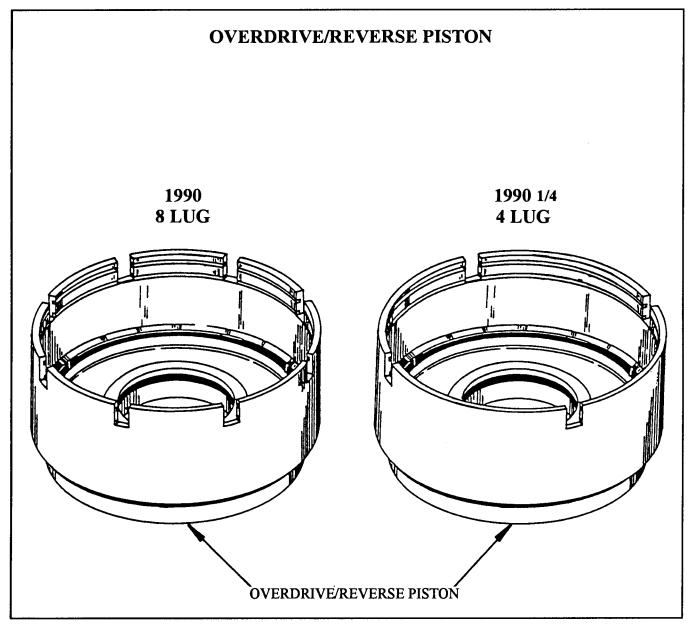
Figure 34

CHANGE: A new Overdrive/Reverse Piston has been introduced for 1990 1/4 model transaxles, and features four reaction plate slots instead of eight slots (See Figure 34).

The new Overdrive/Reverse Piston, and four lug pressure plate will retrofit back to all previous models, if it is used as an assembly. The piston and pressure plate must BOTH be used in these instances. The revised Input Clutch Retainer WILL NOT work with the previous style 8 lug overdrive/reverse piston. Since the part number did not change, to replace an input clutch retainer built in 1990, before the change to the 4 lug overdrive/reverse piston, you MUST also change to the 4 lug design piston and pressure plate.

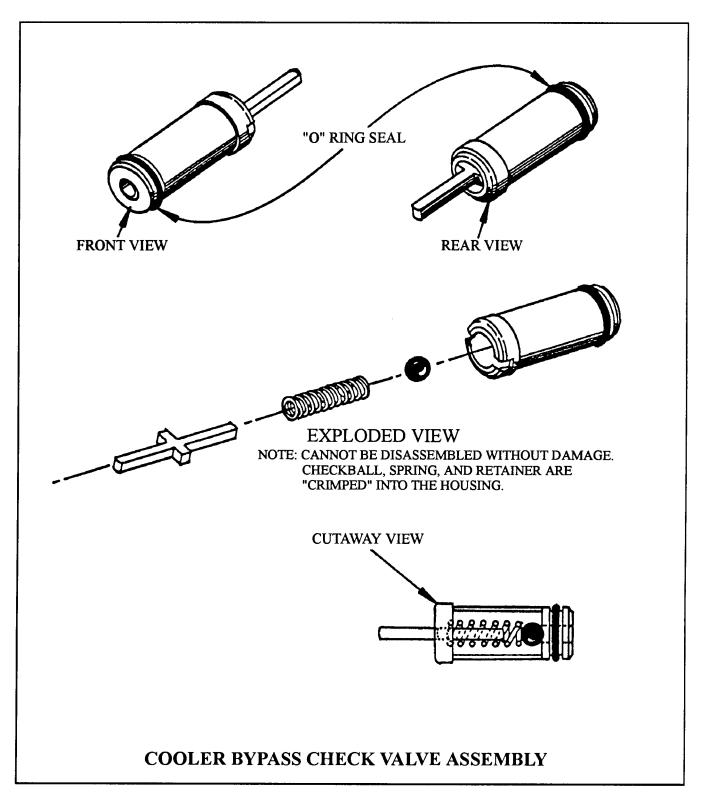
Figure 42

(1) COOLER BYPASS CHECK VALVE - added into the case cooler passage behind the oil pump (See Figure 43). If cooler oil flow is restricted, or blocked, the new check valve will open, and allow cooler feed oil direct into the lube circuit to prevent transaxle damage. Normal operation is resumed after oil temperature is warm enough to again flow through the cooler. (See Figure 42).

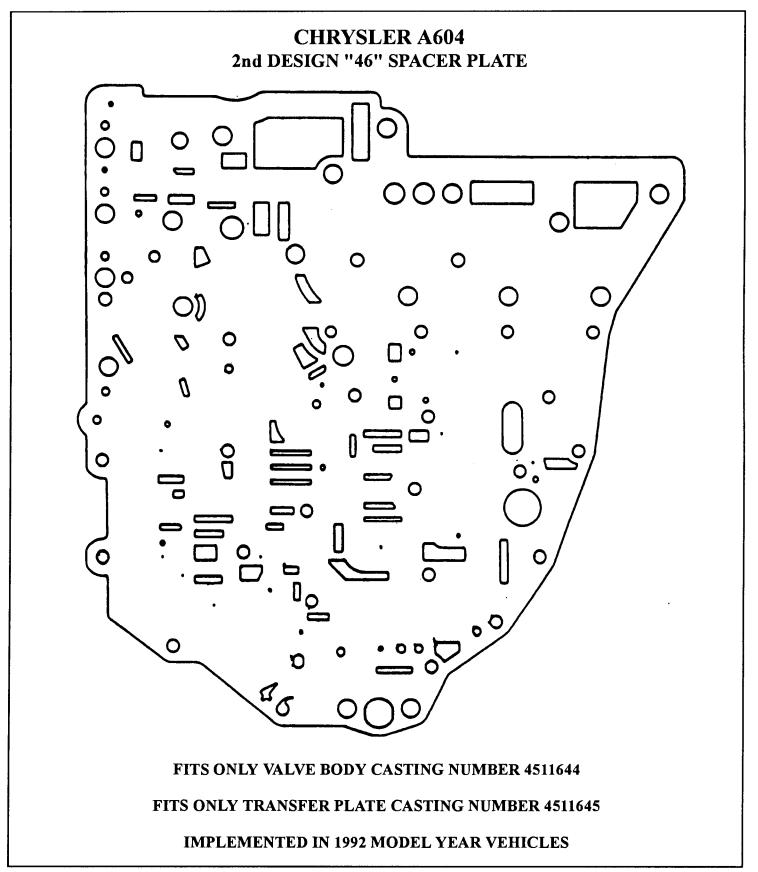
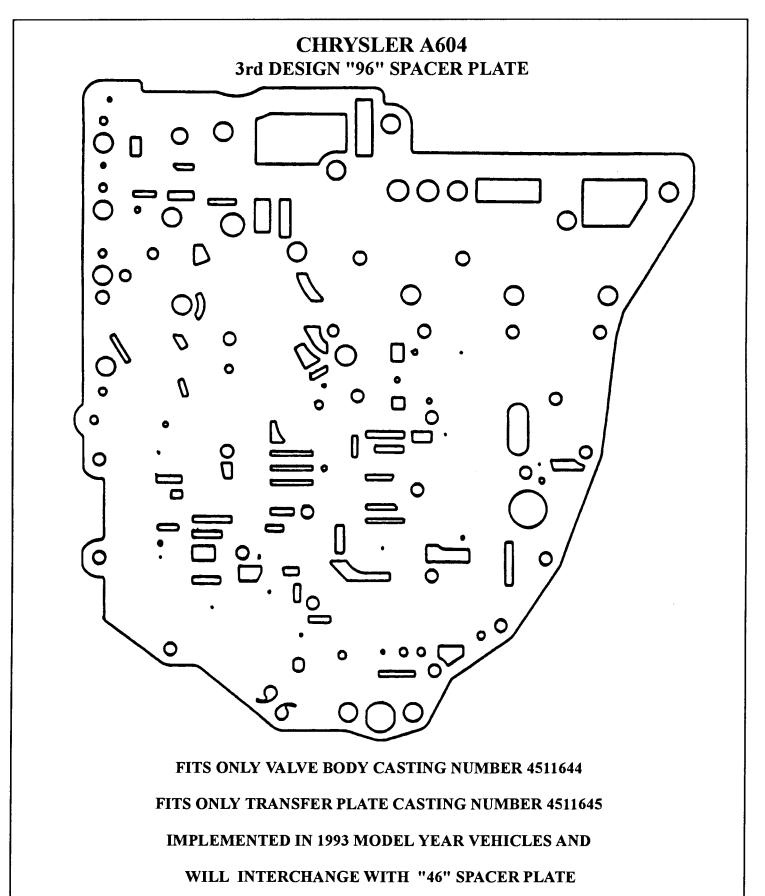
Figure 56

- (1) TORQUE CONVERTER CONTROL VALVE 3rd design valve has two of the lands made .020" thicker than the previous, and has "Groove" cut into stem for I.D. (See Figure 59).
- (2) TORQUE CONVERTER CONTROL VALVE SPRING Calibration changes to accommodate the new design TCC Control valve.
- (3) VALVE BODY SPACER PLATE 3rd design is identified with "96" stamped in plate, and 2nd design is identified with "46" stamped in plate. The 3rd design "96" spacer plate has calibration changes to the new TCC control valve. (See Figures 56 and 57).

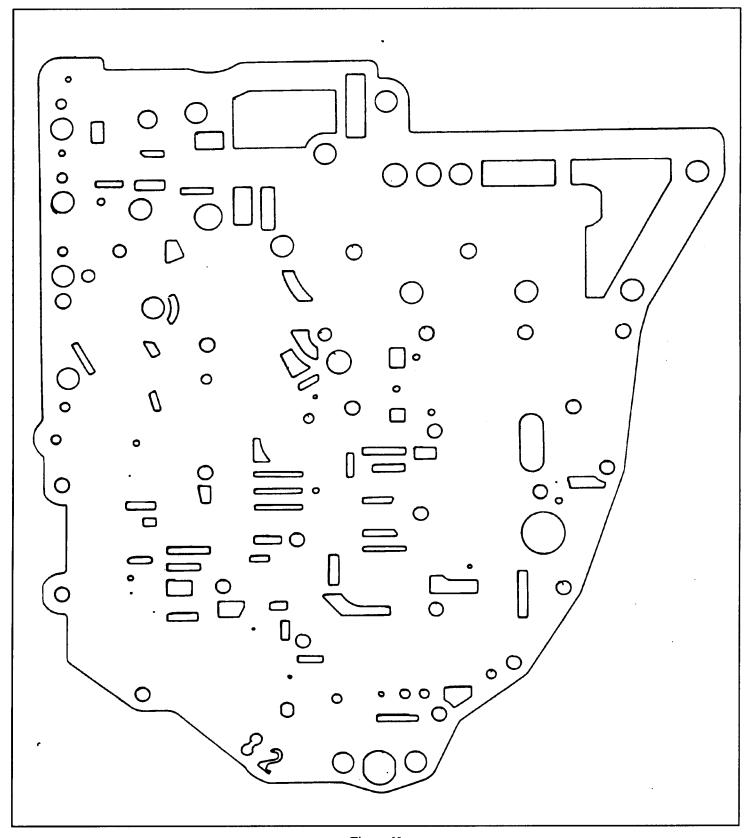
Figure 60

CHANGE: A running change in 1994 was made to the spacer plate (See Figure 60) and to the Pressure Regulator Valve (See Figure 61).

The new "82" spacer plate replaces the previous "96" spacer plate and can retrofit back to all valve bodies and Transfer Plates that use the # 96 spacer plate provided that the new pressure regulator valve is used together with the # 82 spacer plate. Valve bodies that use a 96 spacer plate has a casting number of 4511644 (See Figure 52 on Page 68). Transfer Plates that use the # 96 spacer plate has a casting number of 4511645 (See Figure 54 on Page 70).

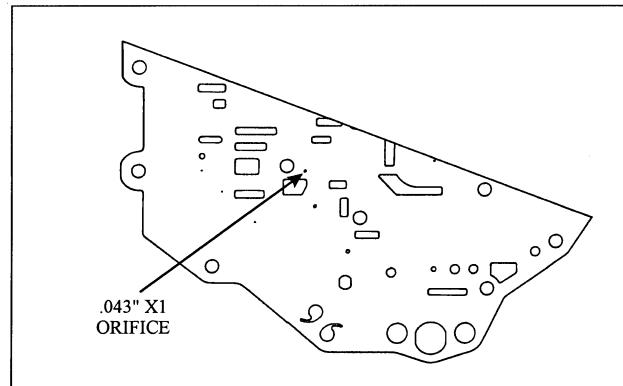
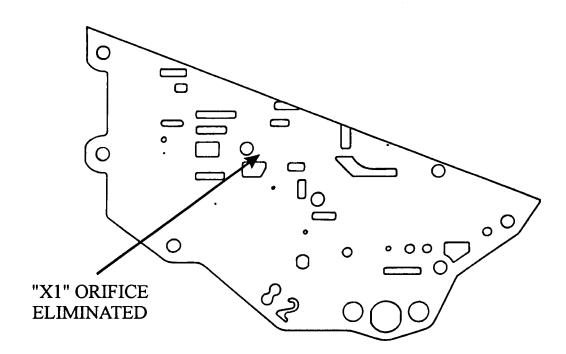
Figure 62

- (1): SPACER PLATE: The "X1 Orifice" in the spacer plate has been eliminated as shown in figure 62. The plate can be easily identified by the number "82" that is punched through the plate (See Figure 62).
- (2): PRESSURE REGULATOR VALVE: A ground step has been machined to the inner land on the Pressure Regulator Valve causing two different diameters to exist on one land (See Figure 63). There are no obvious or visible signs or identification marks to indicate the updated Pressure Regulator Valve. Careful measurement of the valve land is needed to properly identify the valve (See Figure 63). The spring side of the land measures approximately .6255". The opposite end of the same land will measure approximately .6245" (See Figure 63).

PREVIOUS # 96 SPACER PLATE WITH THE "X1" (.042") ORIFICE

NEW #82 SPACER PLATE WITH THE "X1" ORIFICE ELIMINATED

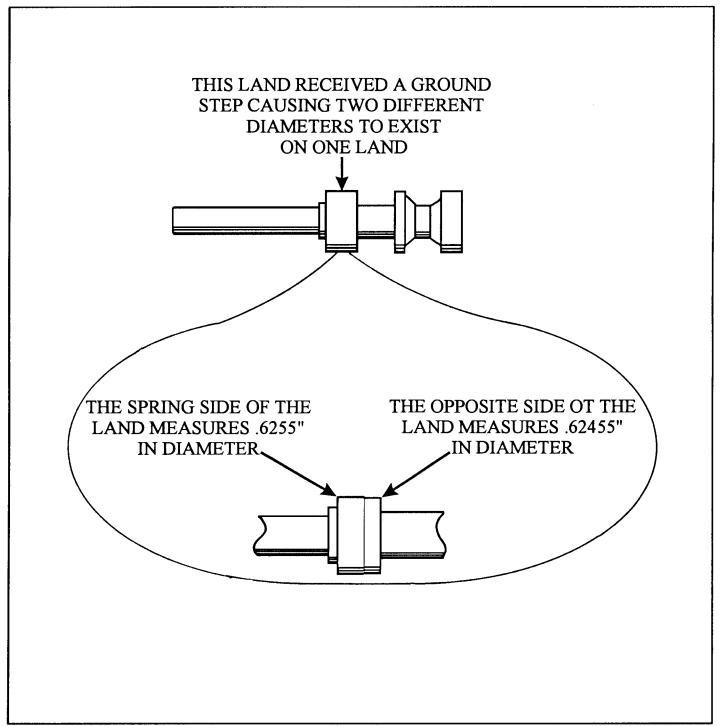
Figure 63

PRESSURE REGULATOR VALVE

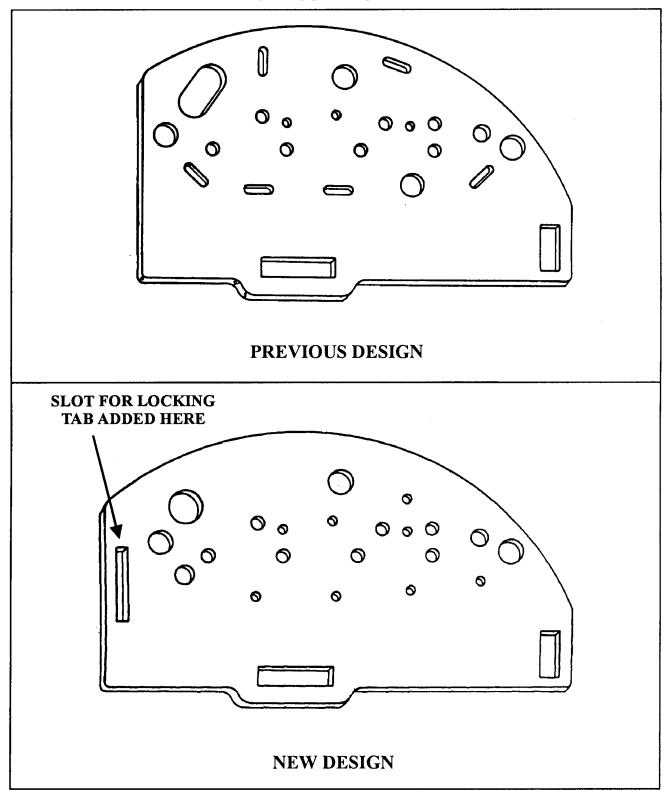
Figure 64

- (1): SOLENOID SOUND COVER An additional locking tab was added to the sound cover for a more secure fit to the solenoid spacer plate.
- (2): SOLENOID SPACER PLATE The solenoid spacer plate received an added slot to accommodate the additional locking tab made to the solenoid sound cover. There were also subtle changes made to the venting holes and slots found in the spacer plate (See Figure 64).

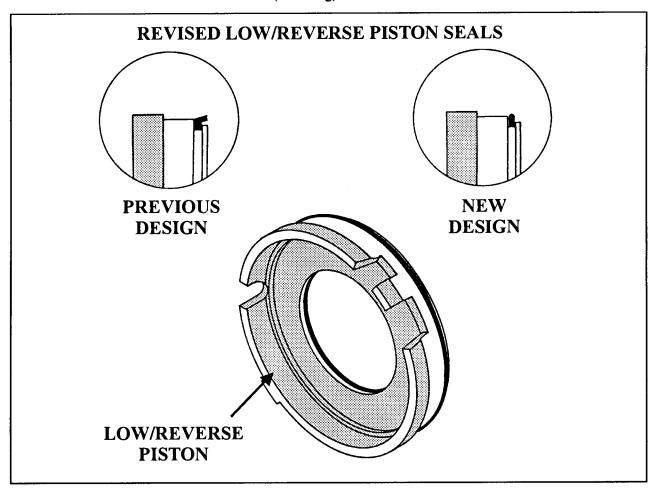
Figure 65
Automatic Transmission Service Group

CHANGE: Beginning at the start of production for 1995 model year, all Chrysler A604 (41TE) and A 606 (42LE) transaxles were produced using revised seals for the Low/Reverse piston. The previous "Lip" type seals have been replaced by a "D" Ring type seal for both inner and outer seals, as shown in Figure 65.

(1) LOW/REVERSE PISTON SEALS - Both the inner and outer lip seals have been replaced by a "D" Ring type seal, as shown in Figure 65. There were no dimensional changes necessary to the Low/Reverse piston to accommodate the new "D" Ring seals. The seals are available under OEM part number 4659185 for the outer seal, and 4659184 for the inner seal.

The new "D" Ring type seals will back service ALL previous models of the Chrysler A604 (41TE) and A606 (42LE) transaxles, without any additional modifications or changes.

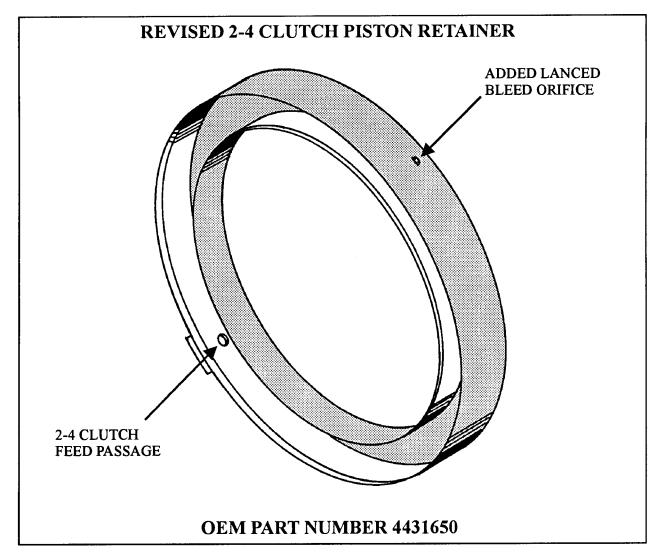
Figure 66

CHANGE: Beginning at the start of production for the 1995 model year, all Chrysler A604 (41TE) and A606 (42LE) transaxles were produced using a revised 2-4 Clutch Piston Retainer with an added lanced bleed orifice (See Figure 66).

(1) 2-4 CLUTCH PISTON RETAINER - Lanced bleed orifice added to the retainer in the location shown in Figure 66.

The revised 2-4 Clutch Piston Retainer with the added lanced bleed orifice will back service ALL previous models of Chrysler A606 (41TE) and A606 (42LE) transaxles. There was not a part number change, so the revised retainer is available under OEM part number 4431650.

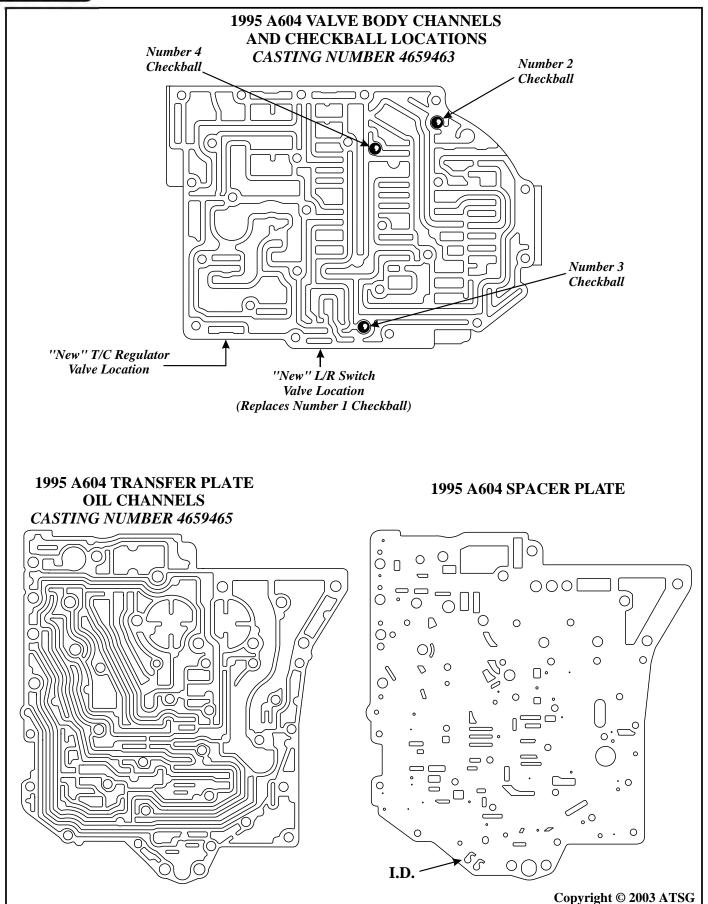
Figure 72
Automatic Transmission Service Group

Number stamped for identification into new spacer plate is "66" (See Figure 72).

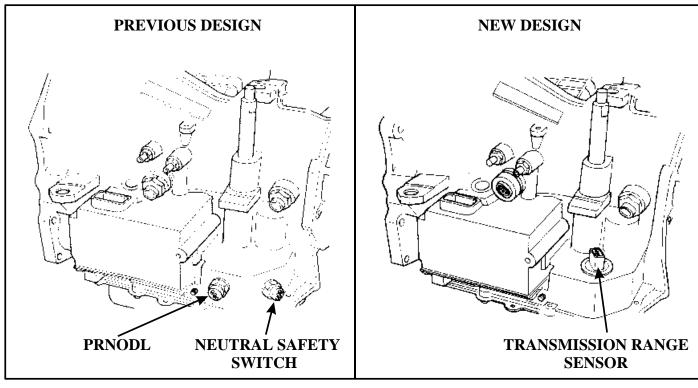
Figure 73

CHANGE: Beginning at the start of production 1996, some models equipped with the 41TE (A604) transaxle replaced the PRNODL and Neutral Safety Switch with a Transmission Range Sensor as seen in Figure 73.

- (1) PRNODL SWITCH The previously used Park, Reverse, Neutral, Overdrive, Drive, Low Switch PRNODL) has been eliminated and replaced with the new Transmission Range Sensor (See Figure 73).

- (2) NEUTRAL SWITCH The previously used Neutral Switch has been eliminated and replaced with the new Transmission Range Sensor (See Figure 73).
- (3) TRANSAXLE CASE The casting of the case change with the elimination of the two threaded holes for the PRNODL and Neutral Safety Switch. An access hole has been added to accommodate the new TRS sensor connector as the switch which is mounted on the valve body (See Figure 73).

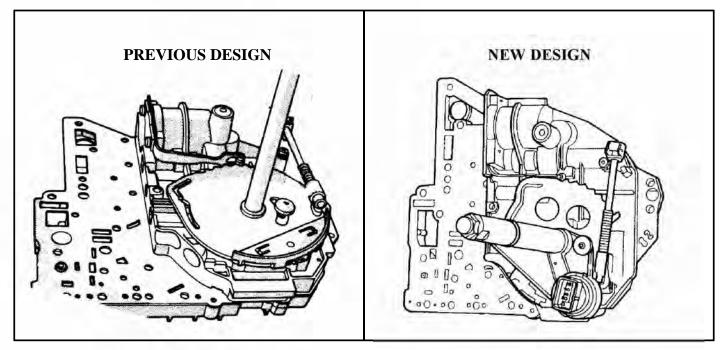
Figure 74

- (4) VALVE BODY The manual arm shaft and rooster comb assembly and the valve body changed in design to accommodate the mounting of the new TRS sensor (See Figure 74).

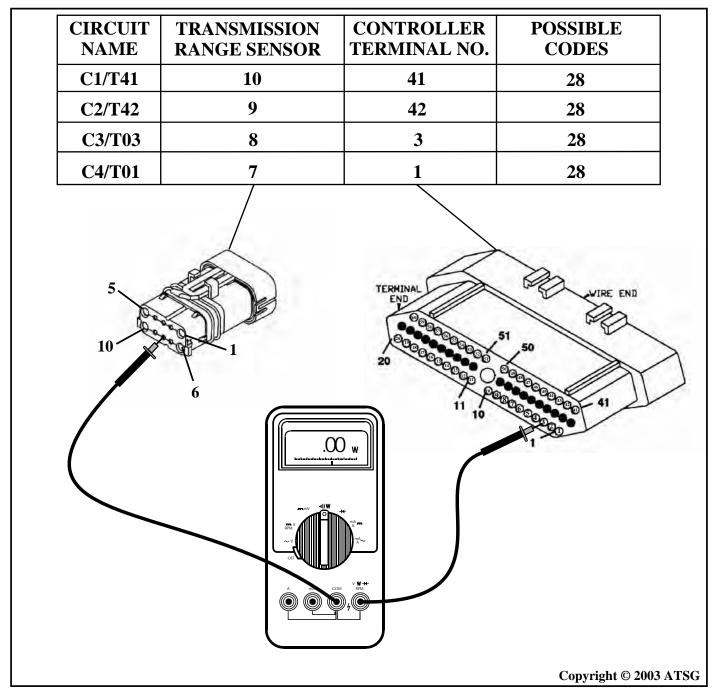
Figure 75
Automatic Transmission Service Group

Once the circuit which malfunctioned has been identified, a continuity check should be made on that circuit. Use the chart found in Figure 75 to assist in identifying the specific circuit or circuits in question. For example, if the scanner reveals that the T3 (C3) circuit does not close when the selector lever is placed in Park, 3 or 1, that specific circuit will need to be checked. In the chart below circuit T3 is the wire which runs from the number eight cavity in the TRS connector to the number three cavity in the TCM connector.

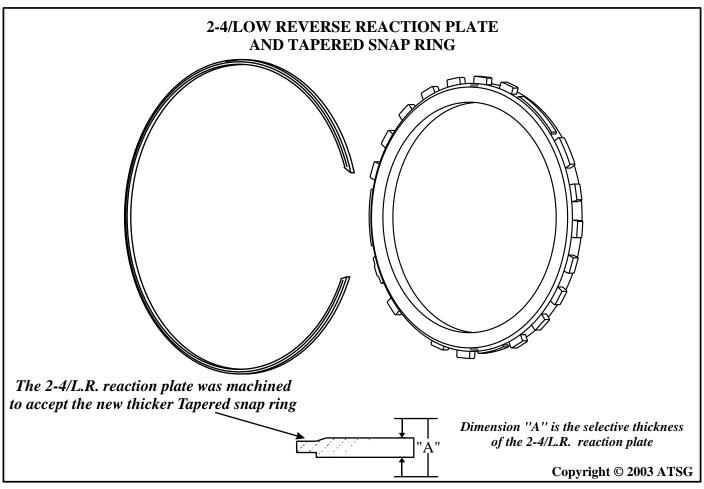
Figure 77
Automatic Transmission Service Group

**CHANGE:** Some time in 1999, four of the previous 2-4/Low Reverse Reaction Plate selectives were changed to acommodate a new Tapered Snap Ring as shown in Figure 77.

NOTE: The thicker tapered snap ring is included in the new 2-4/Low Reverse Reaction Plate package when the Part Number ends with "AA."

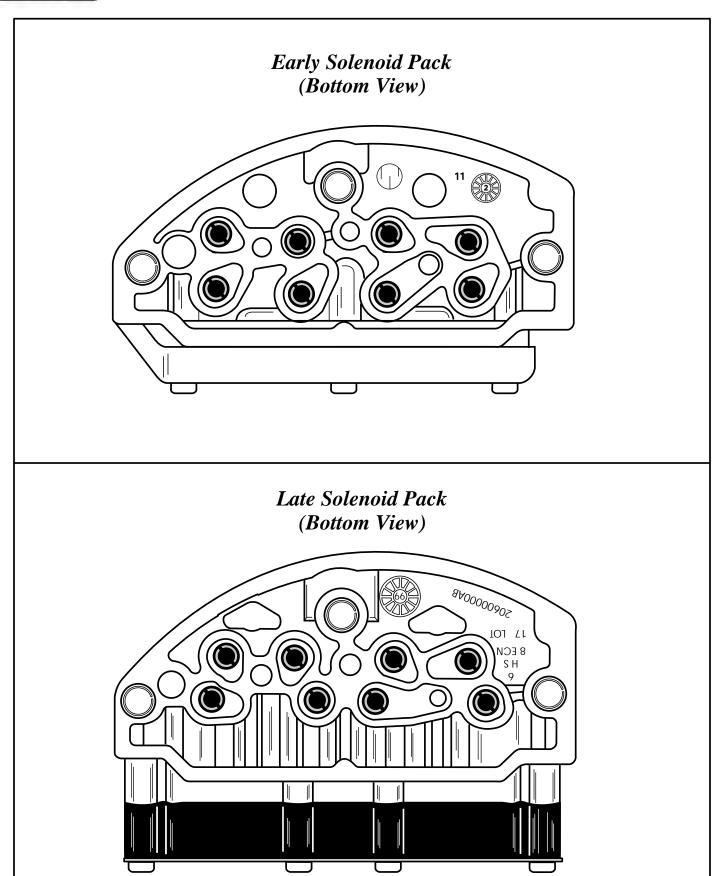
Figure 79
Automatic Transmission Service Group

- (1) SOLENOID PACK Totally re-designed casting with changes in the worm track area and is illustrated in Figure 79. The new design Solenoid Pack, available under OEM part number 5015646AB, is now the only one available for service.
- (2) SOLENOID GASKET Changed to accommodate the changes in the new design solenoid pack, as shown in Figure 80.
- (3) SOLENOID SPACER PLATE Eliminated, with the new design solenoid pack.
- (4) SOLENOID SOUND COVER Eliminated with the new design solenoid pack, as it is no longer needed to dampen the "Buzzing" noise.

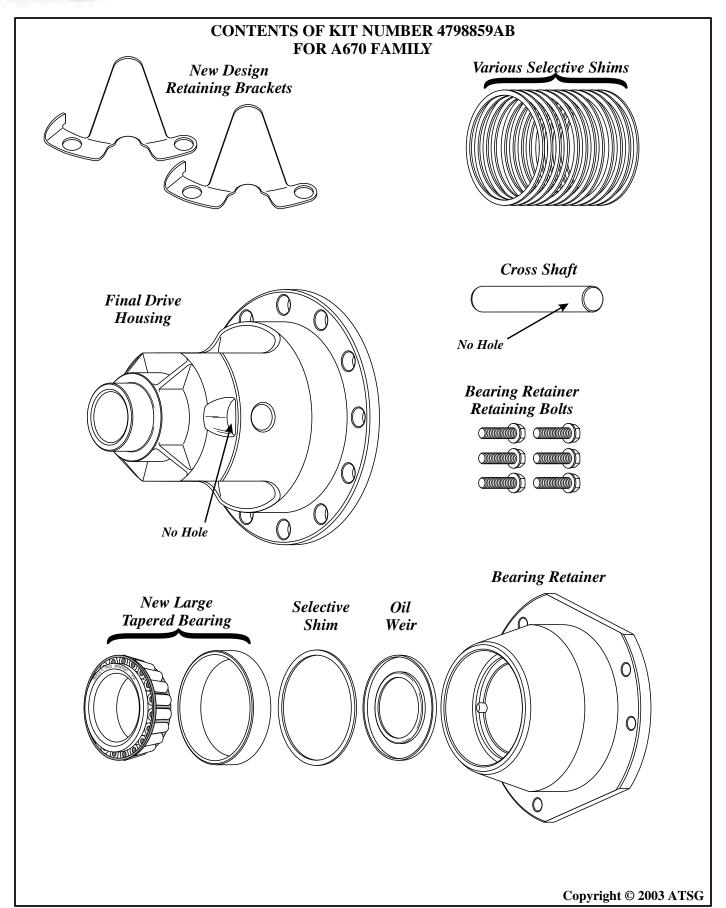
Figure 82
Automatic Transmission Service Group

- (1) FINAL DRIVE HOUSING Retaining pin hole eliminated (See Figure 82).
- (2) CROSS SHAFT Retaining pin hole eliminated (See Figure 82).
- (3) CROSS SHAFT RETAINER New design cross shaft retainer to replace the previous design retaining pin (See Figure 82).

Chrysler has now made available two service packages to back service previous design levels, one kit for the 31TH and one kit for the 41TE transaxles. The contents of these kits are illustrated in Figure 2 and part numbers are listed below under "Service Information".
