# VEHICLE RECALL

G-00508

**SUBJECT: SAFETY RECALL (U.S., EXPORT)**

**Replacement of the Bendix EC-17 1030R electronic control unit (ECU) for air brakes on AmTran FE, RE, and IC buses built from 3/01/1998 through 7/13/2000**

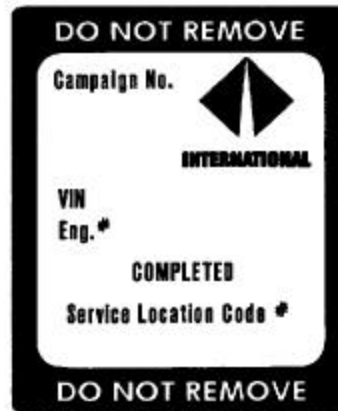
Each vehicle corrected in accordance with Campaign letter **G-00508** will require a CTS-1075 Campaign Identification Label.

Attach the CTS-1075 label on a clean surface next to the vehicle identification number (VIN) plate.
