## **Technical Service Information**

## THM 440-T4 BROKEN T.V. PLUNGER (PART NUMBERS)

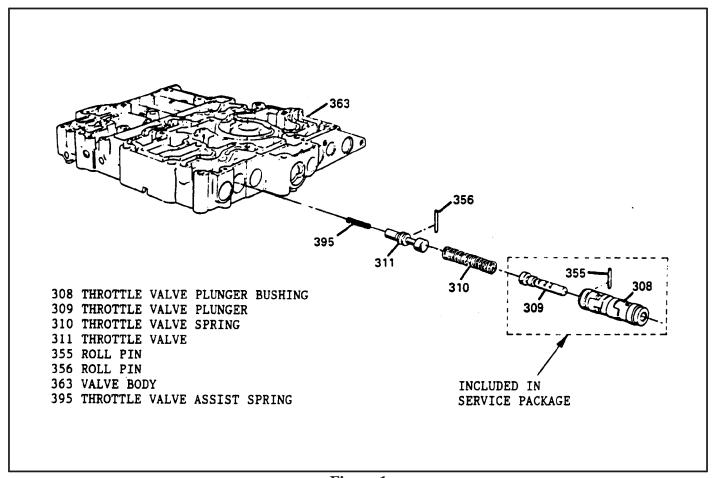
Figure 1

The T.V. Plunger and Bushing Assembly are now available from OEM in a service package, so that buying a valve body is no longer necessary when the TV plunger is broken or cracked (See Figure 1). Refer to the following OEM part numbers as it IS a model sensitive part.

<u>YEAR</u> 1984	TRANSAXLE MODELS 4BC	PART NO. 8649730
1985	50B, 50Y	8649317 8649730 8646435 8649641
1986	6AAH, 6ACH, 6ADH, 6AFH, 6AMH, 6ANH, 6APH, 6ARH, 6ASH, 6ATH, 6AWH, 6AYH 6BAH, 6BBH, 6BCH, 6BDH, 6BLH, 6BMH, 6BSH, 6BTH, 6BYH 6BHH, 6BZH	8649641 8658704 8649730
1987	7ACH, 7ADH, 7AHH, 7ALH, 7ARH, 7HAH, 7HCH	8649641 8646435 8658704
1988	8AAH, 8ABH, 8AFH, 8AJH, 8ANH, 8ATH	8649641 8658704 8646435
1989	9AAH, 9ABH, 9ACH, 9ADH, 9AFH, 9AHH, 9AJH, 9ANH, 9ATH	8649641 8658704
1990	9YAH, 9YBH, 9YCH, 9YFH, 9YJH  OAAH, OABH, OAFH, OAJH, OANH, OATH  OBAH, OBDH, OBFH, OBHH, OBJH,  OBMH, OBPH, OBWH, OPAH  OCHH, OCJH, OLAH, OLMH, OLNH,  OYKH, OYLH	8649641 8658704 8646435
