SERVICE PROCEDURE

**G-01512-R1
JULY 2007**

SUBJECT: VEHICLE RECALL (U.S., EXPORT)

**Lower Steering Shafts On 9000i and 5000i
Models built in July and August of 2001**

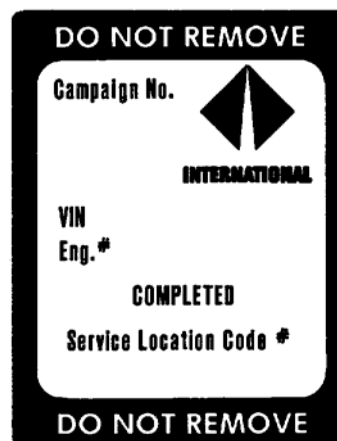
Each vehicle corrected in accordance with Campaign G-01512 will require a CTS-1075 Campaign Identification Label.

Attach the CTS-1075 label on a clean surface next to the vehicle identification number (VIN) plate.
