## **Technical Service Information**

## THM 4L60 (440-T4) REVISED ACCUMULATOR ASSEMBLY

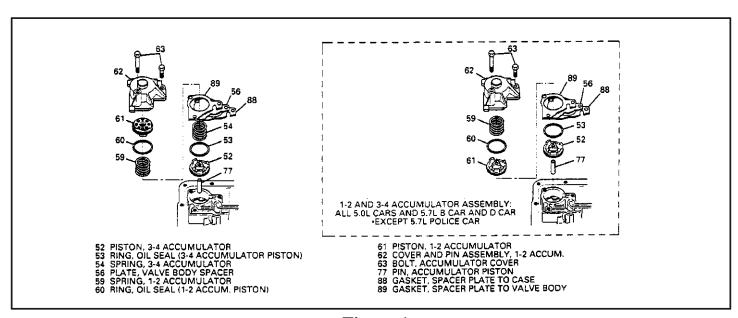
## Figure 1

Beginning with the Start of Production for 1993, <u>SOME MODELS</u> of the THM 4L60 (700-RA) transmissions were built with a new calibration that eliminates the 3-4 accumulator spring, and <u>INVERTS</u> the 1-2 accumulator piston and spring (See Figure 1).
