SHROUD UPPER REINFORCEMENT REMOVAL [PANEL REPLACEMENT]

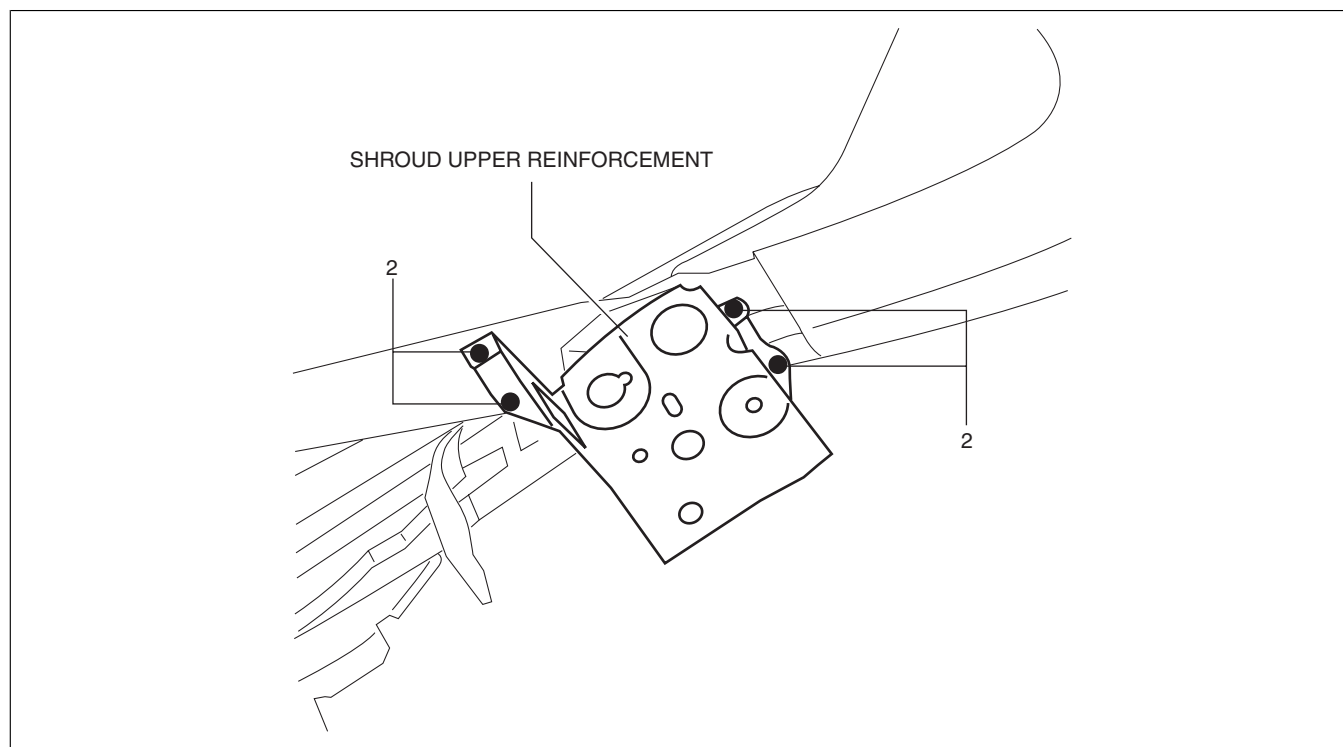
ac5wzb000000240

1. Drill the 4 locations shown in the figure.

- When drilling the 4 locations shown in the figure, do not drill a hole all the way through or there could be a problem when installing the new part.
