Technical Service Information

THM 3L80 (400) VALVE BODY GASKET CHANGE

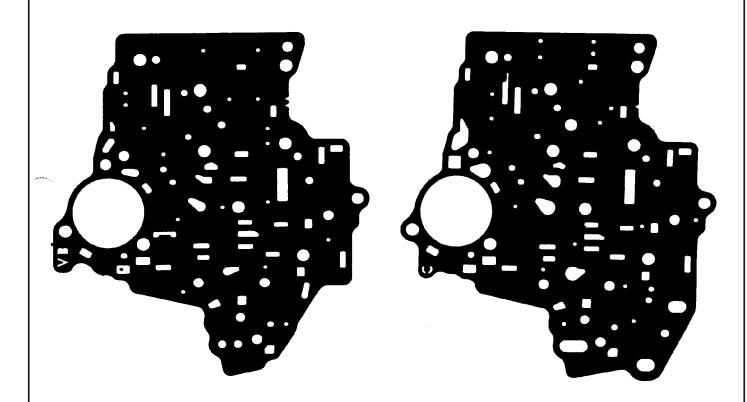
Figure 1

Beginning November 23, 1987, all TH400 transmissions were built, with new valve body gaskets. (SEE BELOW) This change and additional changes done to the case, valve body, and separator plate, were done to relieve a harsh park/neutral to reverse engagement shift feel.

8670447
SEE BULLETIN 88-33 FOR CASE AND SEPARATOR PLATE DIFFERENCES.
