FORD AXOD PUMP & VALVE BODY GASKET CHANGES

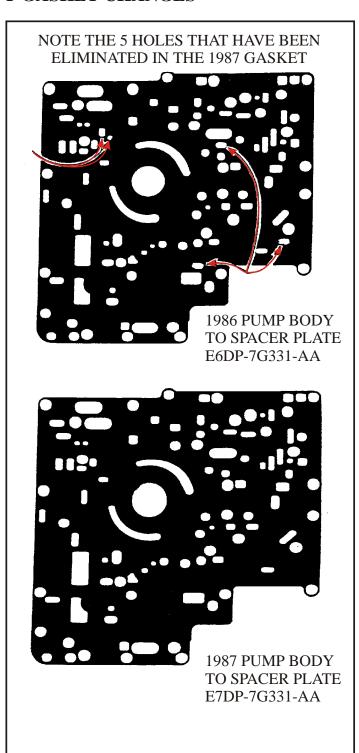
The pump to plate and the plate to valve body gaskets have been changed in 1987. The valve body to plate and the plate to chain cover have also been changed for 1987. The changes are illustrated in this bulletin. IMPORTANT- THE 1986 GASKETS WILL NOT FIT THE 1987 UNITS. NOR WILL THE 1987 GASKETS FIT THE 1986 UNITS. A MIS-MATCH OF THESE GASKETS CAN CAUSE A SLIP, A DELAYED ENGAGEMENT OR A 1-2 SLIDE BUMP.

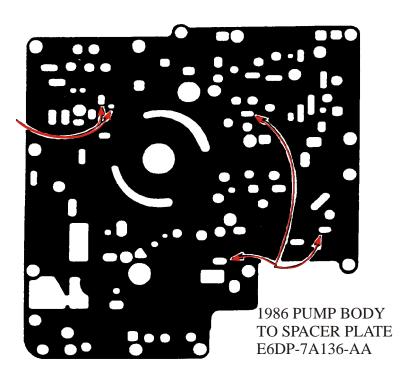
NOTE THE 5 HOLES THAT HAVE BEEN ELIMINATED IN THE 1987 GASKET

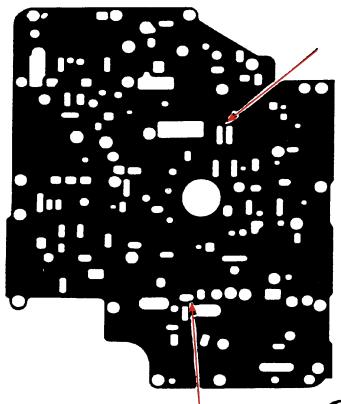
1987 VALVE BODY TO SPACER PLATE GASKET E7DP-7DIOO-AA NOTE: THESE THREE HOLES ADDED TO THE 1987 GASKET

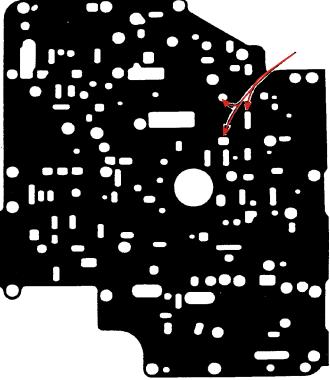
1986 SPACER PLATE TO CHAIN COVER E6DP-7C155-AA NOTE: THESE THREE SLOTS ELIMINATED IN 1987 GASKETS

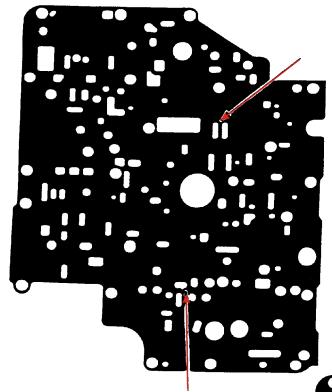
1987 SPACER PLATE TO CHAIN COVER E7DP-7CI55-AA NOTE: THESE THREE HOLES ADDED TO THE 1987 GASKET
